Improved Load Rating Procedures for Deteriorated Unstiffened Steel Beam Ends

- **Current State of Inspection and Corrosion Topologies**
- **Corrosion Mapping via 3D Scanning**
- **Laboratory Experiments and Capacity Evaluation of Rolled Girders with Corroded Ends**

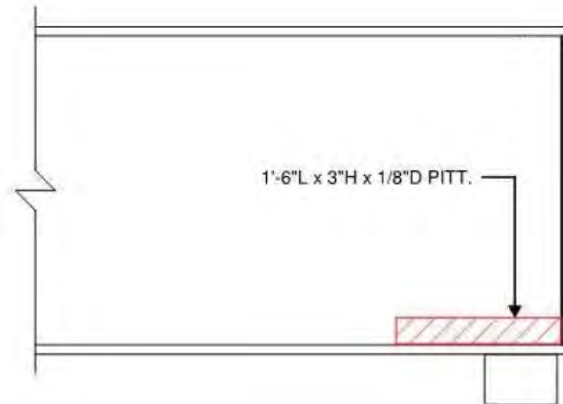
Stringers: Rolled Beams

Poor Condition-See Description

Extensive rust scale with moderate to heavy section loss in the south abutment beam ends, perforations could soon occur.

Assume 24 WF 100 (smallest section):
T = 22.45"
tw = .468"
Original Area = T*tw = 10.5 in²
Lost Area = 3" x (1/8)"/2" = .1875 in²

$100 \cdot (.1875/10.5) = 1.8\%$

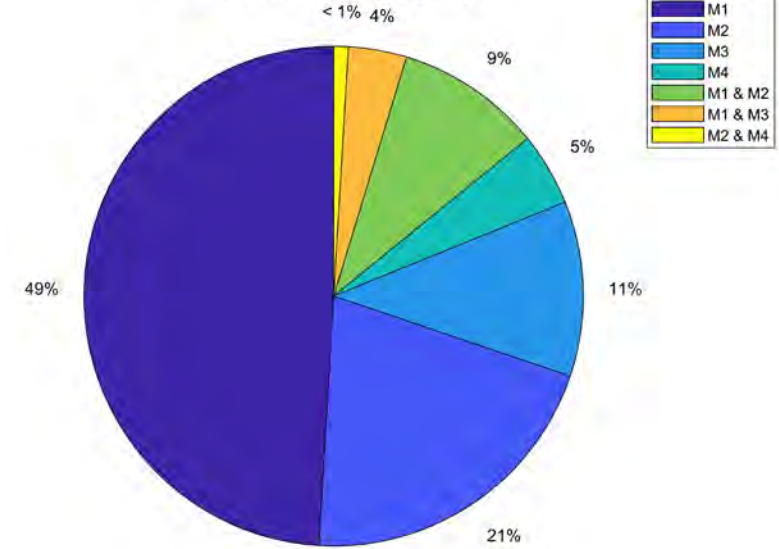
Holes Observed With a Diaphragm

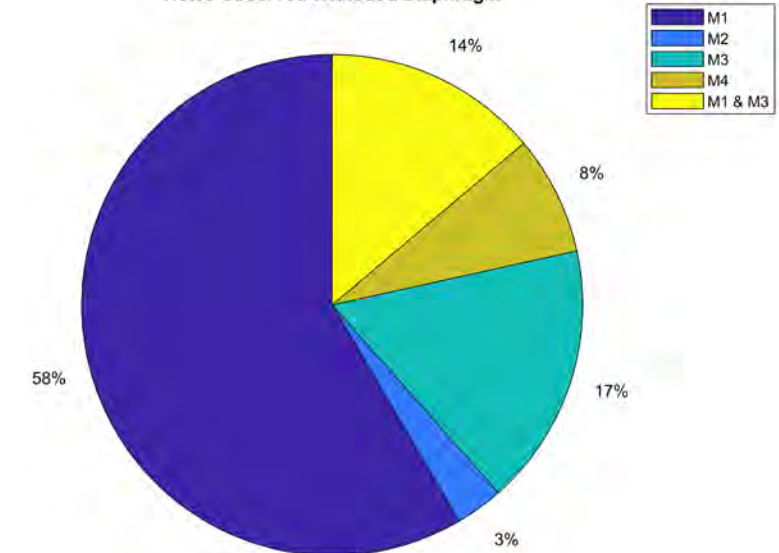
Holes Observed Without a Diaphragm

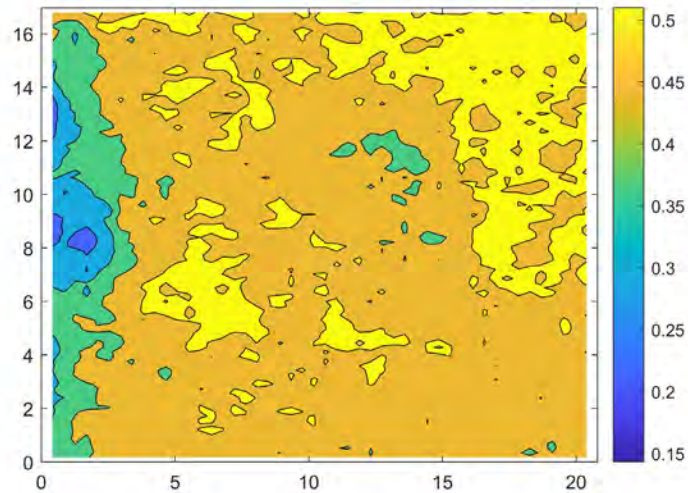
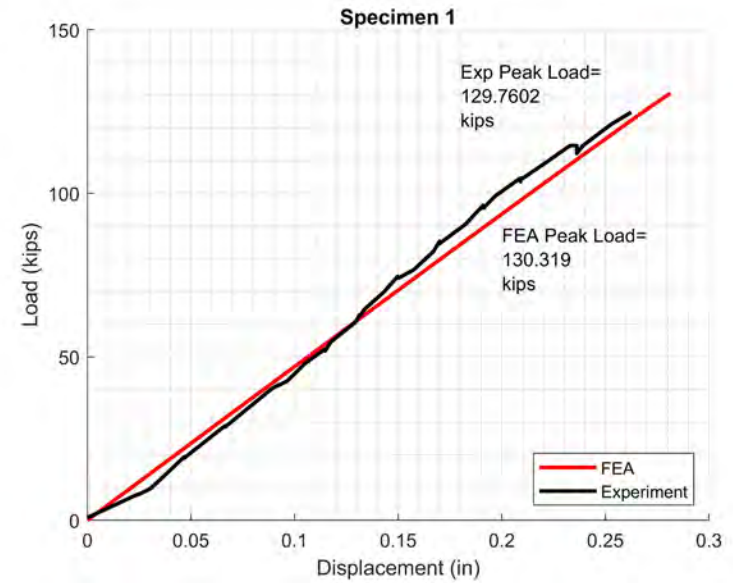
Beam Type: AS 24x65.4 (best match)
Intact Thickness: 0.51 inches
Height: 20 inches

Peak Load:
129.76 kips

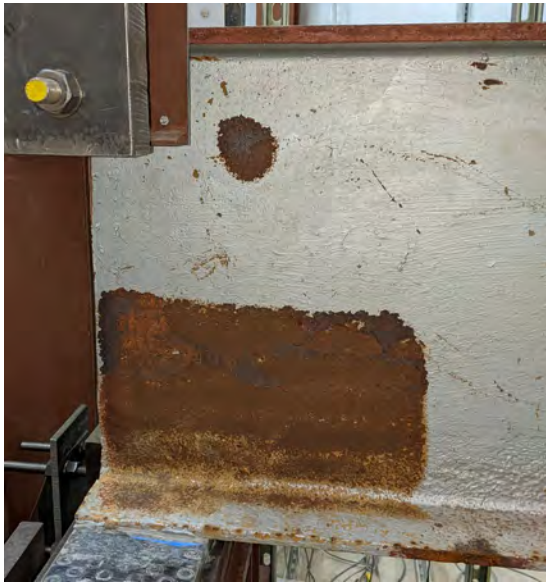
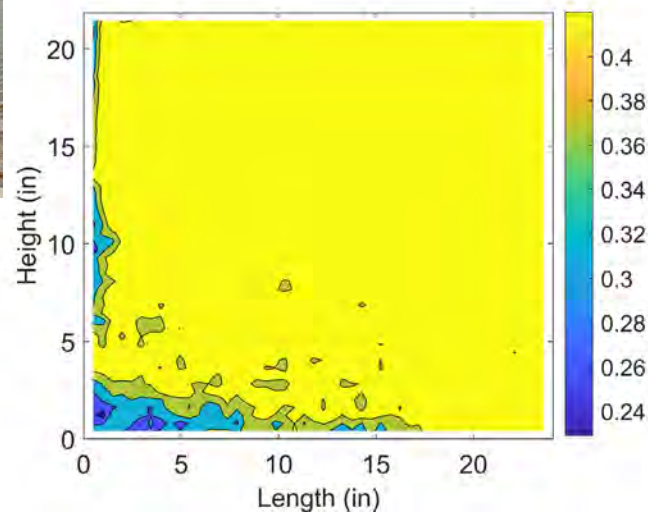
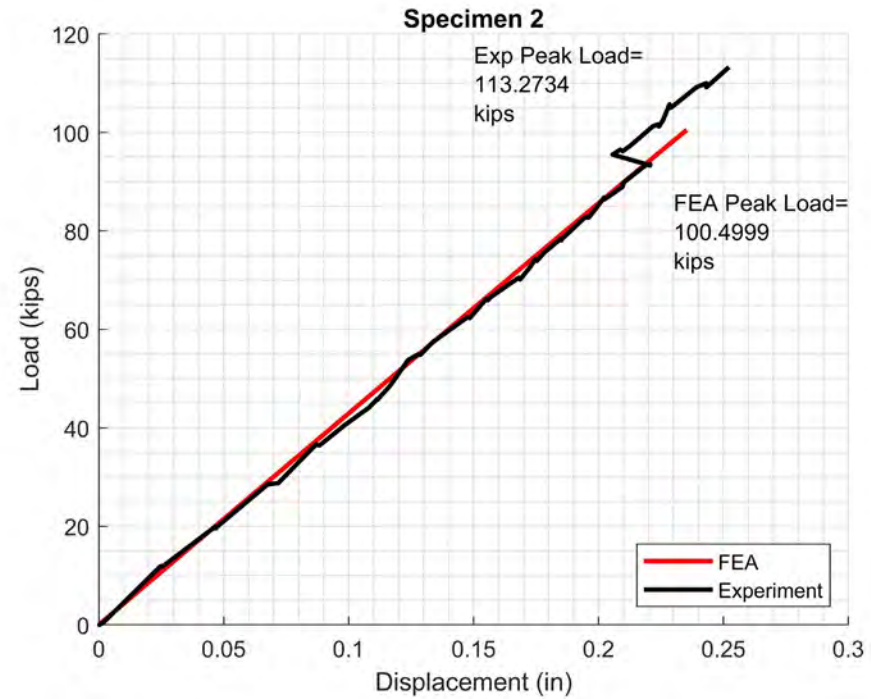
Beam Type: CB 24x8.5 (Best match)
Intact Thickness: 0.42 inches
Height: 24 inches

Peak Load:
113.27 kips

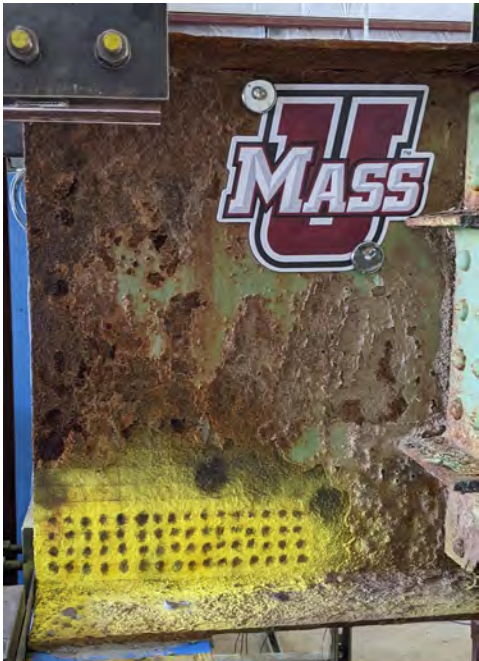
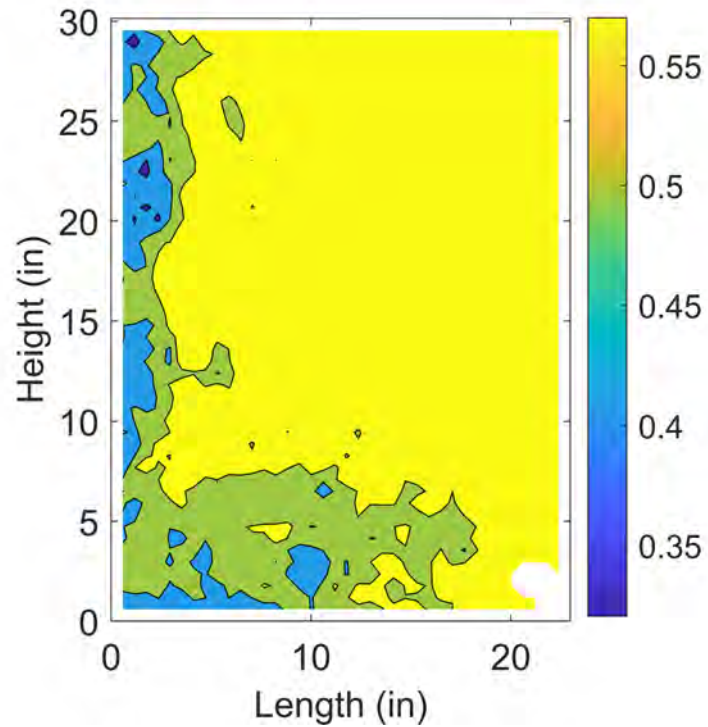
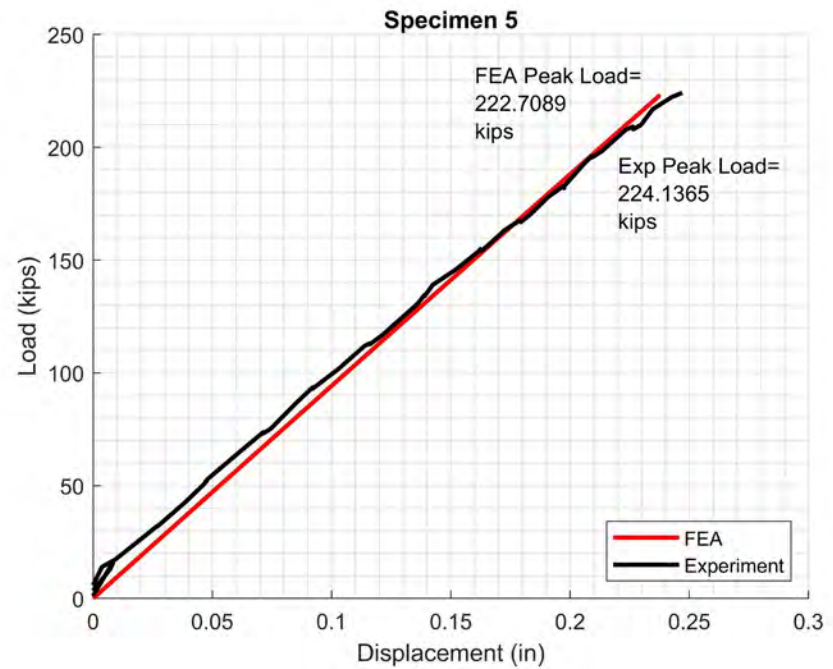
Beam Type: B33x132 Assumed
Intact Thickness: 0.58 inches
Height: 33.150 inches

Peak Load:
 224.14 kips

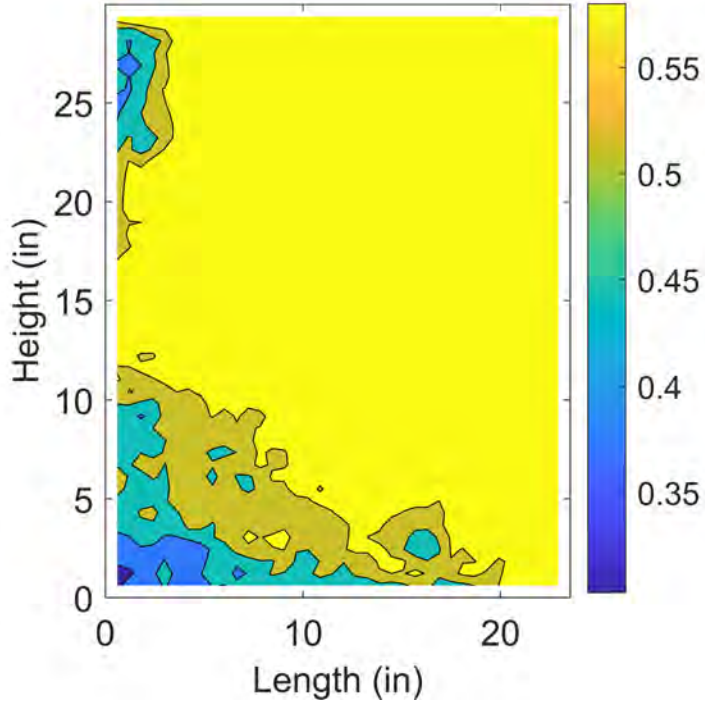
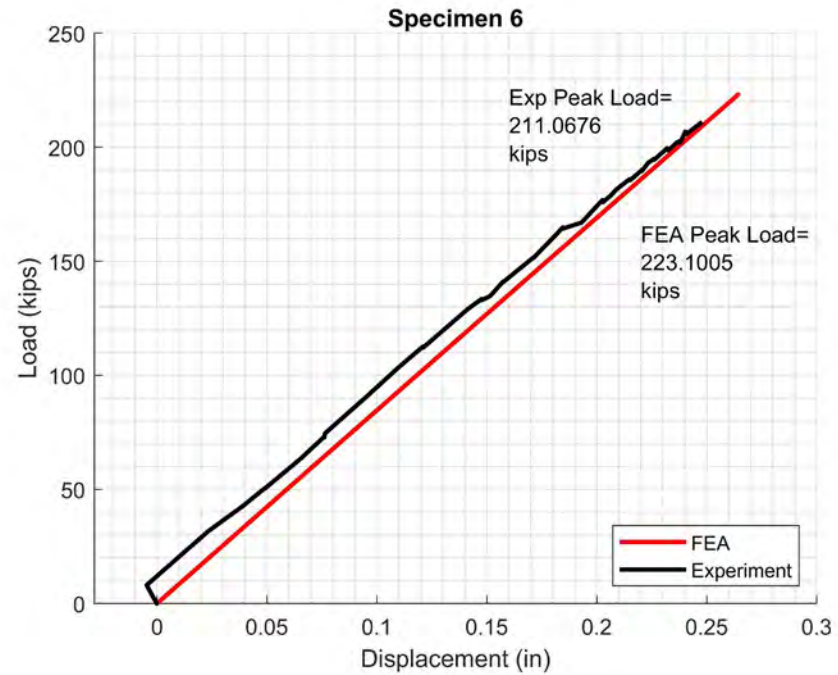
Beam Type: B33x132 Assumed
Intact Thickness: 0.58 inches
Height: 33.150 inches

Peak Load:
211.06 kips

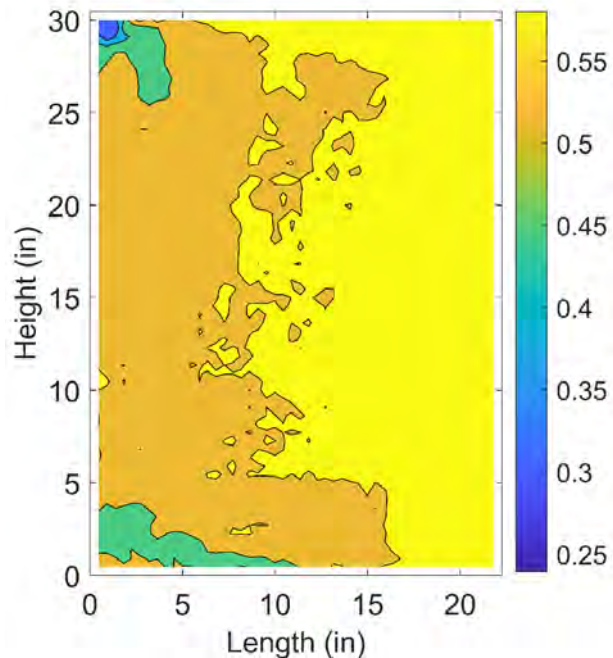
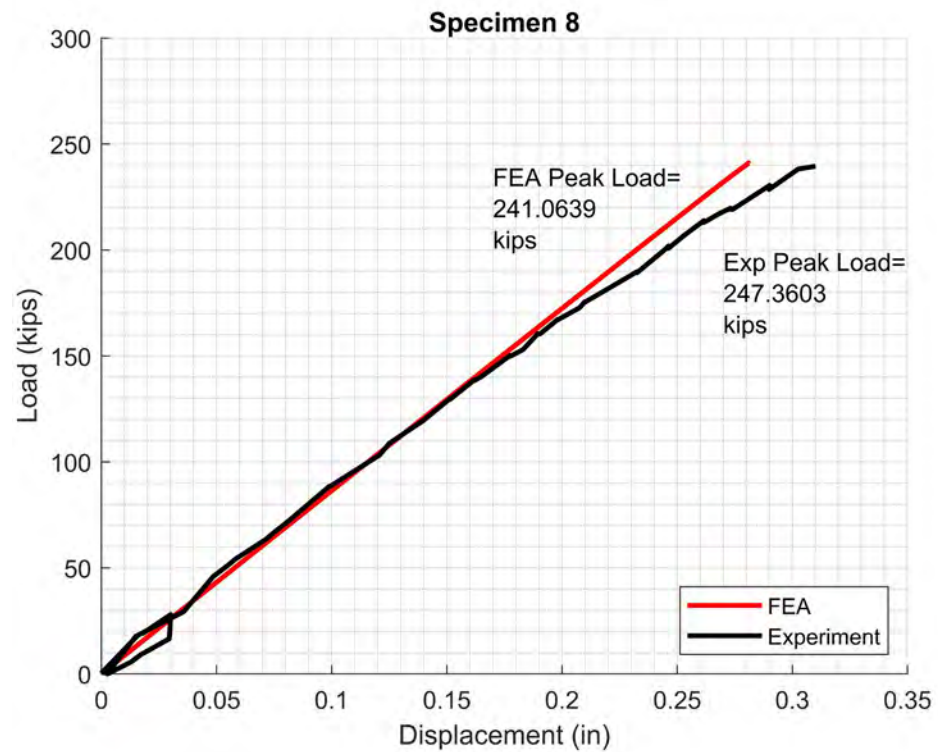
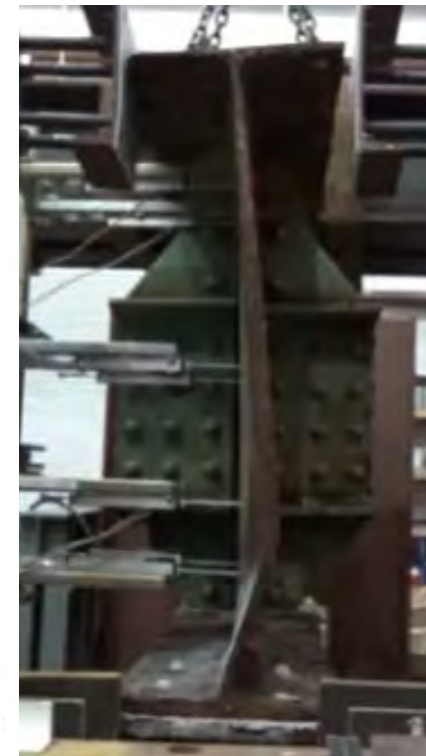
Beam Type: B33x132 Assumed
Intact Thickness: 0.58 inches
Height: 33.150 inches

Peak Load:
 247.36 kips

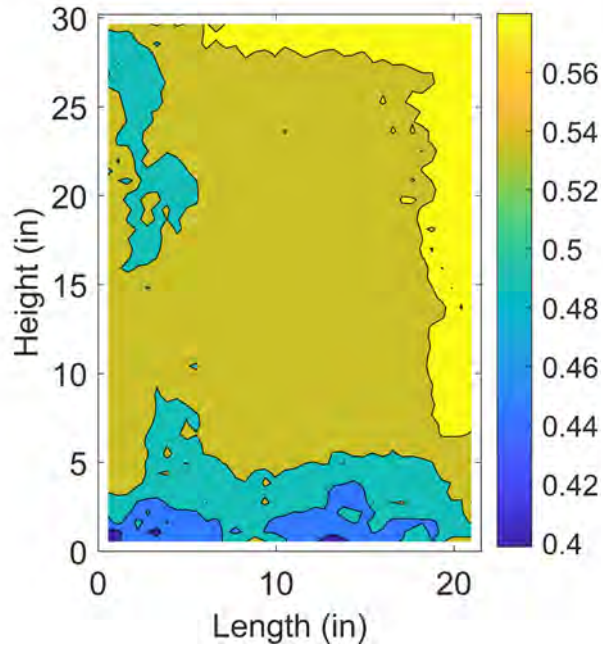
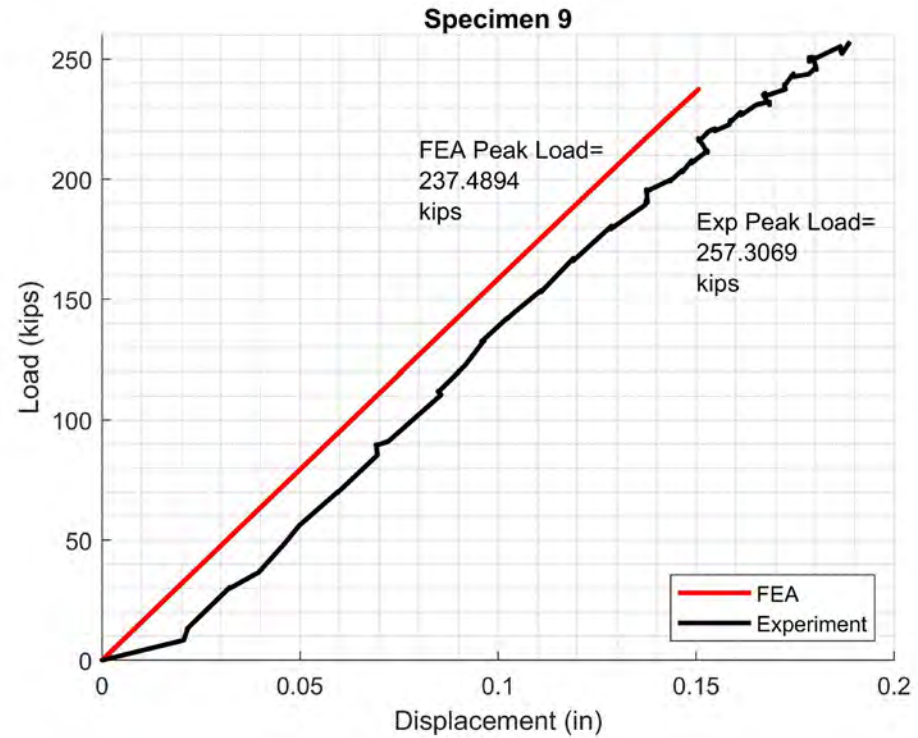
Beam Type: B33x132 Assumed
Intact Thickness: 0.58 inches
Height: 33.150 inches

Peak Load:
257.31 kips

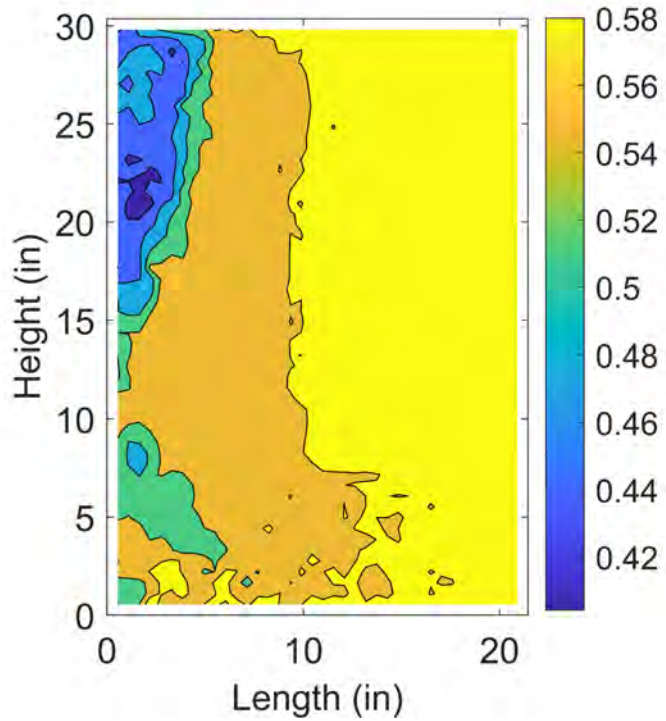
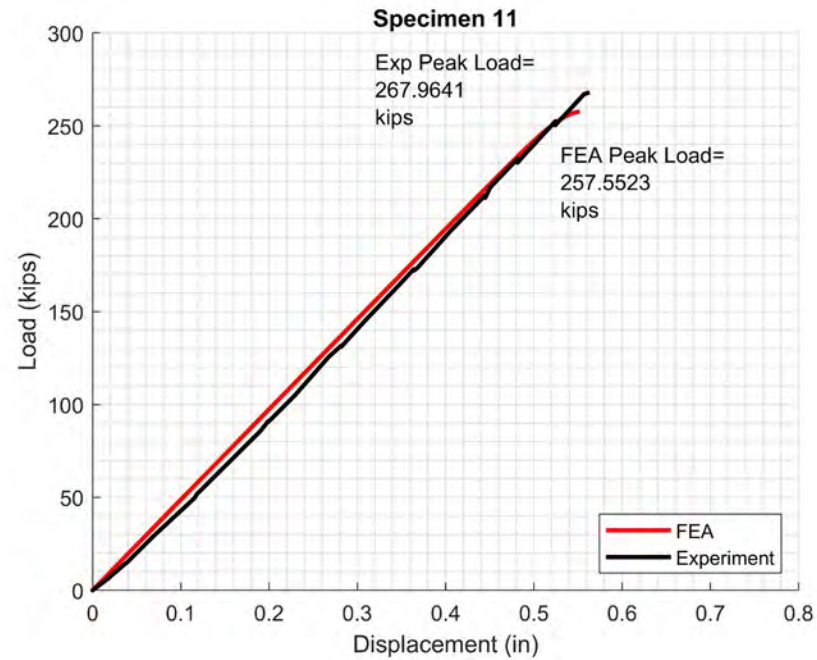
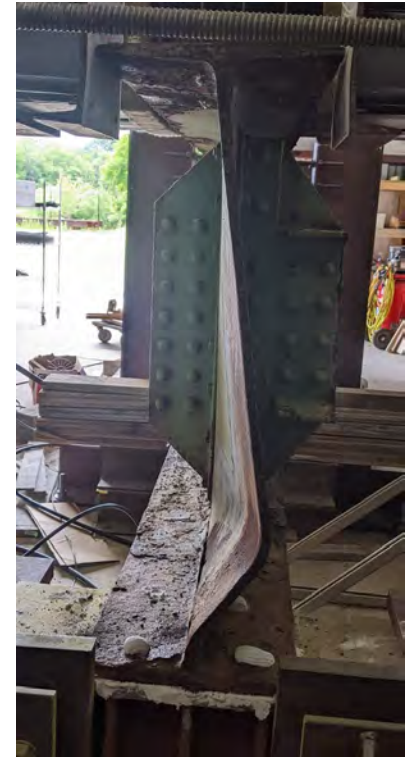
Beam Type: B33x132 Assumed
Intact Thickness: 0.58 inches
Height: 33.150 inches

Peak Load:
267.14 kips

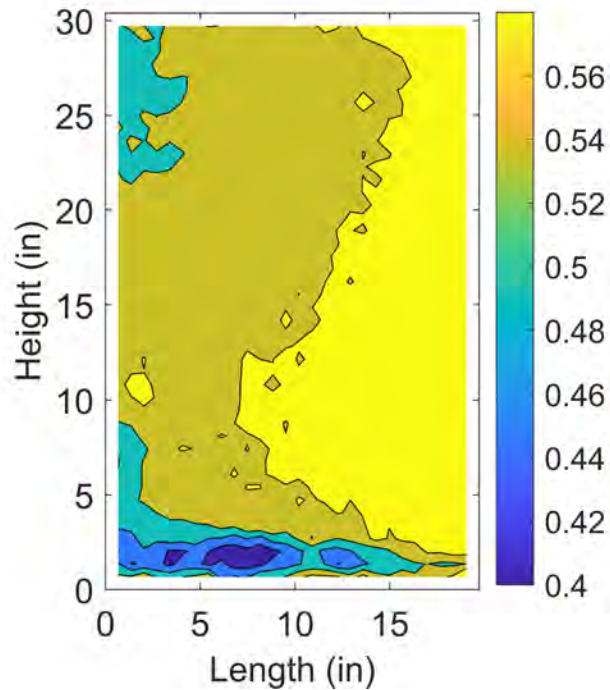
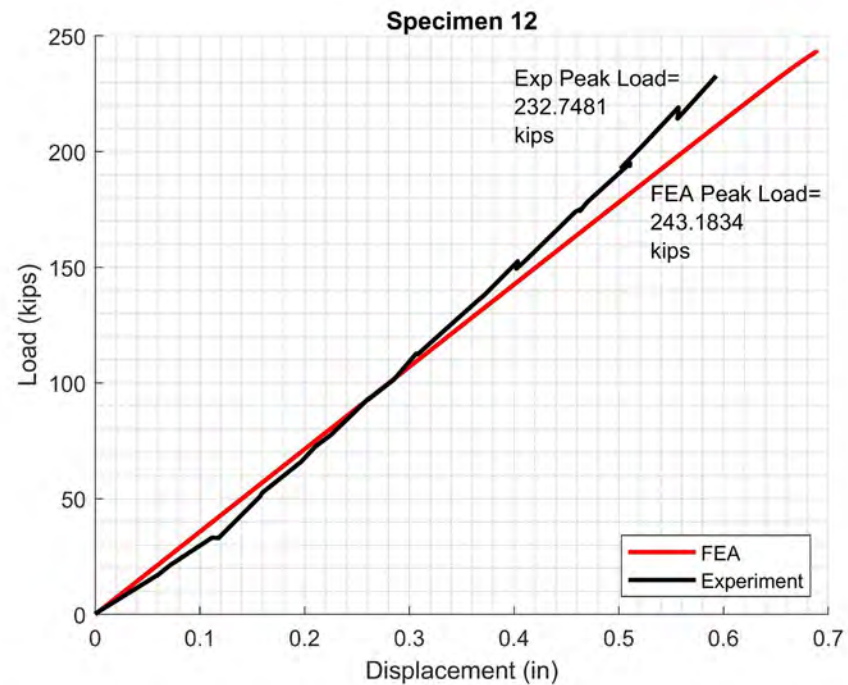
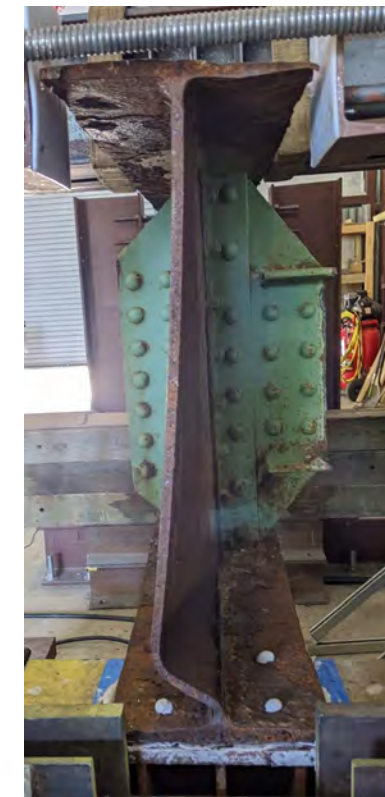
Beam Type: B33x132 Assumed
Intact Thickness: 0.58 inches
Height: 33.150 inches

Peak Load:
232.32 kips
