Investigation of Northern Long-Eared Bat Roosting Sites on Bridges

Prepared for
The New England Transportation Consortium
May 25, 2017

NETCR 100

Project No. 14-2

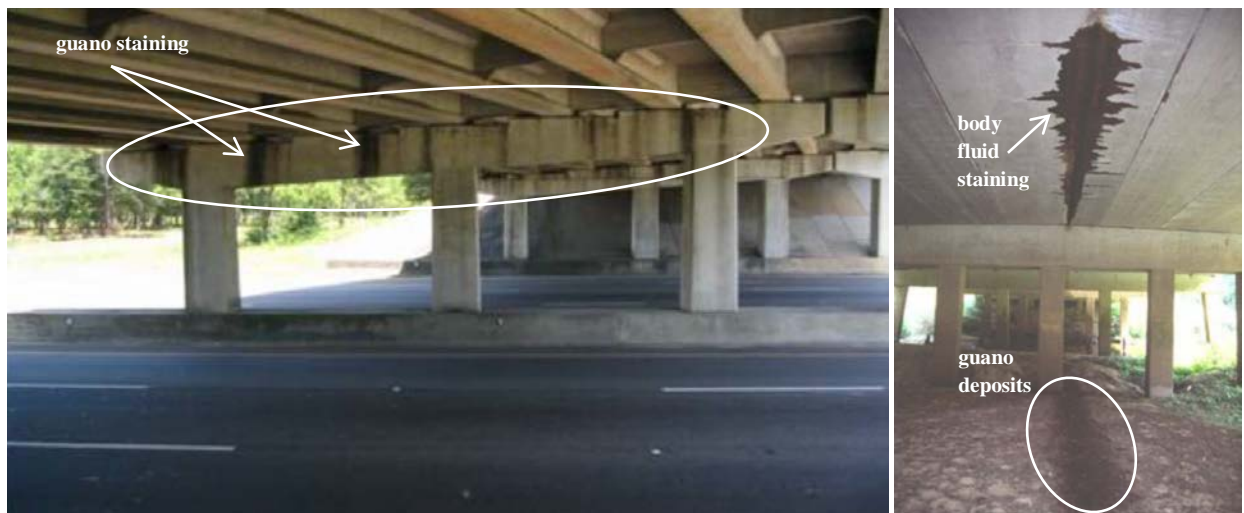
Figure 2-7: Bridge staining from known bat usage (photos courtesy of Jeff Gore, Florida Fish and Wildlife Conservation Commission)

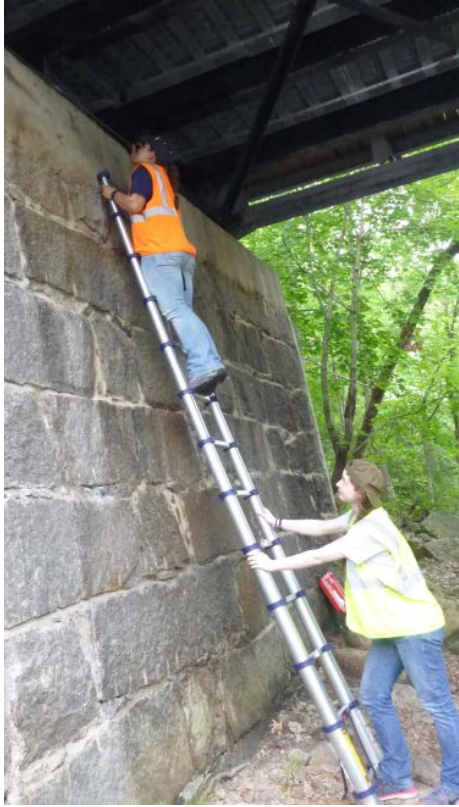
Figure 3-1: Demonstrating visual inspection of bridges utilizing a ladder and flashlight

The main pieces of equipment used in visual inspection were flashlights, waders, a ladder for investigating crevices, and a monocular and a borescope for investigating inaccessible crevices, as well as a camera for documentation. Flashlights fitted with red bulbs were utilized when inspecting inside crevices to avoid potential disturbance to bats, though white light was often used once likely absence was determined for the crevice. A Milwaukee 12-volt lithium-ion 9.5 mm M-Spector AV inspection camera kit borescope was also utilized. This borescope has a small 0.4 in (9.5 mm) camera head on a 3 ft (0.9 m) rigid cable allowing for inspection of crevices in the bridge and in small spaces otherwise inaccessible. The zoom feature allows for better inspections, and the LED brightness control can be useful in not disturbing any bats found roosting in crevices. Compared to other units, the Milwaukee borescope was chosen as it was equipped with the necessary features for inspection, including the appropriately small camera head and long cable, and was a recommended, durable brand. The borescope was utilized to investigate deep crevices and hard to reach cracks and expansion joints. In some cases, the borescope was also useful in identifying the source of staining at bridge locations. Figure 3-1 demonstrates visual inspection of bridges using a ladder and flashlight. Figure 3-2 shows the use of the borescope to investigate crevices in the bridge.

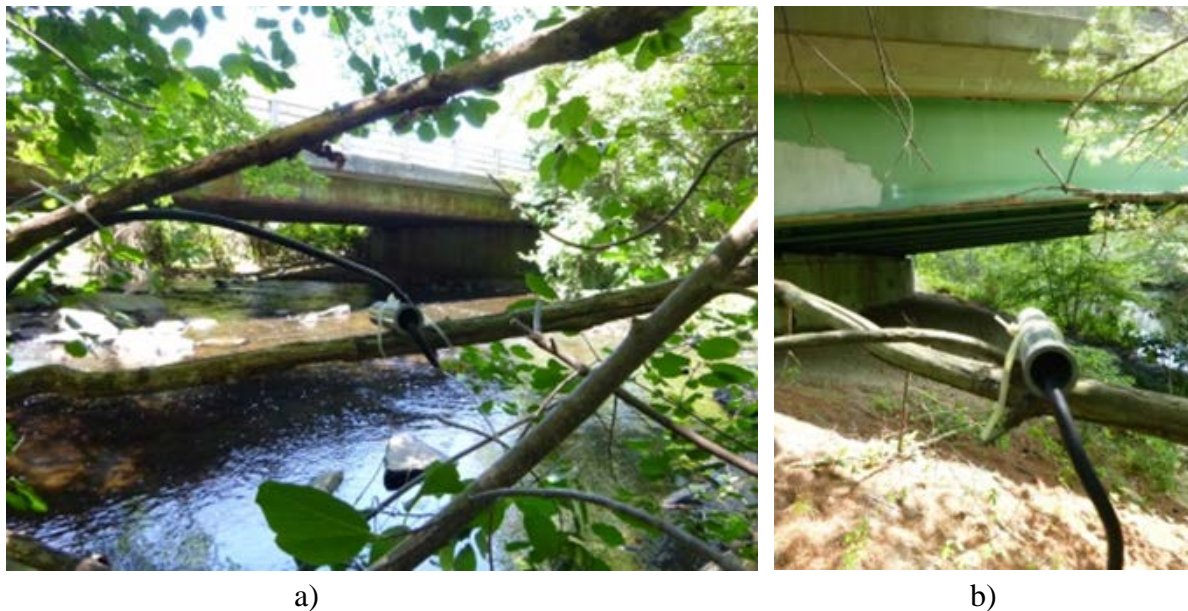
Figure 3-3: Microphone/detector placement (a) generalized and (b) localized

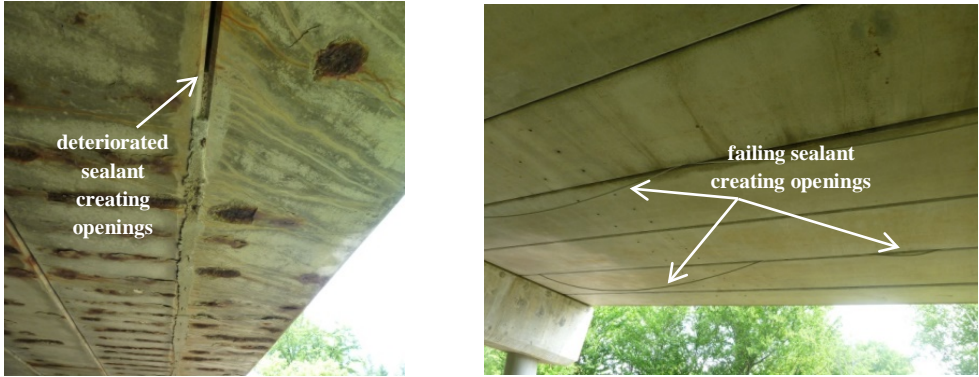
Figure 3-7: Deterioration of the sealed gaps between beams

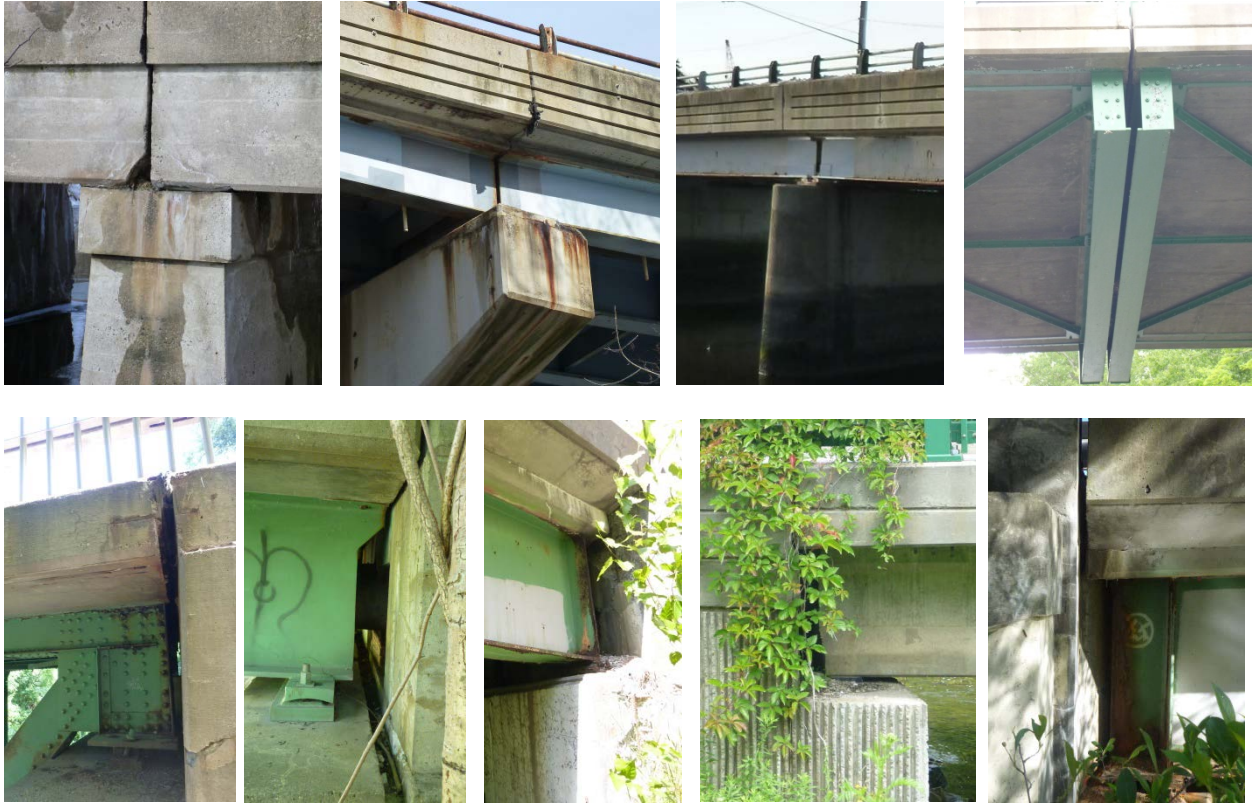
Figure 3-8: Expansion joints

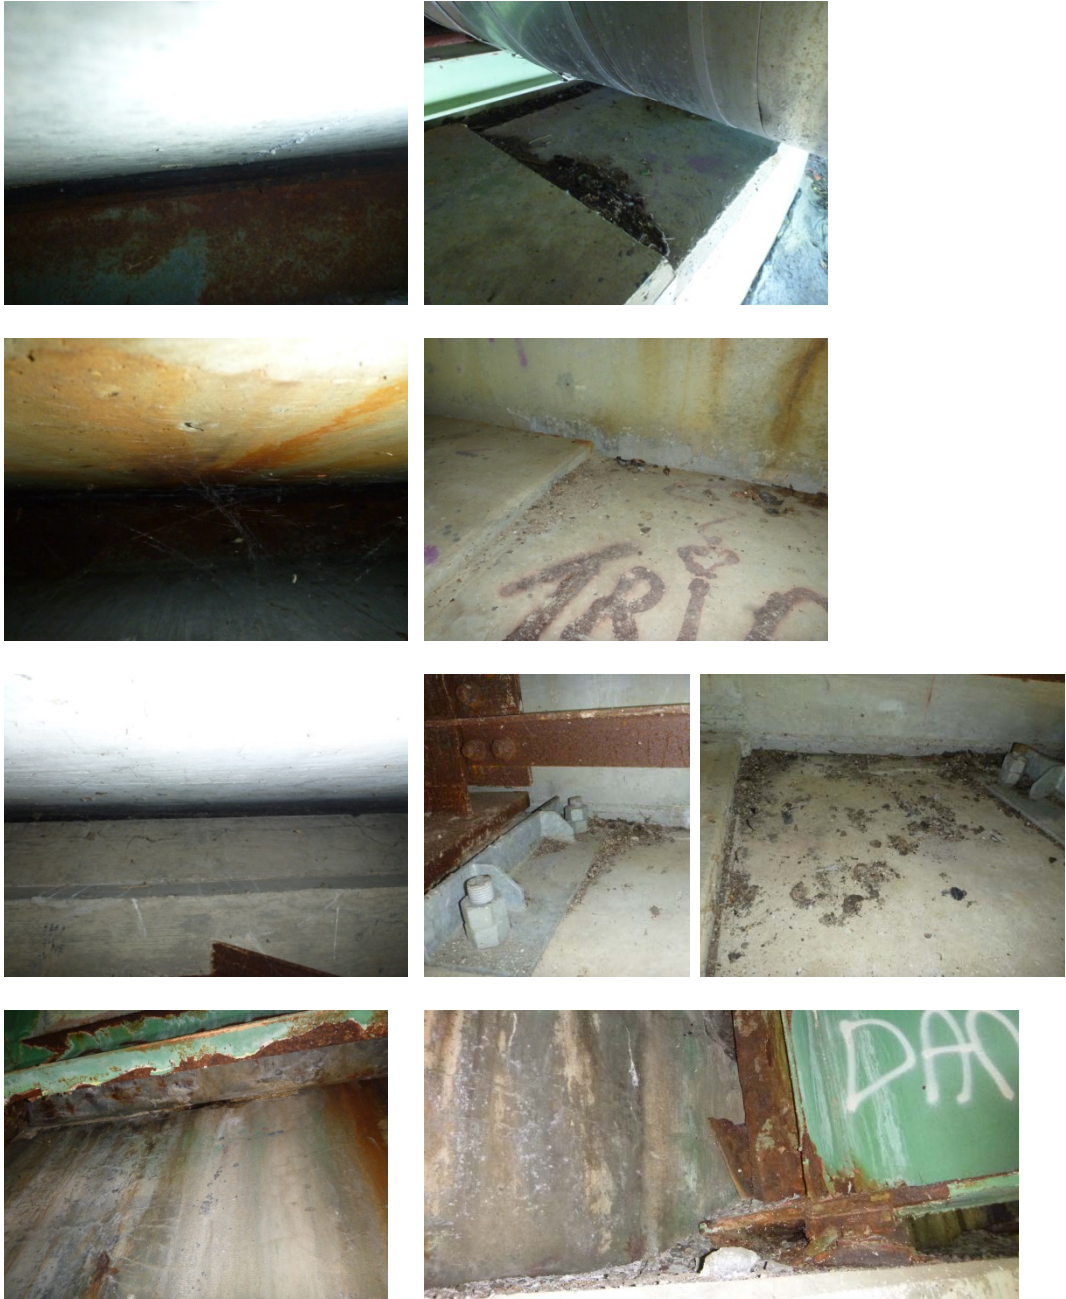
Figure 3-9: View into the expansion joint (left), and the material found below (right)

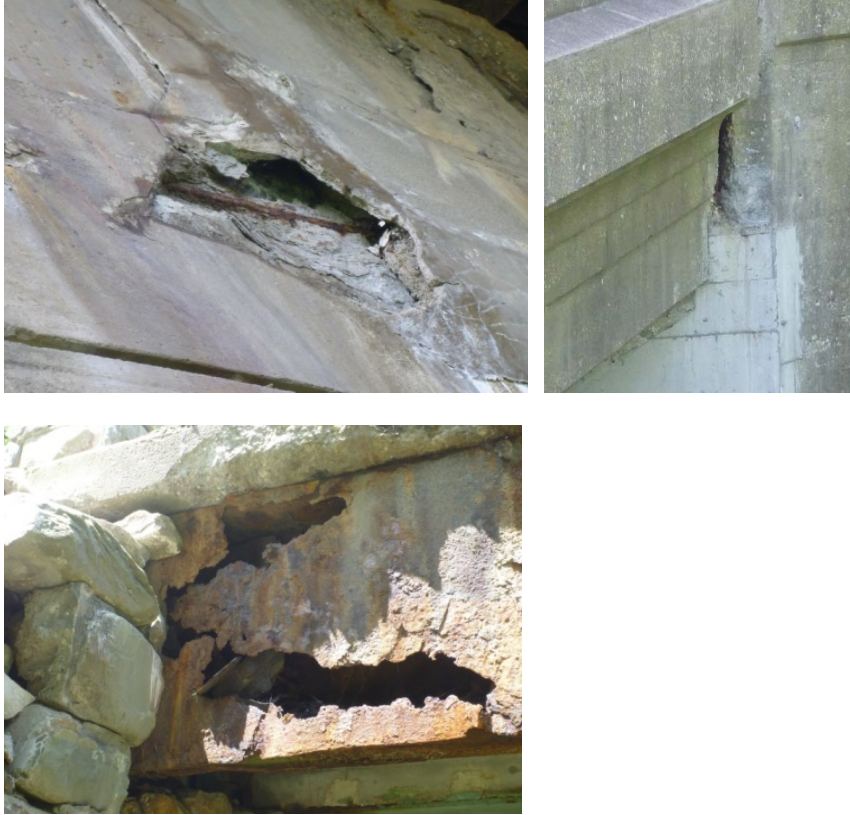
Figure 3-10: Localized deterioration creating suitable roosting crevices

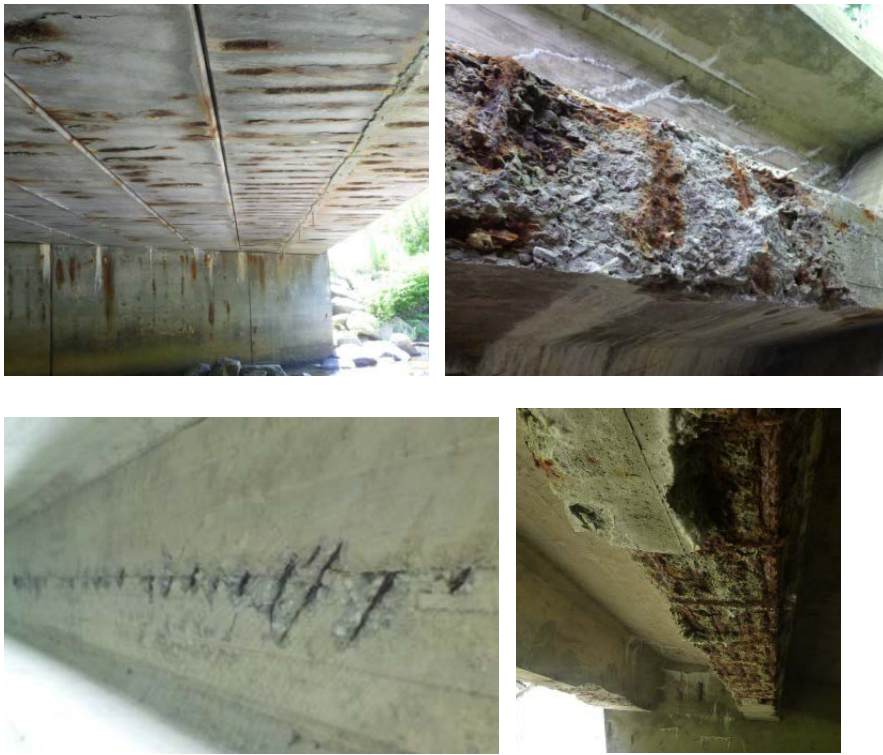
Figure 3-11: Not all deterioration will create crevices

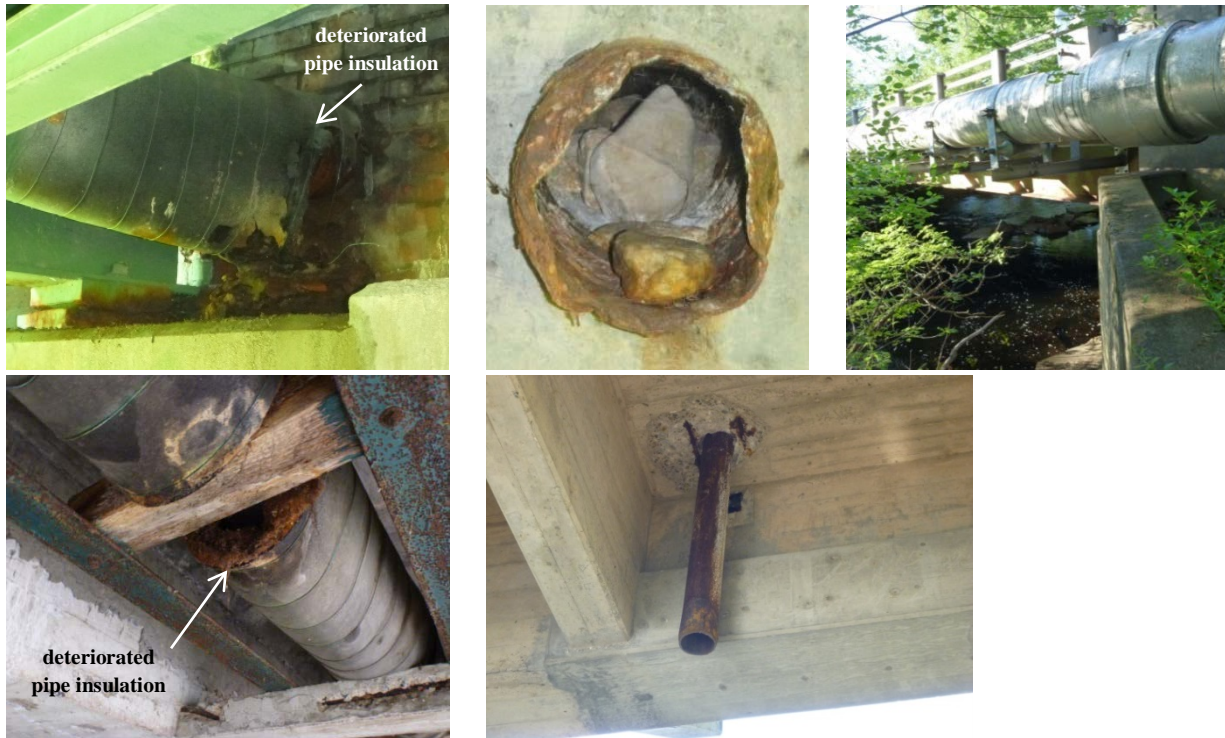
Figure 3-12: Pipes can create suitable roosting locations

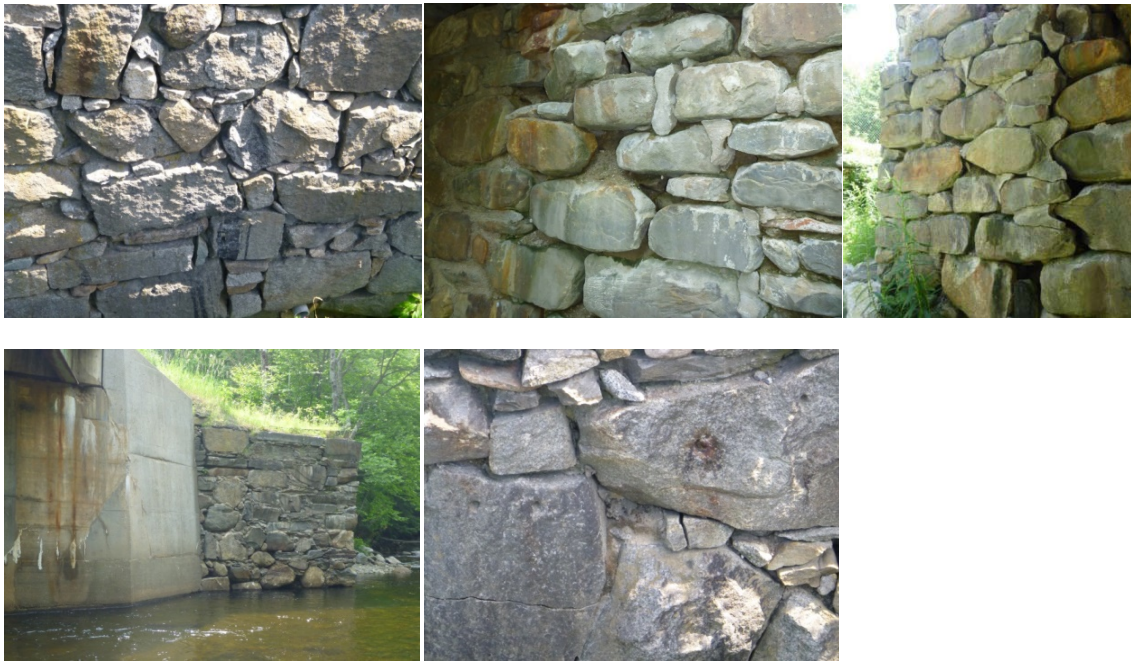
Figure 3-16: Non-grouted stonework (a) or deteriorated grout (b) creates suitable roosting crevices and locations

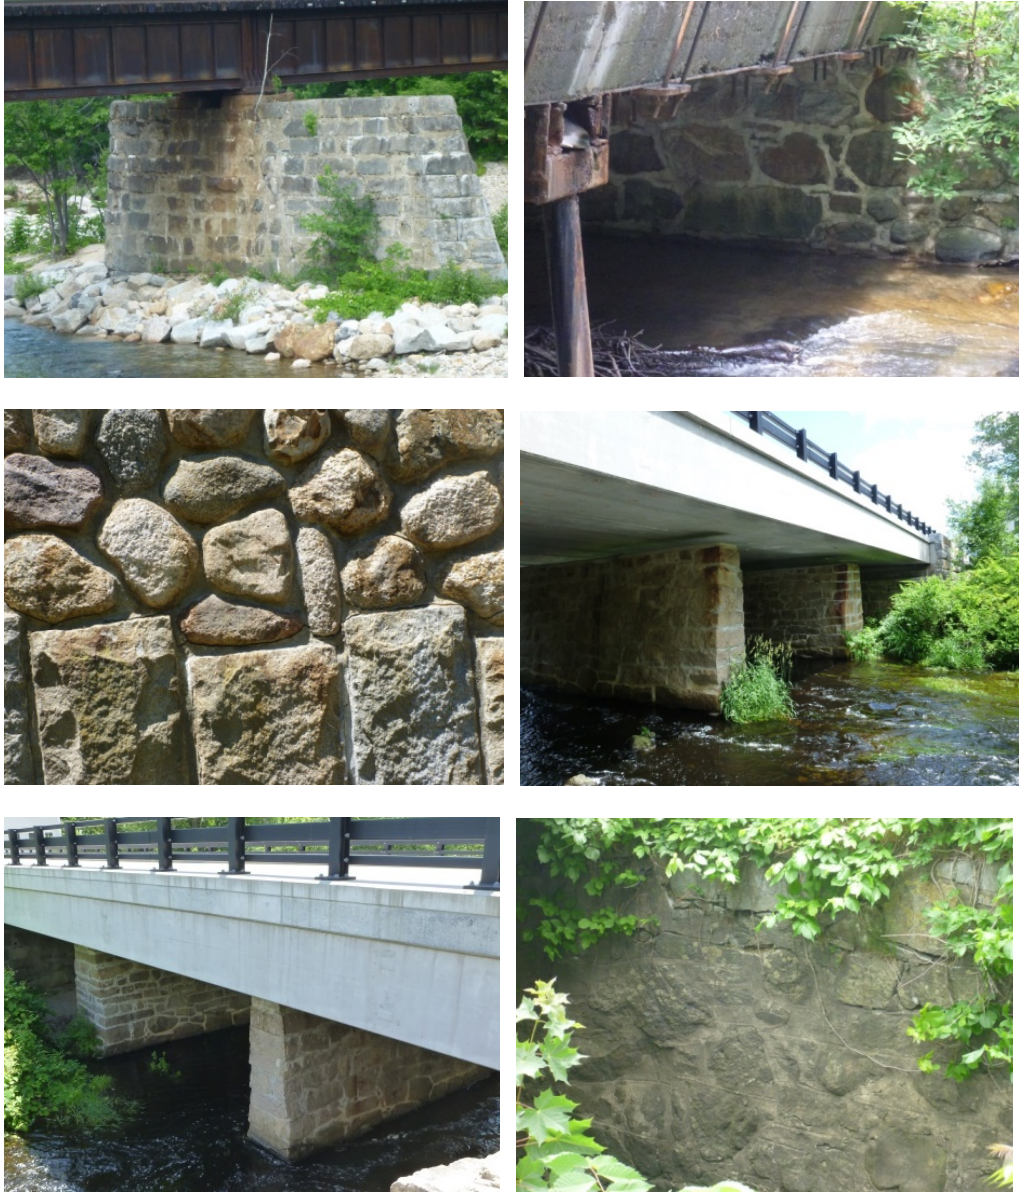
Figure 3-17: Grouted stonework does not create suitable roosting crevices and locations

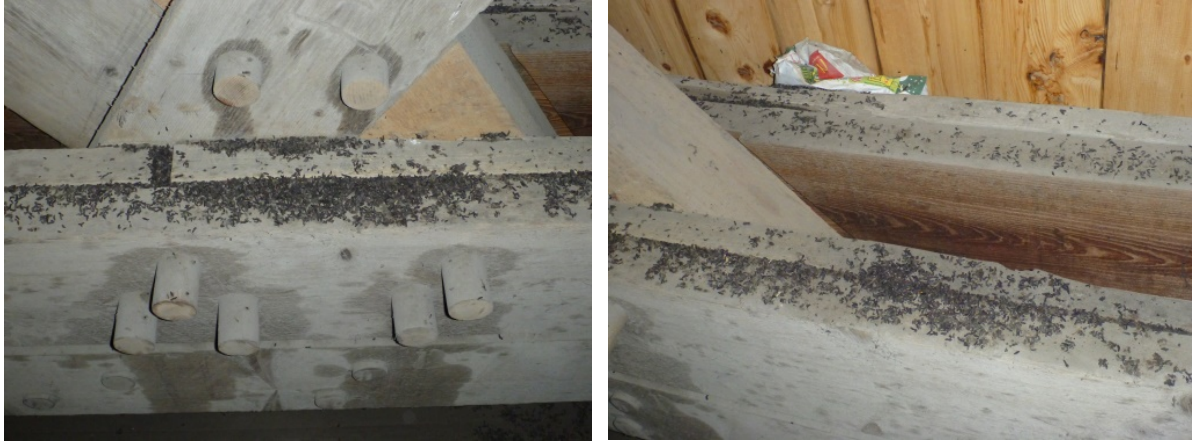
Figure 4-1: Guano evidence of roosting at bridge in Addison County, VT (confirmed as MYLU through DNA sequencing)

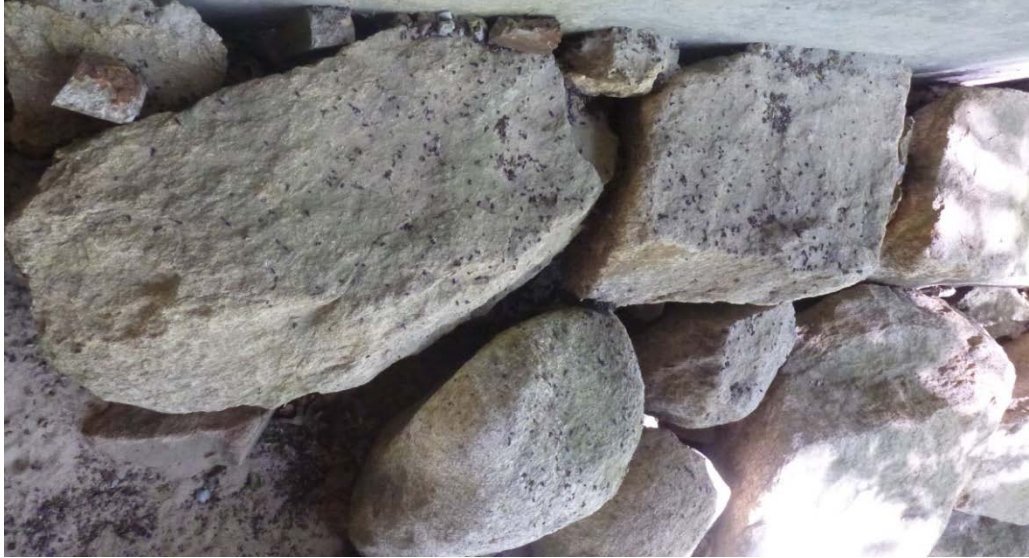
Figure 4-11: Guano evidence of roosting at bridge in Washington County, RI (confirmed as EPFU through DNA sequencing)

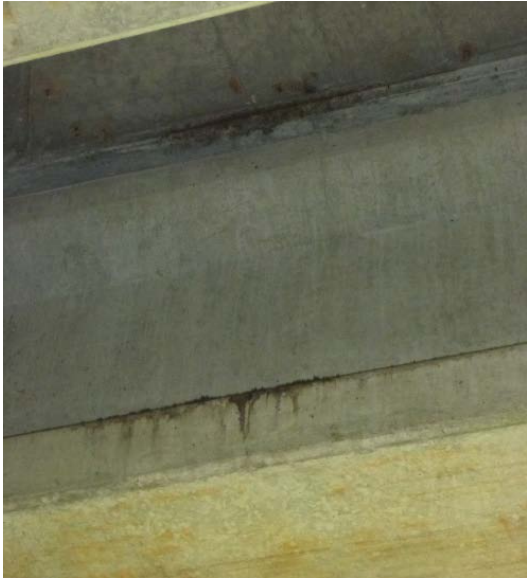
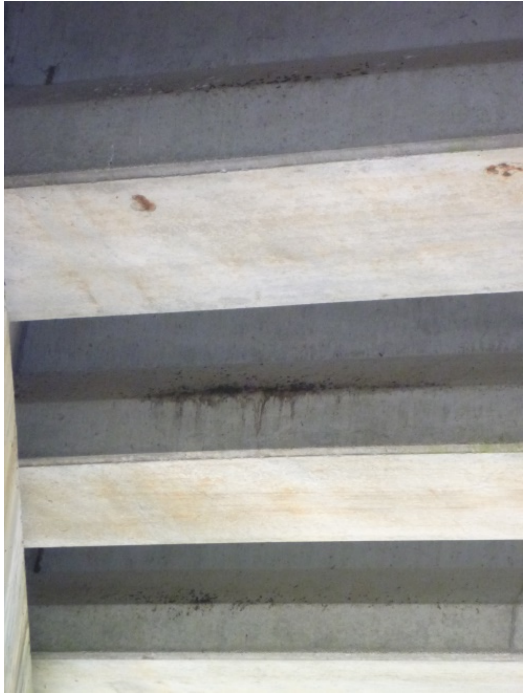
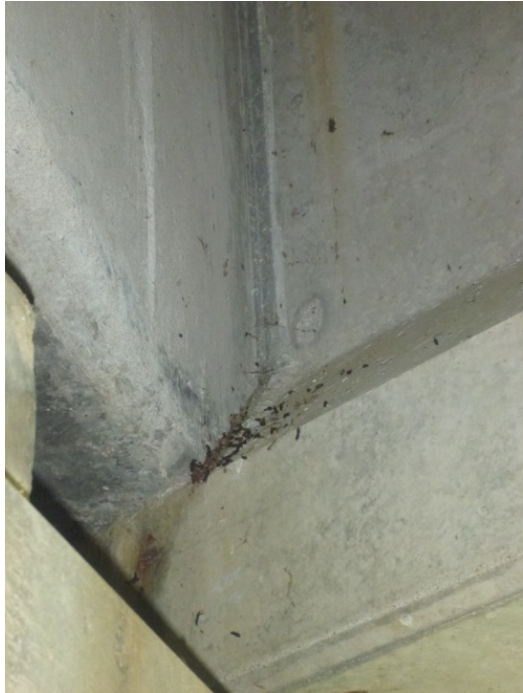
Figure 4-12: Staining evidence of roosting on bridge girders at bridge in Washington County, RI

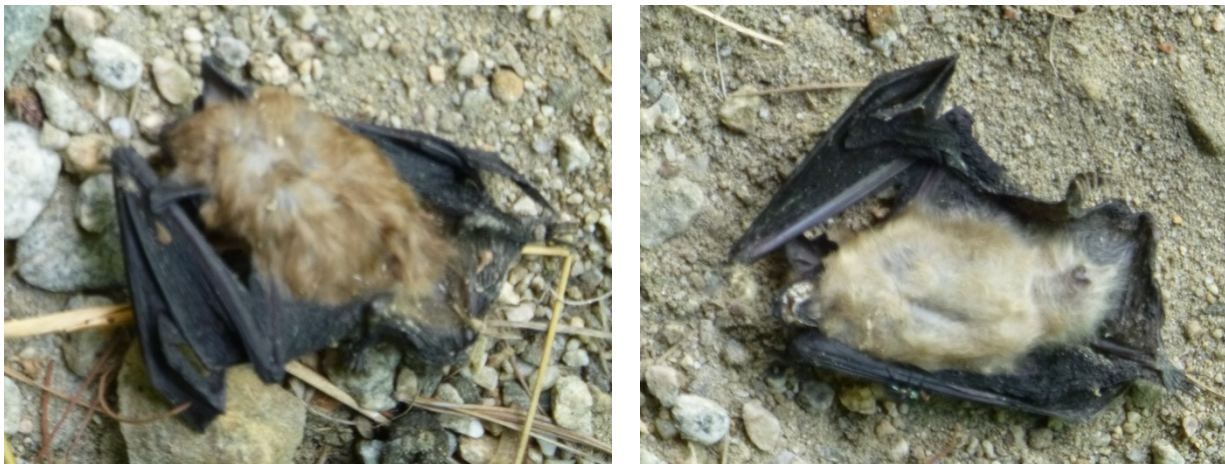
Figure 4-14: Dead bat found below abutment at bridge in Providence County, RI

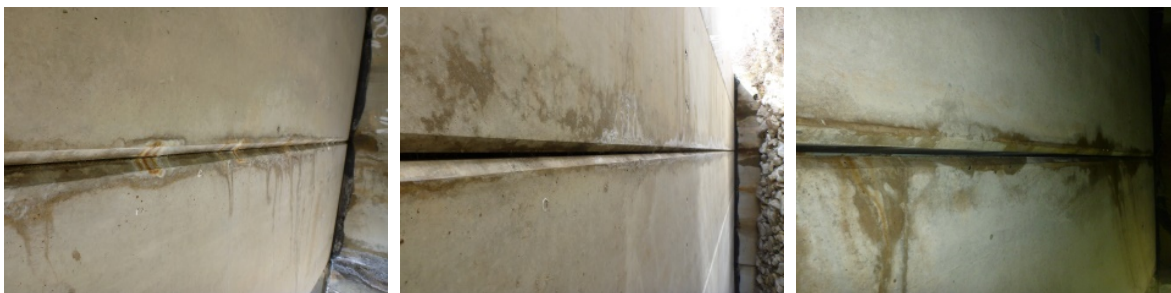
Figure 5-4: Staining of unknown causation between girders of CT-concrete

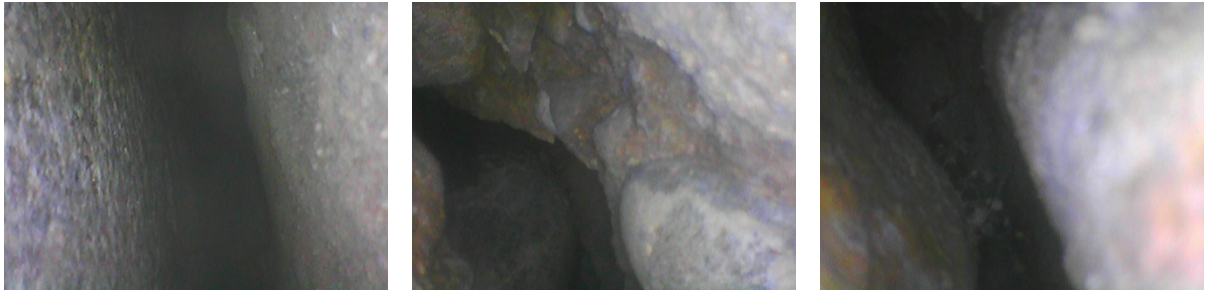
Figure 5-12: Boroscope view of gaps in non-grouted and deteriorated retaining walls by ME-concrete

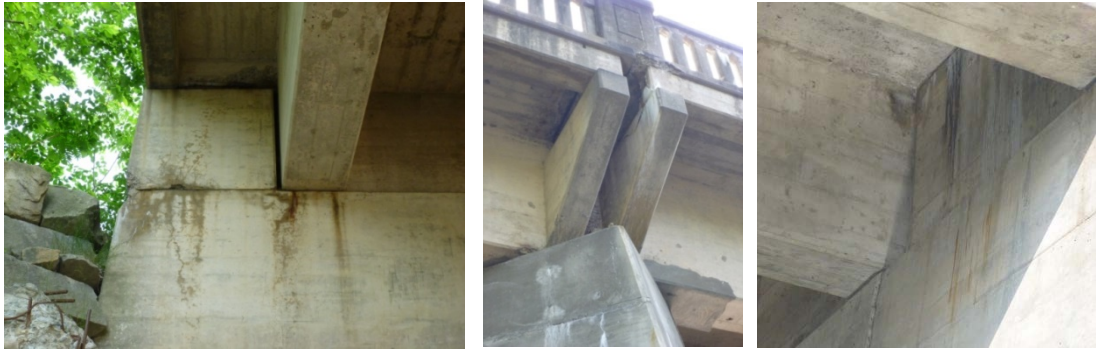
Figure 5-13: Possible roost locations at ME-concrete

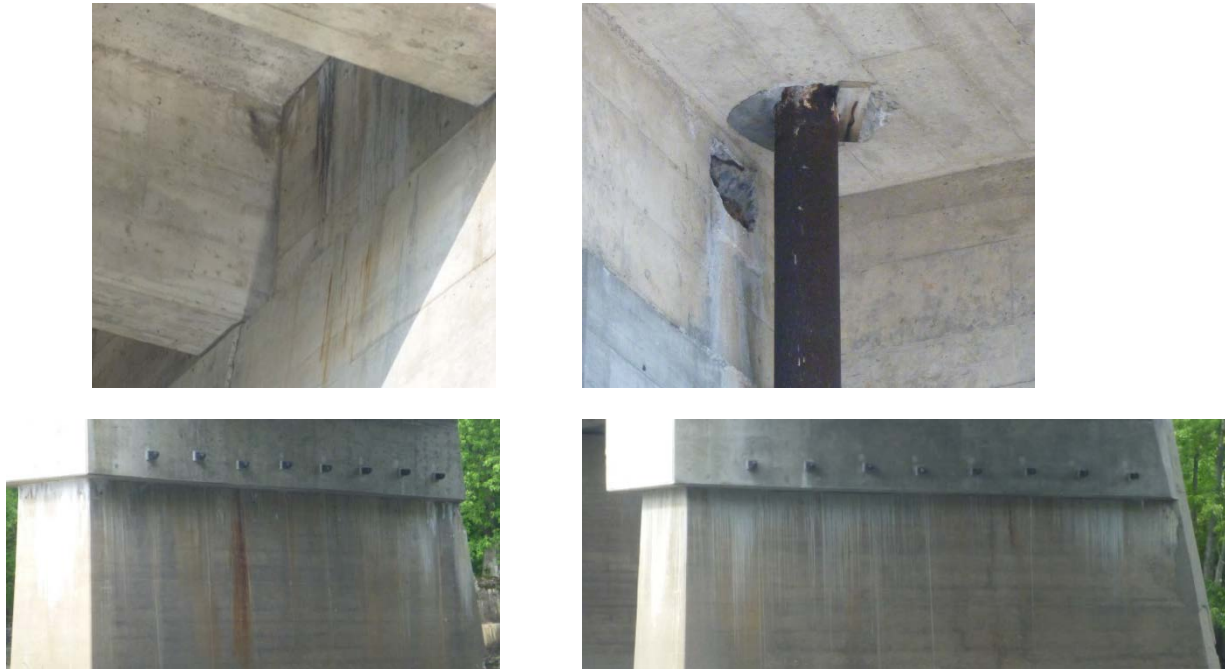
Figure 5-14: Staining of unknown causation at ME-concrete

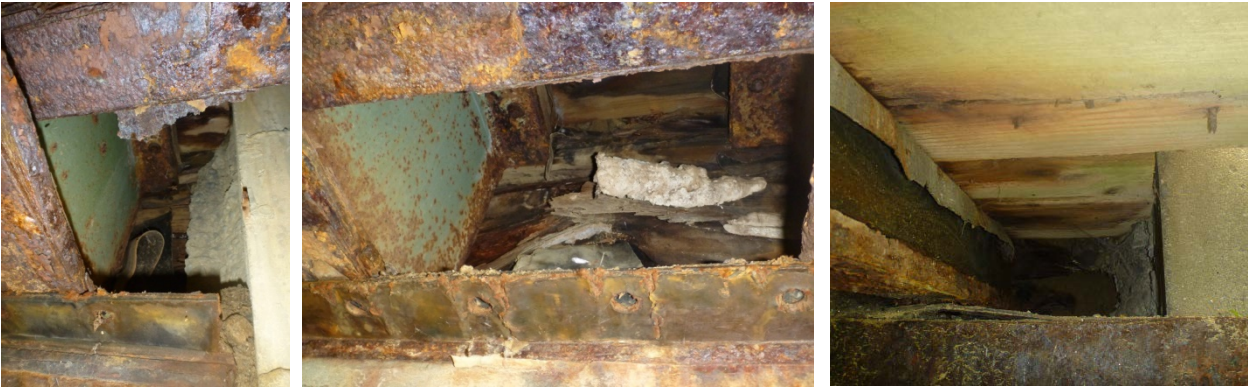
Figure 5-21: Potential roosts by the abutments in ME-steel/wood

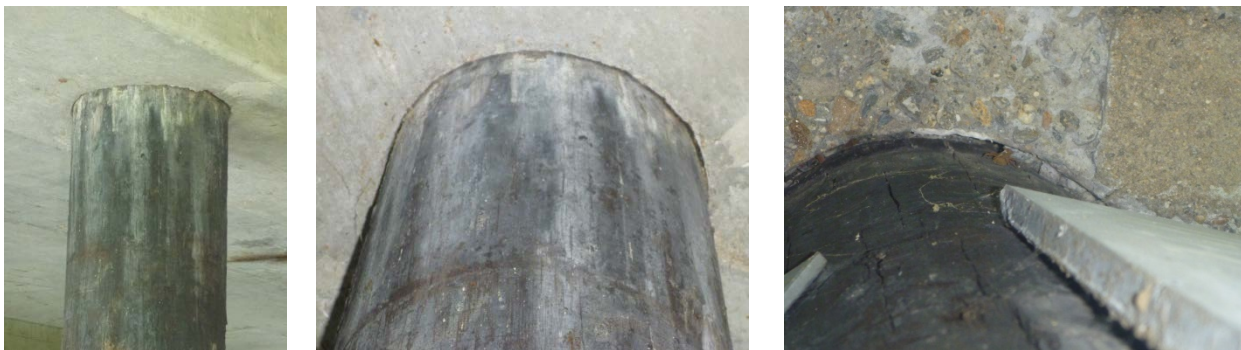
Figure 5-26: Staining on piers and gaps where piers meet deck at MA-concrete

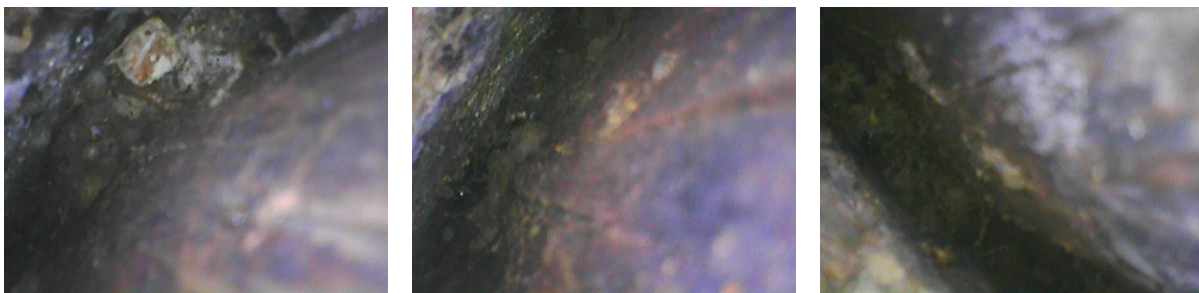
Figure 5-27: Boroscope views between deck and wooden piers at MA-concrete

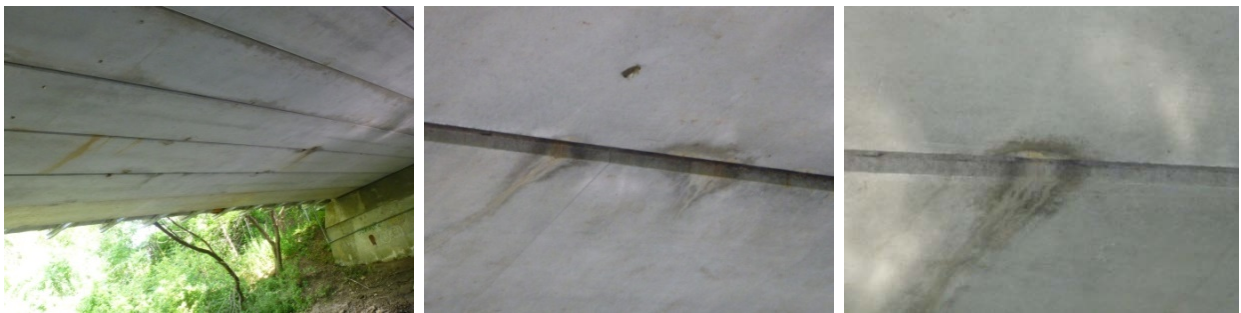
Figure 5-37: Staining in between beams in MA-precast_concrete

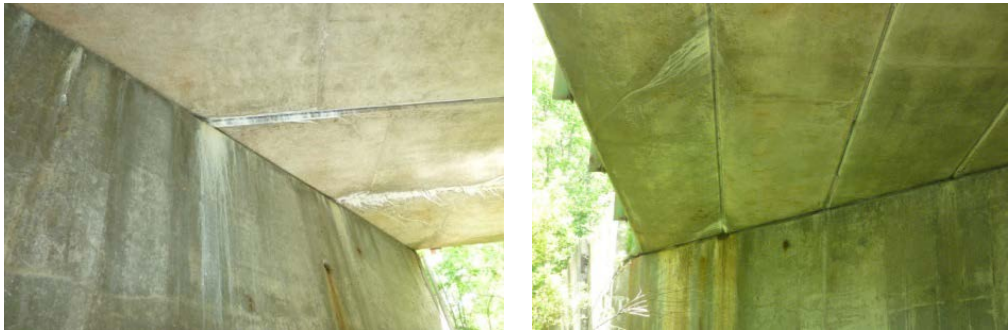
Figure 5-41: Staining of unspecified causation from gaps under beams at MA-precast_concrete_2

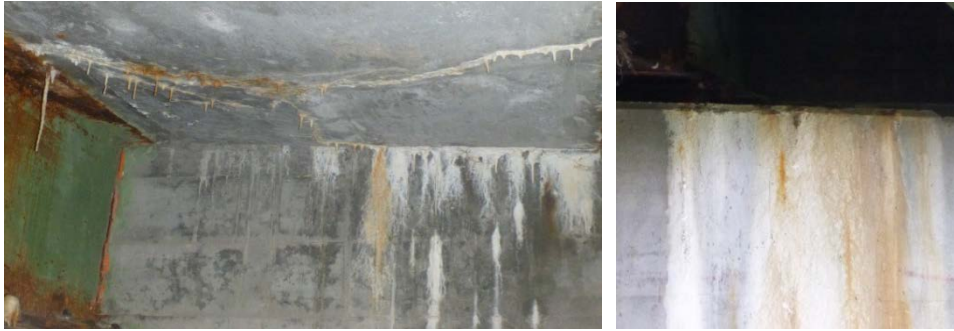
Figure 5-48: Staining of unconfirmed causation (likely structural) at MA-steel

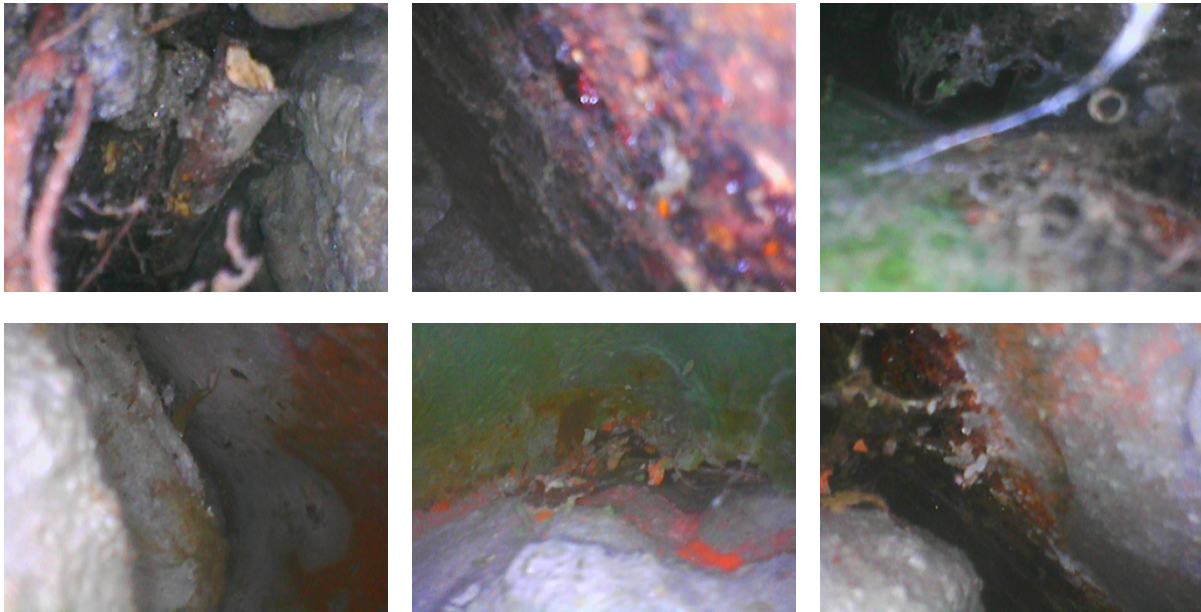
Figure 5-53: Boroscope views into cracks showing debris in crevices at MA-steel

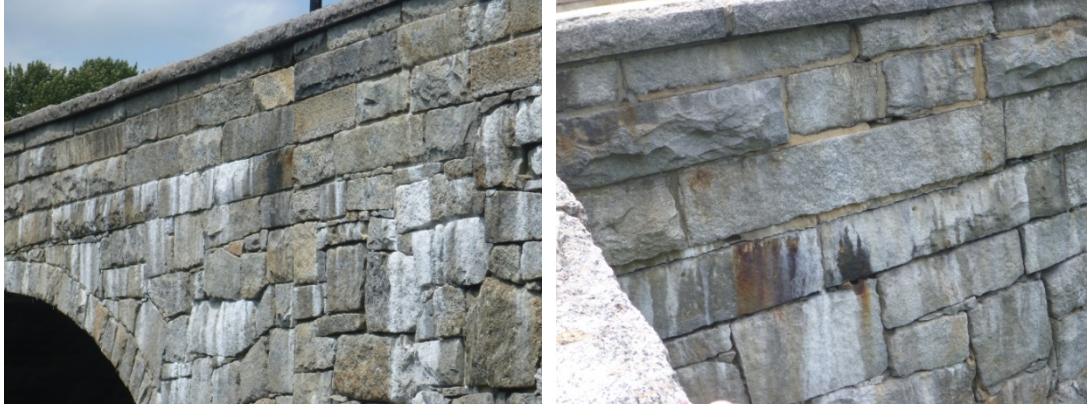
Figure 5-58: Roosting crevices and staining on the stone façade in NH-concrete_arch

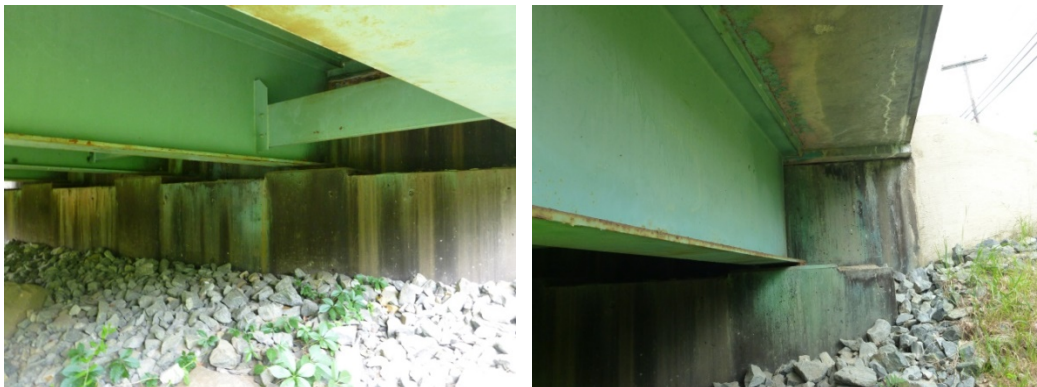
Figure 5-63: Staining observed at the abutments in NH-steel (likely structural)

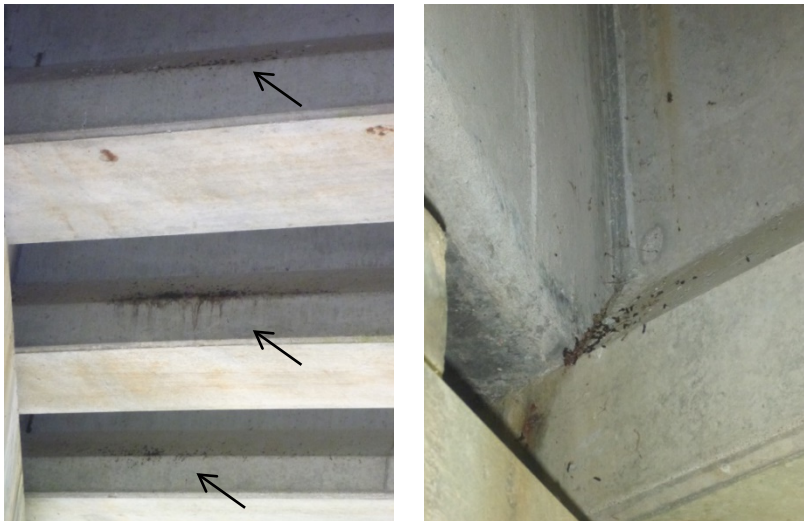
Figure 5-73: Staining evidence of roosting on bridge girders at RI-concrete

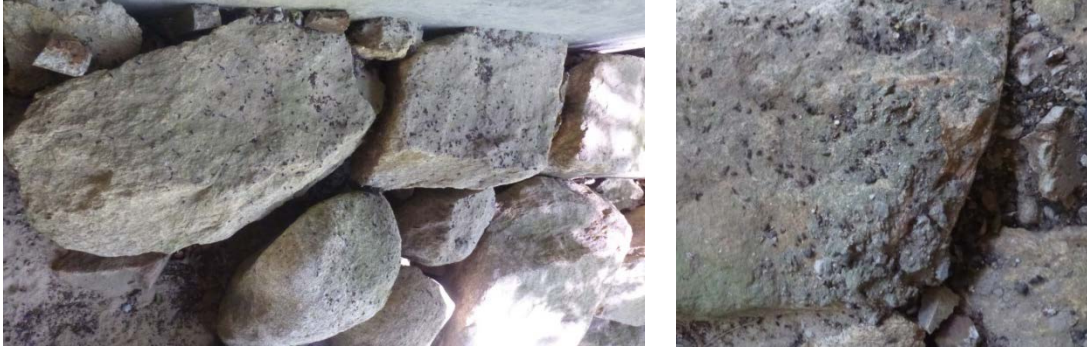
Figure 5-74: Guano evidence of roosting at RI-concrete (confirmed EPFU)

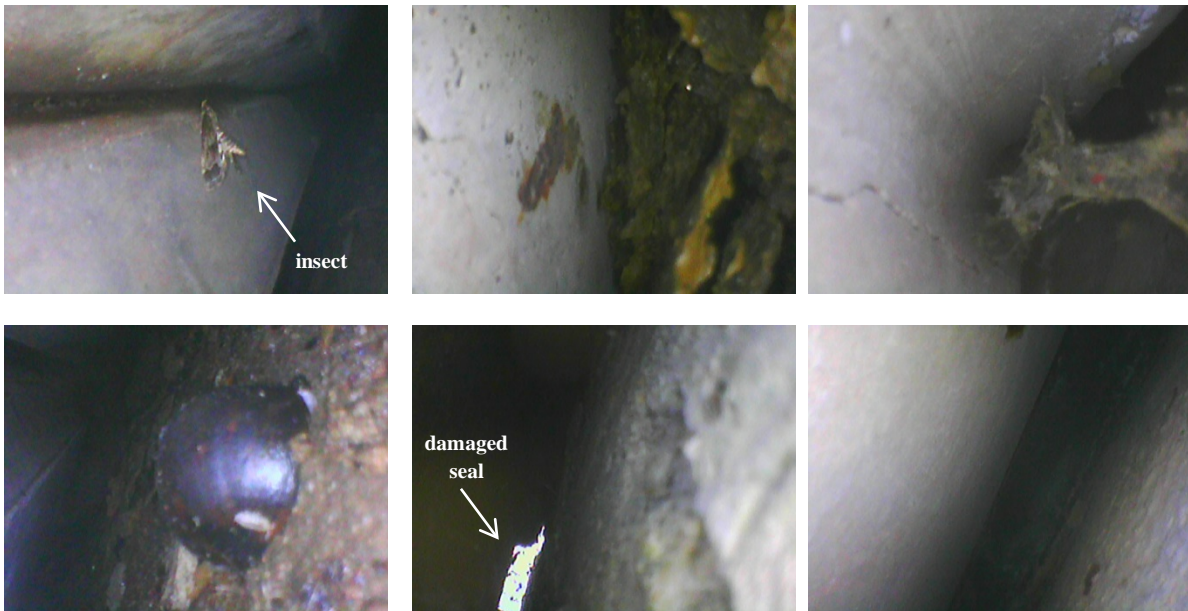
Figure 5-83: Boroscope view between girders and between girders and the abutment at RI-precast_concrete showing insects, debris, structural components, sealant damage, and clean gaps

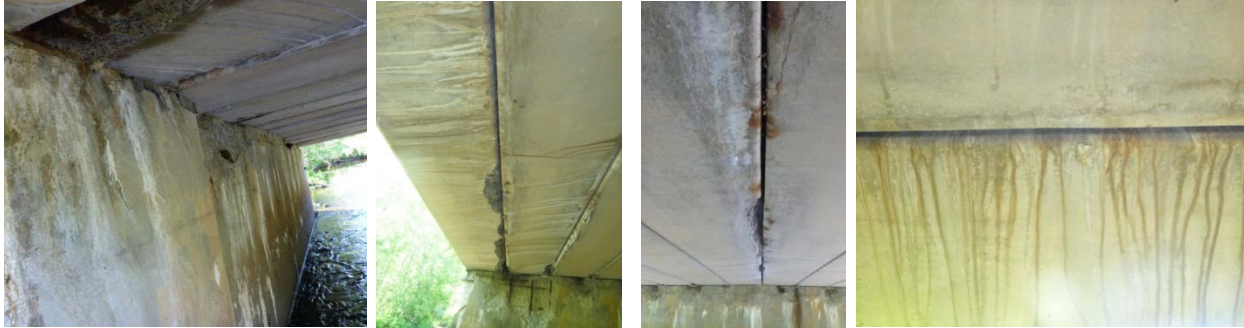
Figure 5-87: Cracks and crevices that can be potential roost sites in RI-precast_concrete_2

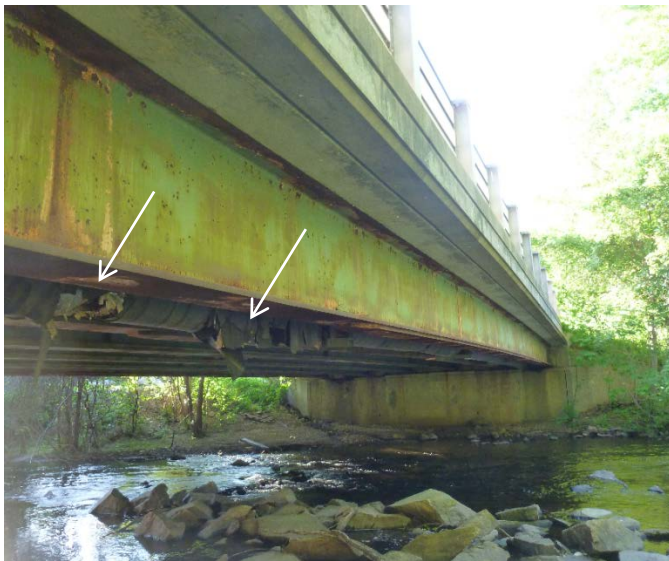
Figure 5-91: Steel construction bridge selected in RI (RI-steel) with pipe insulation deterioration (arrows)

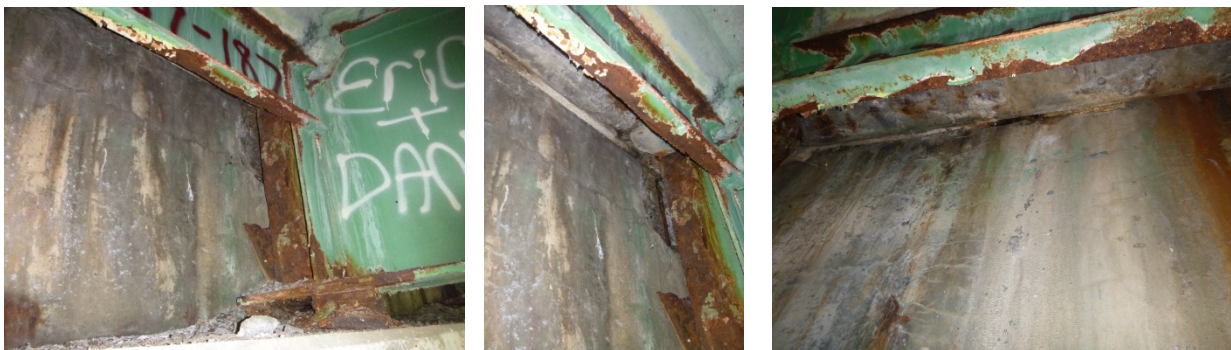
Figure 5-97: Crevices and staining in the abutment under which the dead bat was found at RI-steel_2

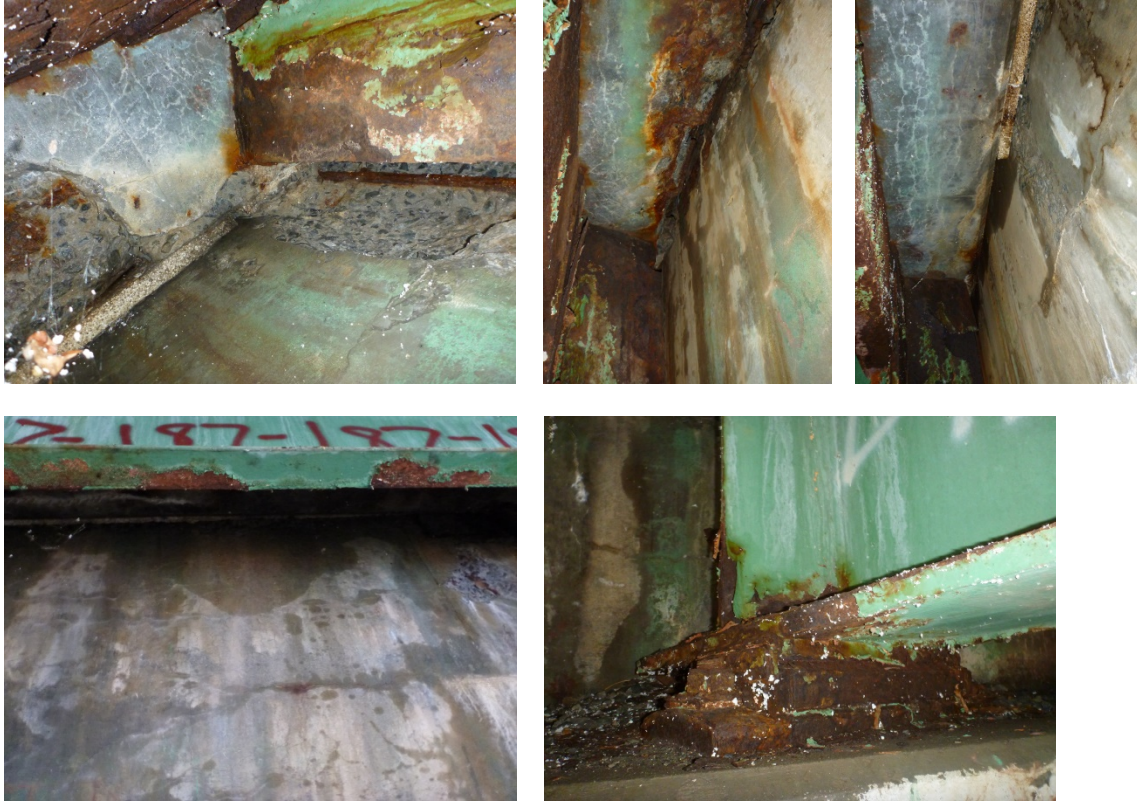
Figure 5-98: Staining caused by water damage at RI-steel_2

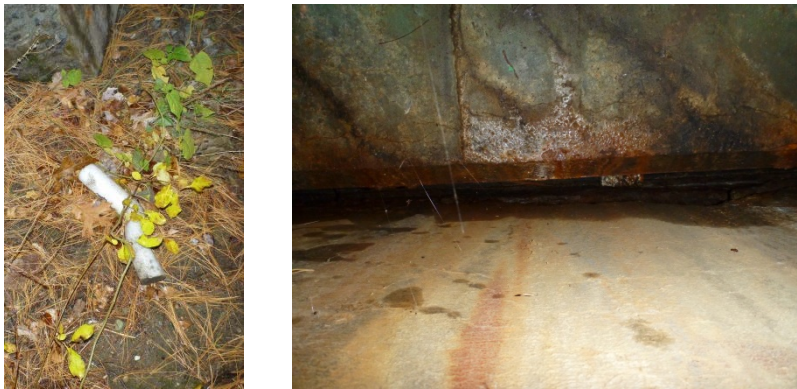
Figure 5-99: Insulation (left) that has fallen out of an expansion joint (right) at RI-steel_2

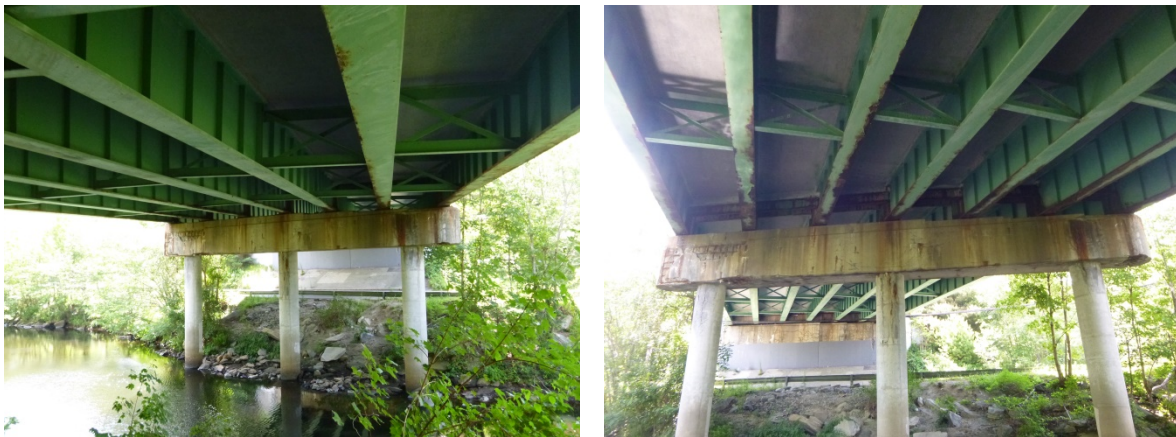
Figure 5-101: Staining of unidentified causation in the center pier of RI-steel_2
