Investigation of Northern Long-Eared Bat Roosting Sites on Bridges

Prepared for
The New England Transportation Consortium
May 25, 2017

NETCR 100

Project No. 14-2

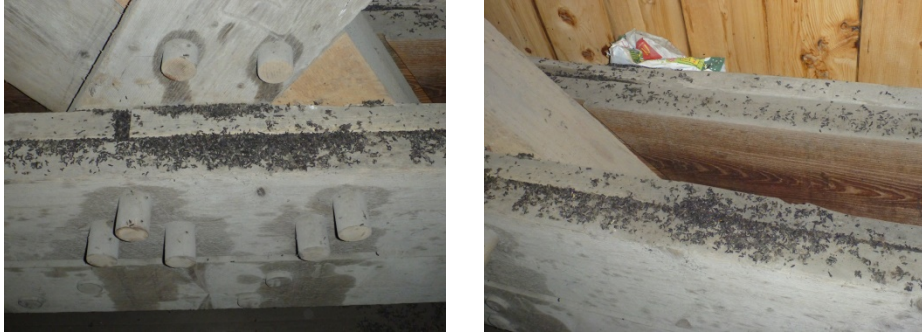
Figure 5-114: Guano evidence of roosting VT-covered (confirmed MYLU)
