NETC 18-2:

**Framework of Asphalt Balanced Mix
Design (BMD) for New England
Transportation Agencies**

Project Summary

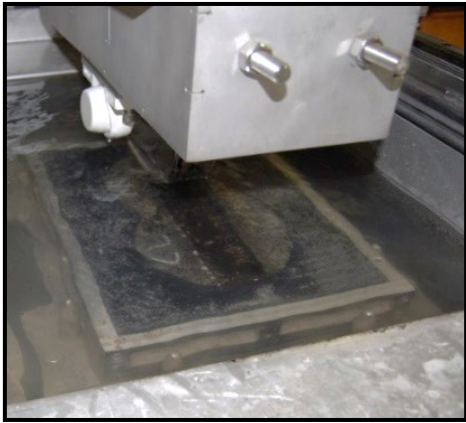
Hamburg Wheel Tracking

Rutting

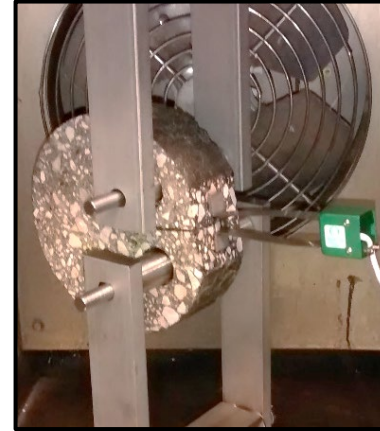
DC(T)

Thermal Cracking

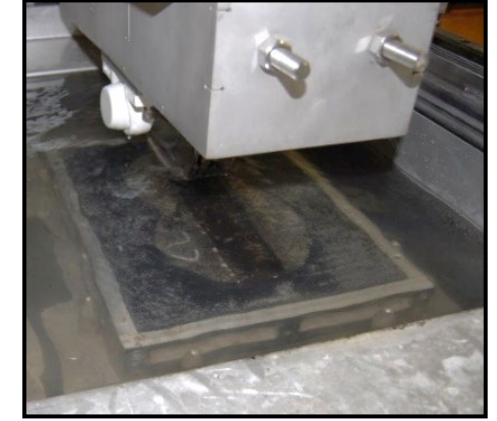
Hamburg Wheel Tracking

Moisture Damage

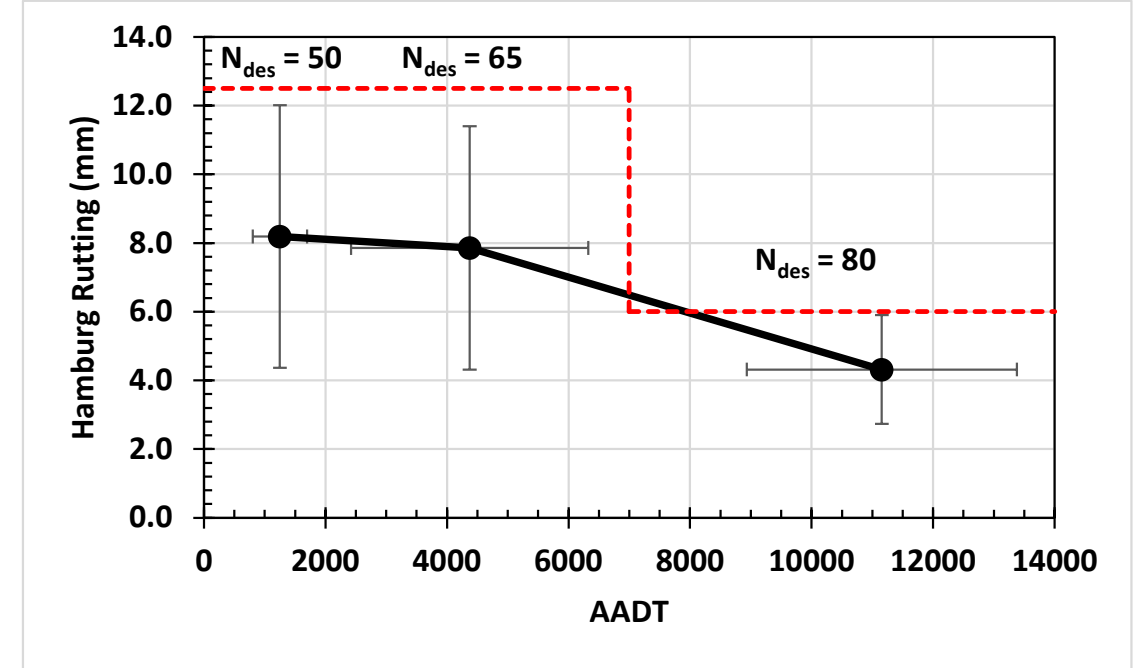
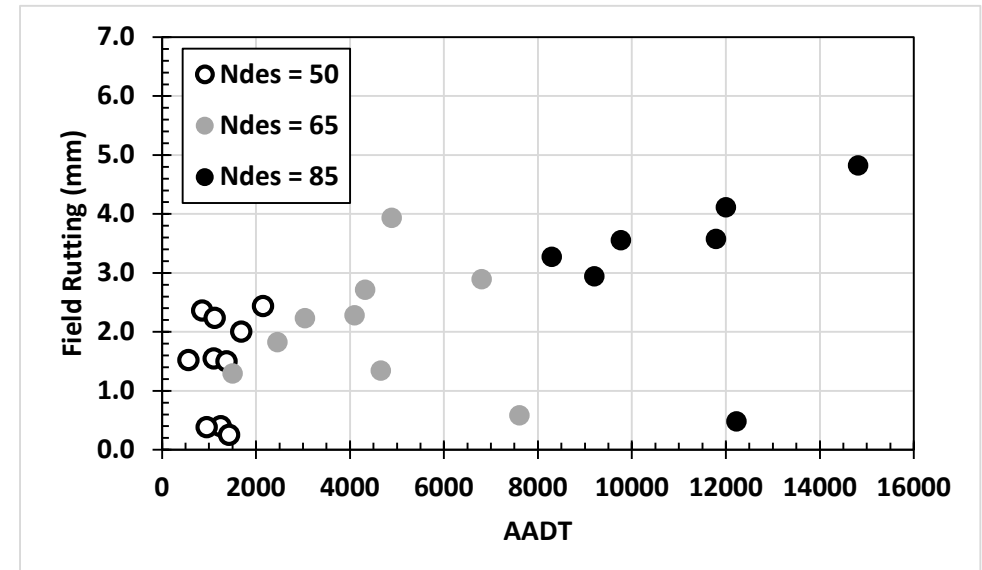
Vermont – Hamburg Wheel Tracking

- Final performance criteria for Hamburg must include traffic
- Figure shows recommended initial criteria for different mixes
 - $N_{des} = 50$ & $N_{des} = 65 < 12.5$ mm
 - $N_{des} = 80 < 6.0$ mm
- When evaluating average Hamburg rutting for $N_{des} = 50$ & $N_{des} = 65$, statistically equal
- AADT = 7,000 was selected at dividing area based on inflection point in Field Rutting vs AADT curve
- **Emphasize: All projects had GOOD field rutting performance**

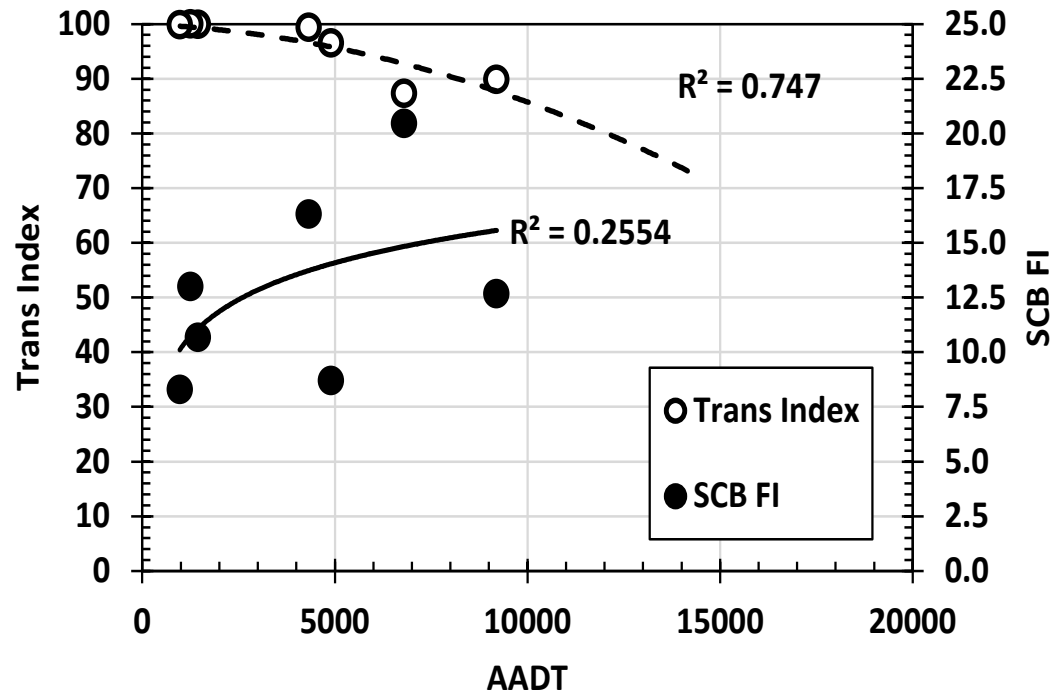
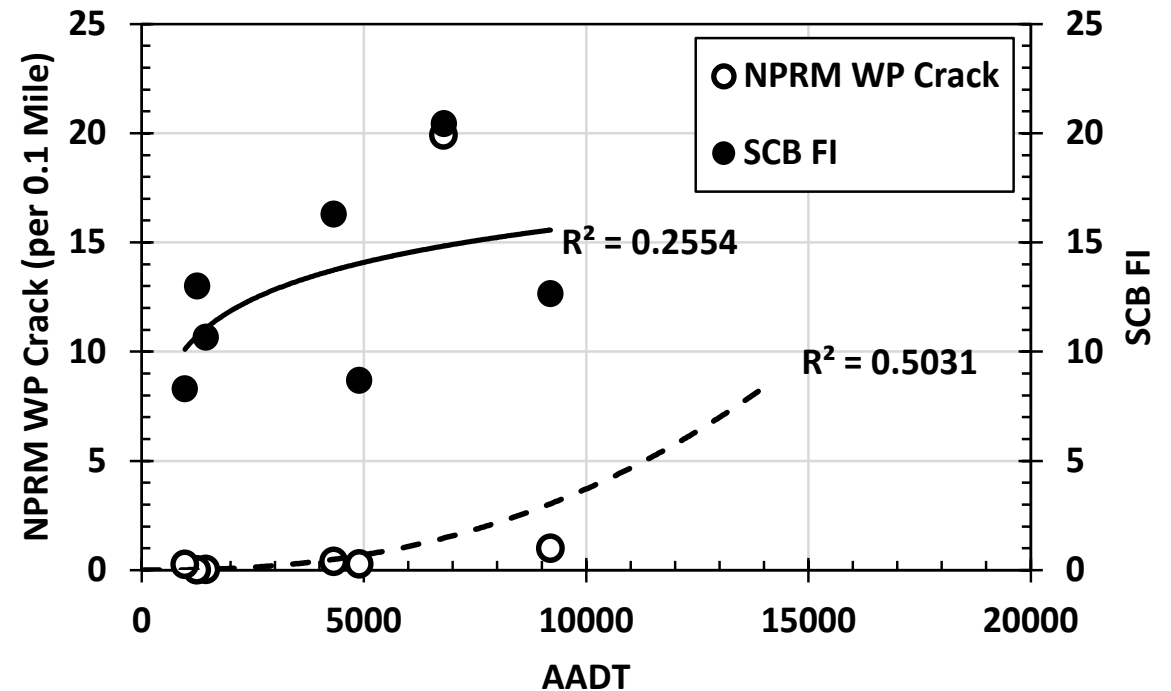
Vermont – SCB Flexibility Index

- Could not generate a simple relationship between SCB FI & Field Cracking
 - Cracking typically later life distress – only 2 years of field performance with SCB FI
 - Looked at only trying to compare the 2018 data
 - PMS distress indices appear to be related to the traffic level (AADT) but still shows low magnitudes of cracking in the field

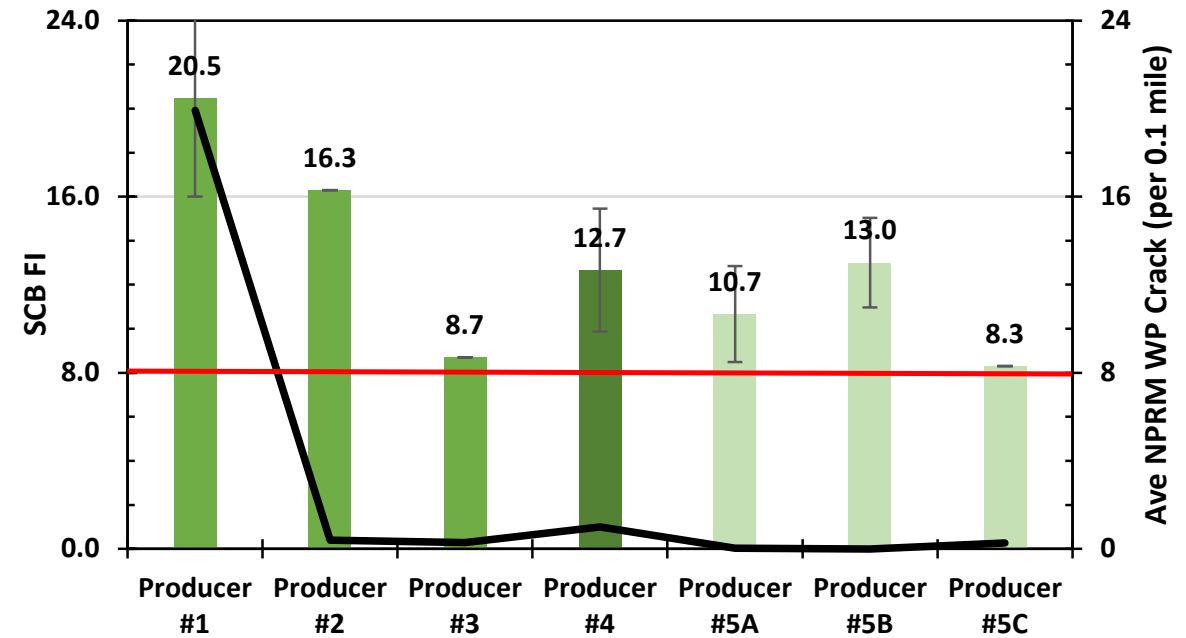
Vermont – SCB Flexibility Index

- Because significant field cracking was not observed in pavement sections, recommend initial SCB Flexibility Index > 8.0
 - Need to continue to review these sections over time

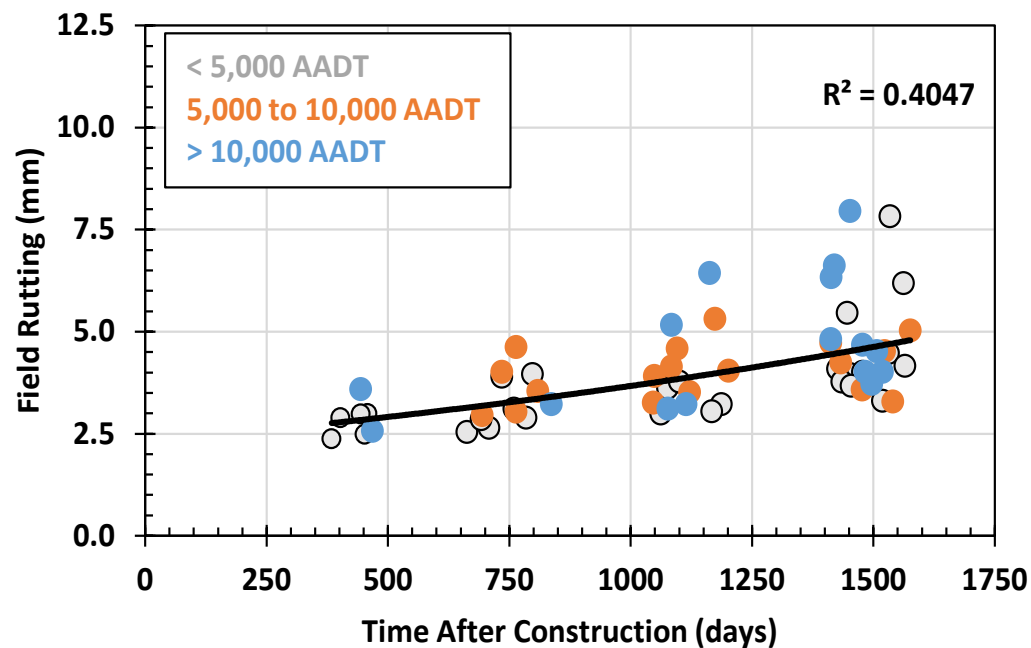
Maine - Rutting

- Discussions with MaineDOT indicated that field rutting observed to continue well past first few years of field service
- Separating field rutting results out by time after placement clearly confirmed field rutting continues into 4th year of service life – regardless of AADT!
 - Therefore, criteria developed only using 4th year

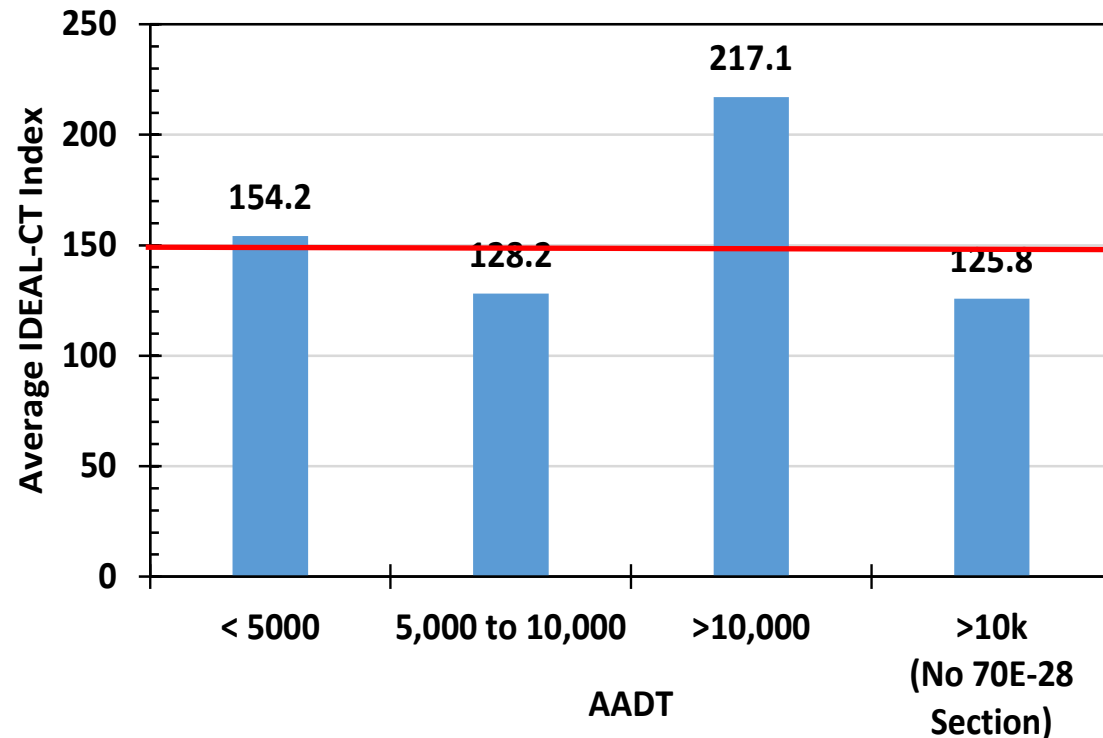
Maine – Fatigue Cracking

➤ IDEAL-CT Index > 150 for all mixes at test temperature of 25°C

➤ Intermediate and higher AADT had more field cracking but lower IDEAL-CT when compared to the lower AADT

➤ Criteria would have resulted in 10 of 18 mixes failing (8 failing when considering two mixes resulted in IDEAL-CT Index of 145.0)

- Divided MaineDOT performance based on 3 AADT Levels;
 - < 5,000 AADT; 5,000 to 10,000 AADT; and > 10,000 AADT
- Field performance does show that as the AADT divisions increase in magnitude, greater field distress is observed
 - Therefore, need to make sure higher AADT levels achieve better IDEAL-CT Index

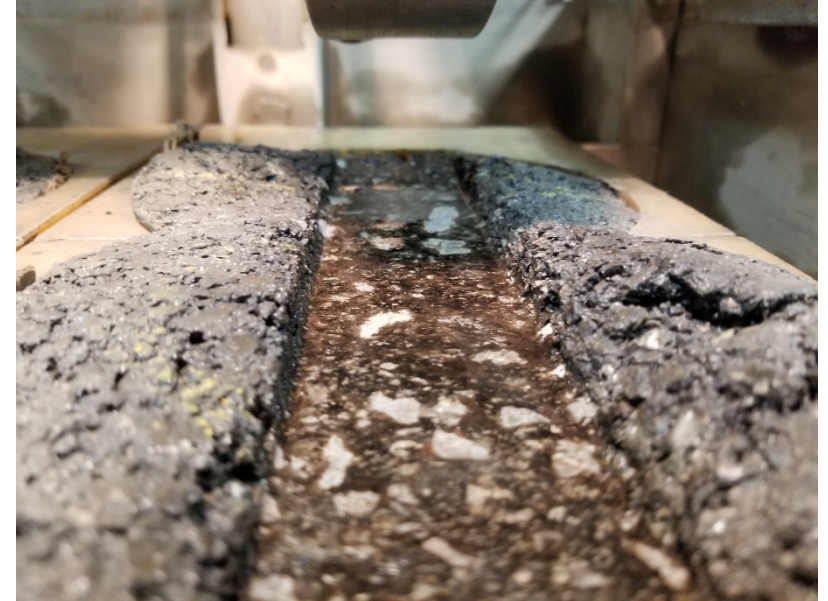
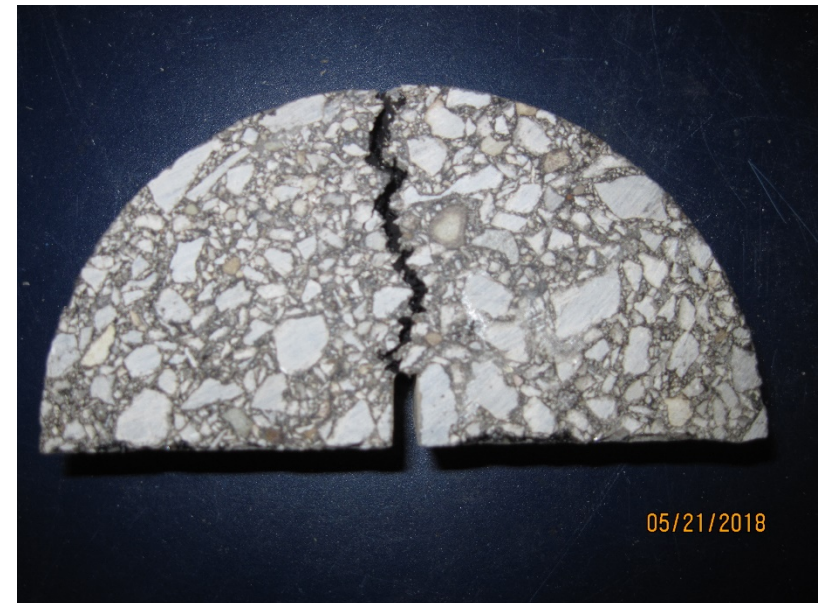
1. Criteria Validation - Performance Testing of Field Cores

- Proposed test sections will help validate criteria
 - Good and poor field performance
- Things to be careful of when testing field cores
 - Influence of air voids on test results
 - Fully dry prior to measurement (wet coring)
 - CoreDry
 - To be taken away from distress areas
 - Between wheelpaths and outside of wheelpath
 - Minimum thickness/specimen size to confidently run test method
 - Full depth cores can be used after cutting for Hamburg
 - Thickness correction for SCB and IDEAL-CT

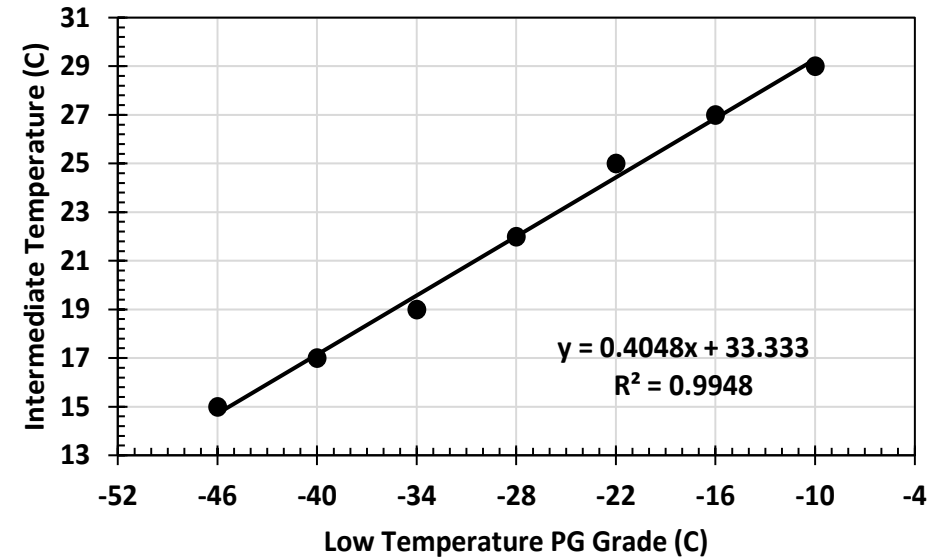
2. Adjustment of Fatigue Cracking Test Temperature

- Maine and Vermont currently using test temperature of 25°C for IDEAL-CT and SCB FI, respectively
- Selected test temperatures may not represent regional intermediate temperature
 - Results in superior laboratory performance due to asphalt binder grade
- Recommend the states consider evaluating the recommended intermediate temperatures from NCHRP 9-59 project
 - Based on required low temperature PG grade at 98% reliability
