Improved Load Rating Procedures for Deteriorated Unstiffened Steel Beam Ends

AUTHORS: Aidan Provost, Georgios Tzortzinis, Shahrukh Islam, Simos Gerasimidis, Sergio Breña
REPORT #NETCR125

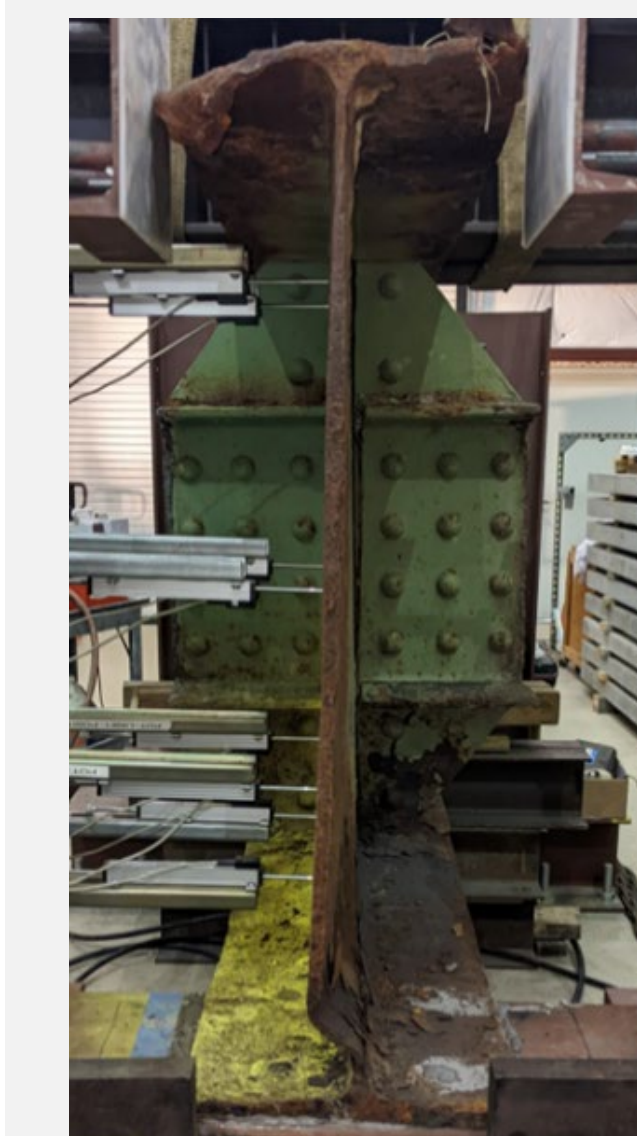
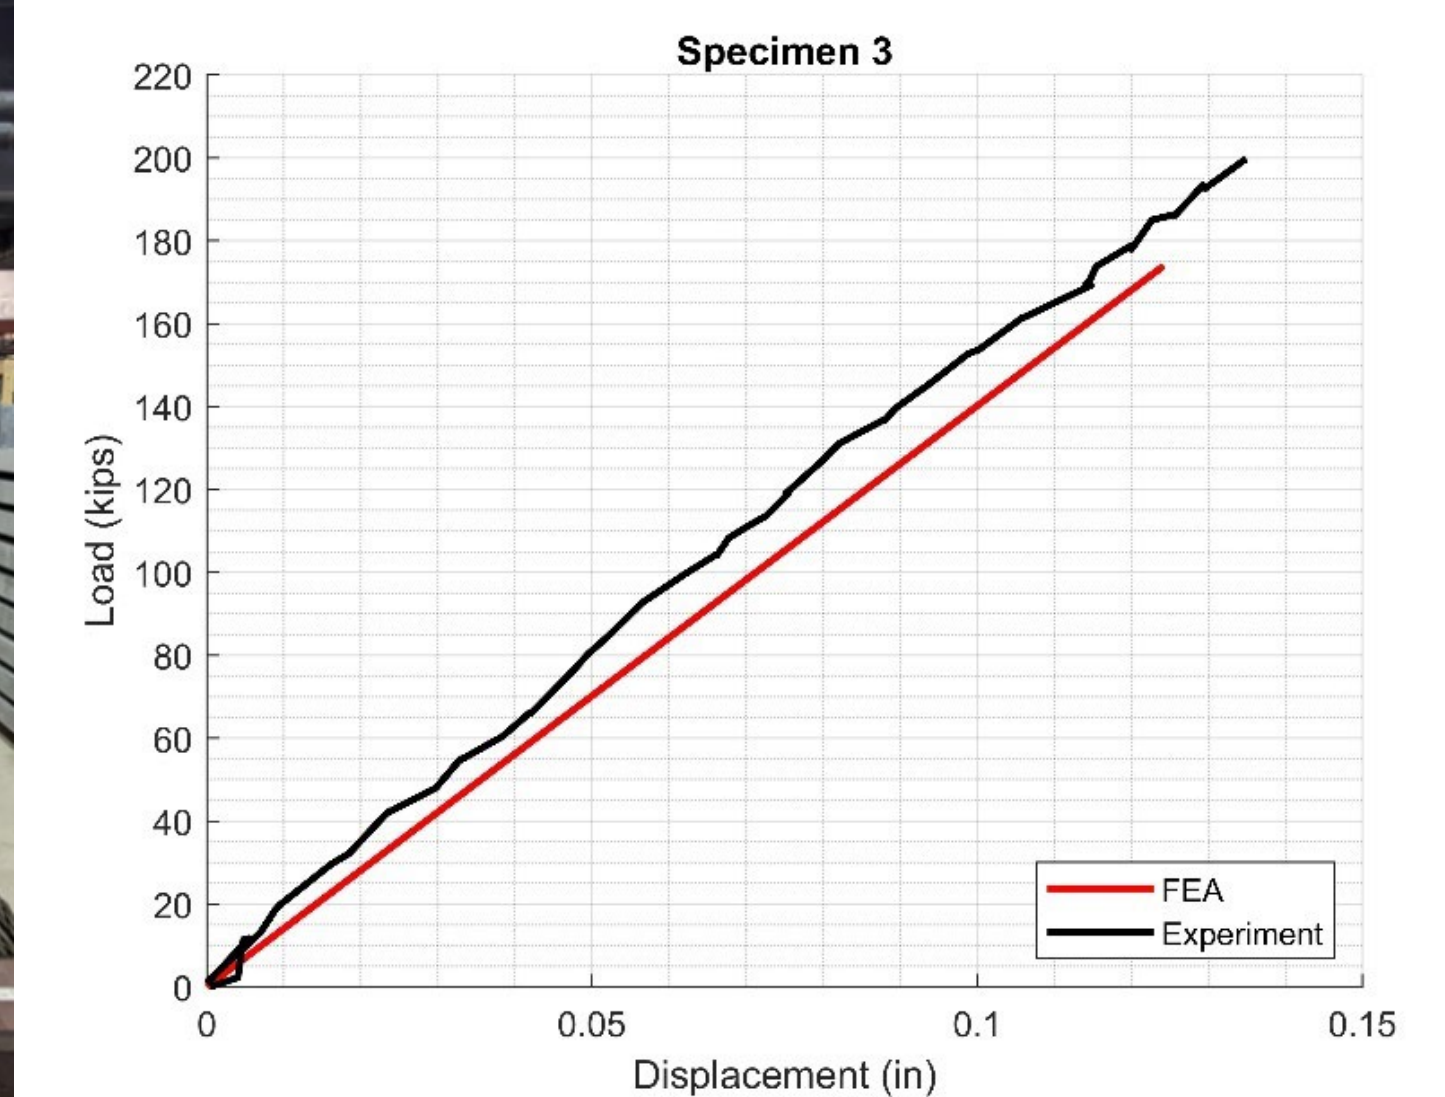
3D scanning and in-house developed algorithms allowed the team to capture section loss profiles. The beam specimens were loaded to test their remaining capacity. Using additional in-house made algorithms, the section loss profile was input into ABAQUS to replicate the experiment via finite element analysis.

Each corroded beam end was documented and tested like the specimen above. Following this, the team used each of the New England state's capacity provisions for corroded ends to evaluate their accuracy against experimental results. For each of these evaluations, the 3D scanning data captured made it very easy for the team to calculate the average thickness in the critical region of the beam end. The graph to the right shows the performance of these state provisions normalized to the experimental results.
