1. Report No.	2. Government Accession No.	3. Recipient's Catalog No.	
4. Title and Subtitle Improved Load Rating Procedures for Deteriorated Unstiffened Steel Beam Ends Deliverable 1: Identification of common unstiffened steel beam-end corrosion topologies		5. Report Date August, 2021

15. Supplementary Notes			
16. Abstract This report contains the information regarding the first task of an ongoing project aiming to enhance load rating methods for assessing corroded unstiffened beam ends for the six New England States. The first task of the project aims to collect and compile the information provided by DOTs within New England. Within this task, based on reports provided by the DOTs, the most common corrosion patterns were identified. From the information collected, the research team was able to carefully identify trends and patterns in the data, which allowed the research team to determine the most common scenarios of corrosion encountered in bridges within New England States.

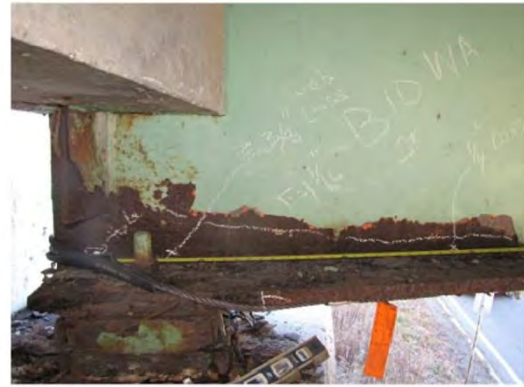
**Figure 4 : The same beam, as was described by sketch (left) and by photograph (right).
Adopted from W46010-3RY-DOT-NBI (district 5, City of Wrentham)**

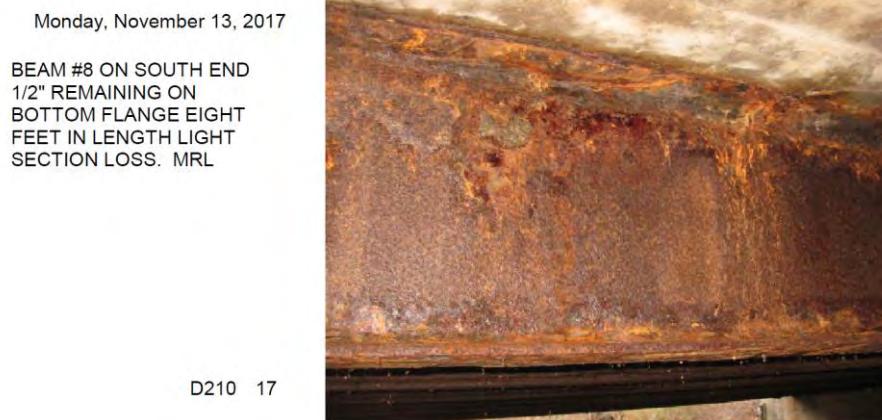
Figure 7: Example of corrosion damage taken from the records of a bridge from NHDOT

It is crucial to note that a “photos” section was not provided in the reports but was reported in a separate file by NHDOT. Every photograph was labeled, but they are often not referenced in the text. While photos from the inspections are provided, no sketches regarding corrosion damage are found on the photographic records. Figure 7 depicts an example of corrosion damage taken from the records of a bridge from NHDOT.

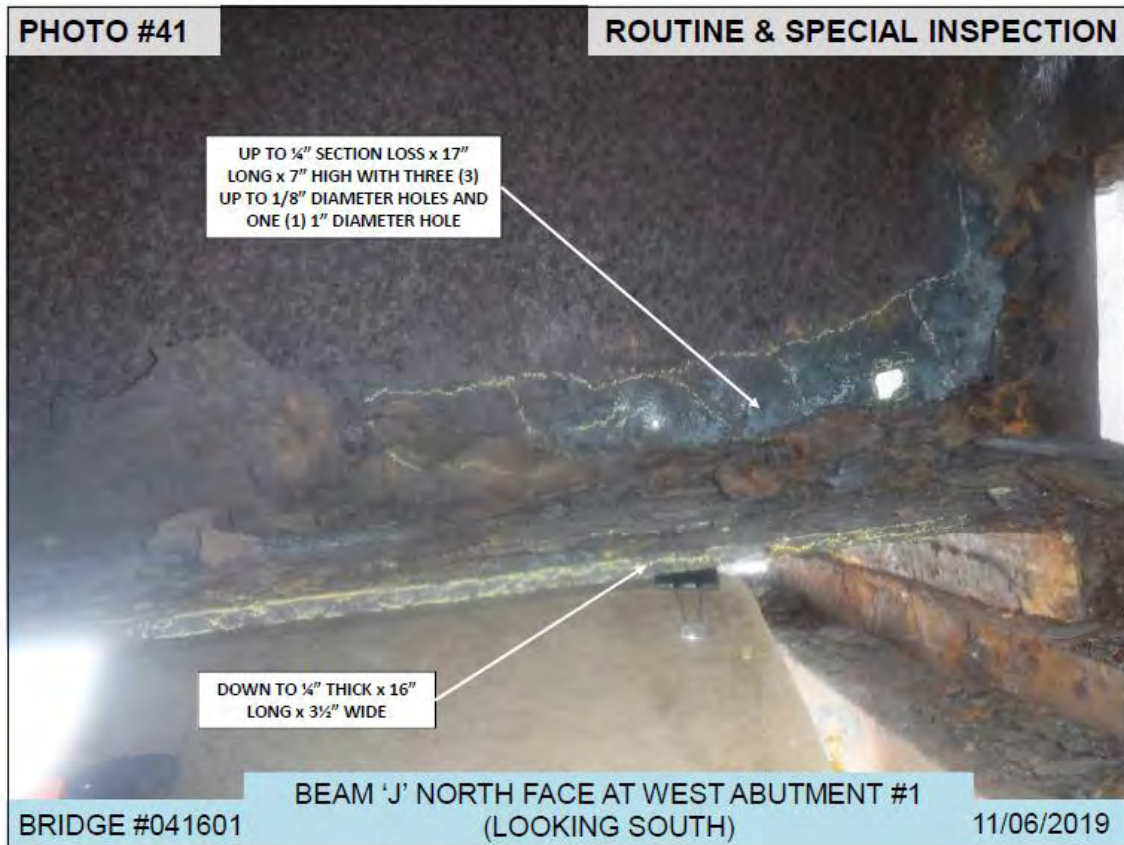
Figure 9: An example of picture provided by RIDOT

While the RIDOT reports do not present a section containing photos, all reports provided are accompanied with photographic records. The photographs are labeled with comments and measurements provided, as depicted in Figure 9. For some reports and bridges, more documentation on corrosion damage was provided. Among the outstanding documents, section loss calculations and corrosion damage sketches were provided.

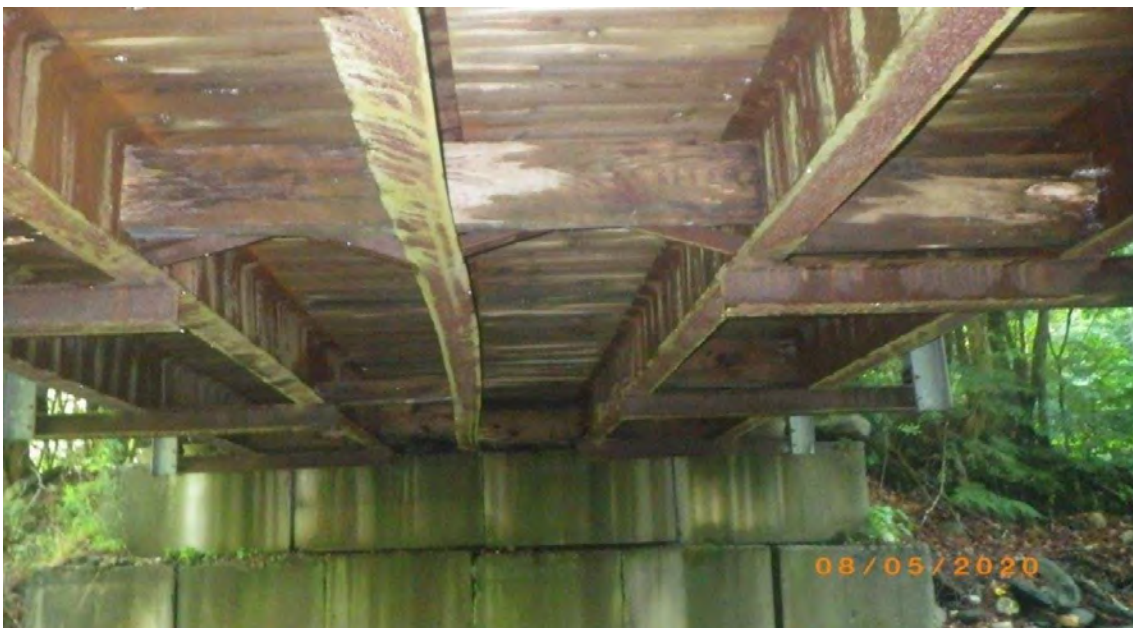
Figure 10: Example of photo of a buckled beam found in VTrans web-portal

The reports do not depict photographic records, as this type of data can be found for all bridges in the VTrans web-portal. Not all pictures are labeled, and the text does not often reference the photographs. No sketches regarding corrosion are provided along with the photographs or the inspection reports. Figure 10 depicts an example of photo which can be found in VTrans web-portal.

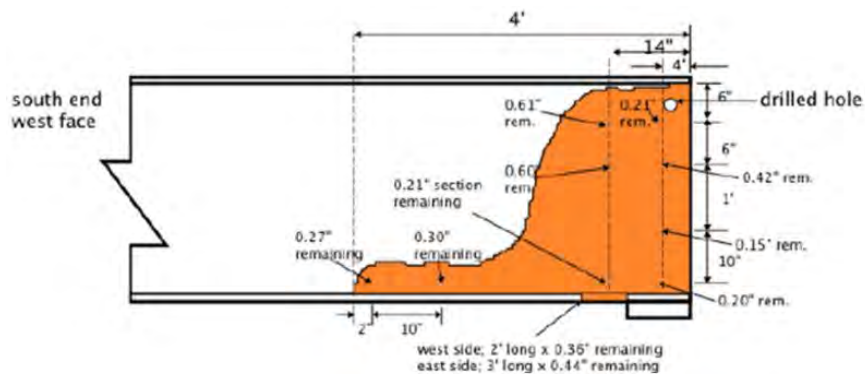
Figure 21: Corroded area described by multiple thickness loss values. Sketch adopted from H08003-18J-MUN-NBI (District 2, Town of Hardwick)

There are also cases, where multiple thickness measurements are provided in an effort of the inspector to provide higher accuracy as Figure 21. It is worthwhile to note that the thickness measurement and its variation throughout the corroded region are important parameters needed when assessing the load capacity of the beams.

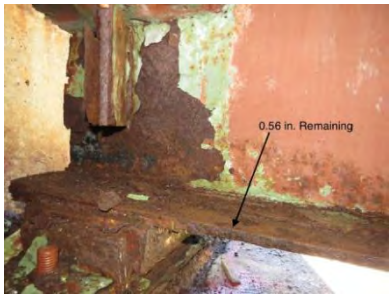
Table 4: Web corrosion pattern W1

<p data-bbox="940 1077 1433 1171">Adopted from H-23-011-1UQ-DOT-NBI (District 3, Town of Hopkinton)</p>
	<p data-bbox="384 1211 1437 1391">Short description: W1 is a rectangular shape corrosion pattern which appears at the beam end above the bearing. The dimensions of the damaged area are C_H for the depth of the damaged area and C_L for the length. B_L is the bearing width and B_o is the length of the free end of the beam beyond the bearing. The photograph on the right shows a case of W1 for which the C_H is equal to the depth of the beam web H_o.</p>

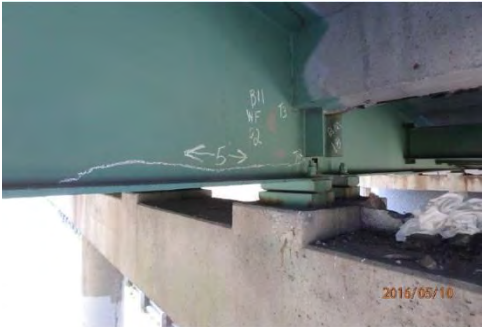
Table 5: Web corrosion pattern W2

<p data-bbox="930 741 1414 831">Adopted from N-06-015-3WR-DOT-NBI (District 5, Town of New Bedford)</p>
<p>Short description: W2 is similar to W1 with the addition of a triangular shaped corrosion area at the end of the rectangular shape. For W2, C_H is the depth of the damaged area, while C_{L1} is the length of the rectangular part of the corrosion. C_{L2} is the length of the triangular damage. B_L is the bearing width and B_0 is the length of the free end of the beam beyond the bearing. The photograph on the right shows a typical case of W2.</p>

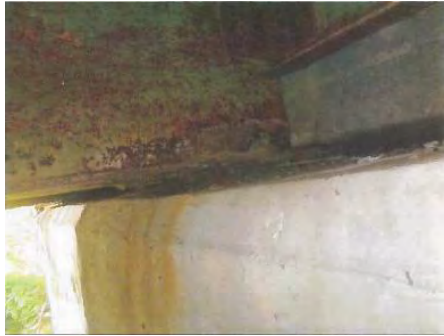
Table 8: Web corrosion pattern W5

<p>Adapted from W-05-024-0T4-MUN-NBI (District 2, Town of Ware)</p>
<p>Short description: W5 is a simple triangular shape corroded area described by C_H which is the height of the triangle and C_L which is the length of the triangle. B_L is the bearing width and B_0 is the length of the free end of the beam beyond the bearing. The photograph on the right shows a typical case of W5.</p>

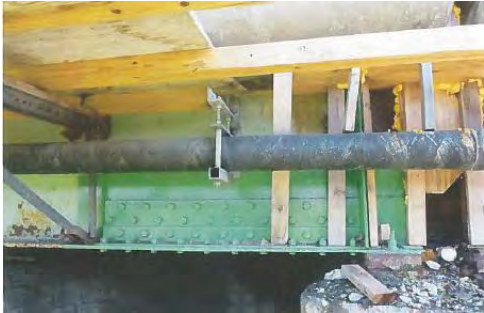
Table 9: Web corrosion pattern W6.

<p>The diagram shows a cross-section of a beam with a welded section at the bottom. The height of the welded section is labeled H₂, and the height of the corrosion area above it is labeled H₁. The total height of the beam is labeled H. The length of the corroded area is labeled CL₁.</p>

<p>Adapted from N-19-064-10C-DOT-NBI (District 2, City of Northampton, Massachusetts)</p>
<p>Short description: W6 is a rare case but it is included here for the sake of completeness. It involves a plate at the bottom side of the web. The corrosion extends above the welded section as shown in the graph above (left). For this case, H₁ is the height of the corroded area, CL₁ is the length of the corroded area, and H₂ is the height of the welded plate. The photograph on the right shows a typical case of W6.</p>

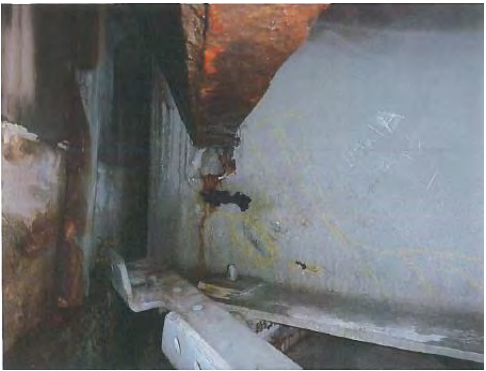
Table 11: Web hole pattern M2

<p>Adapted from S-24-017-14K-DOT-634 (District 2, City of Springfield, Massachusetts)</p> <p>Short description: M2 is a case where the beams have a diaphragm and the hole appears just below the diaphragm. For this case, a is the height of the hole and b is the length of the hole. The photograph on the right shows a typical case of M2.</p>

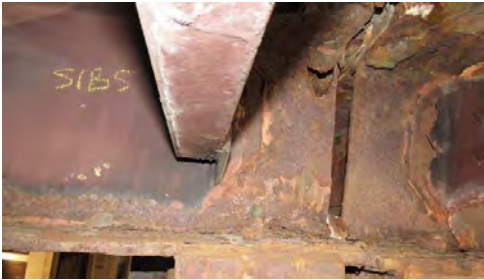
Table 12: Web hole pattern M3

<p data-bbox="909 689 1382 815">Adapted from F-04-017-23N-DOT-634 (District 3, City of Fitchburg, Massachusetts)</p> <p data-bbox="373 842 1407 945">Short description: M3 is a case where a hole appears at the top part of the beam. For this case, a is the height of the hole and b is the length of the hole. The photograph on the right shows a typical case of M3.</p>

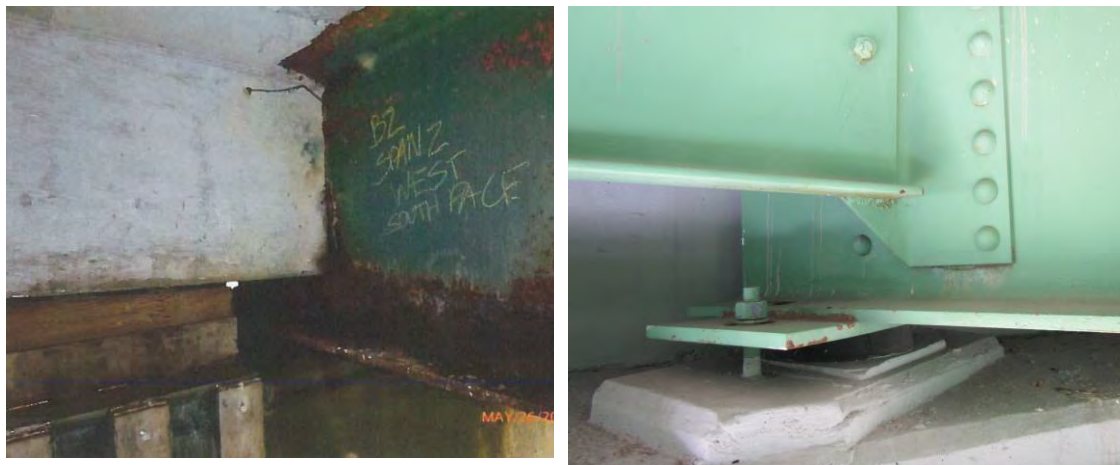
Figure 26: To the left is P-01-005 (Massachusetts) and the right structure is 042401 (Rhode Island)

Additionally, with the division of results by states, the results were further divided into two categories; to address structures that had diaphragms and structures that did not. It is imperative to distinguish that a structure was considered to have “diaphragms” for either concrete diaphragms or for cases in which the connection plate of the metallic diaphragm occupied a significant area of the web, as depicted in Figure 26.

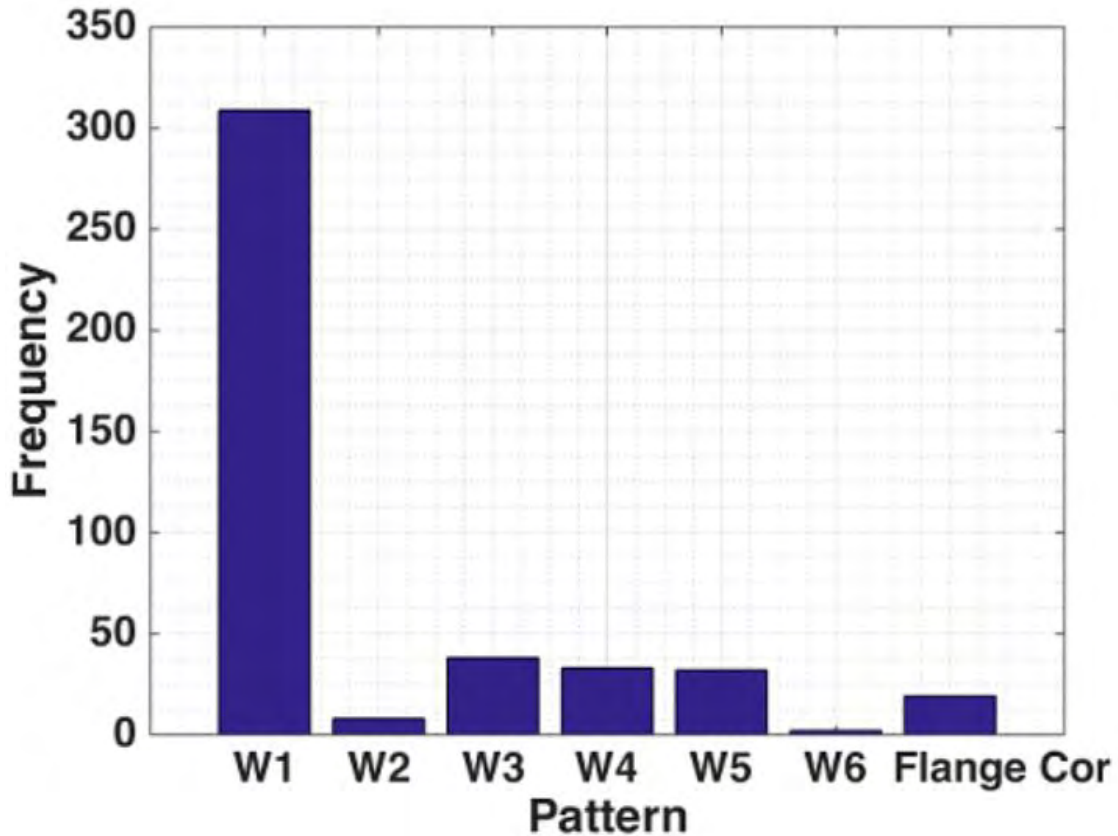
Figure 27 depicts the frequency of patterns obtained for beam ends without diaphragm from the reports provided by CTDOT.

Figure 27: Web corrosion patterns distribution for beams ends without a diaphragm – CTDOT

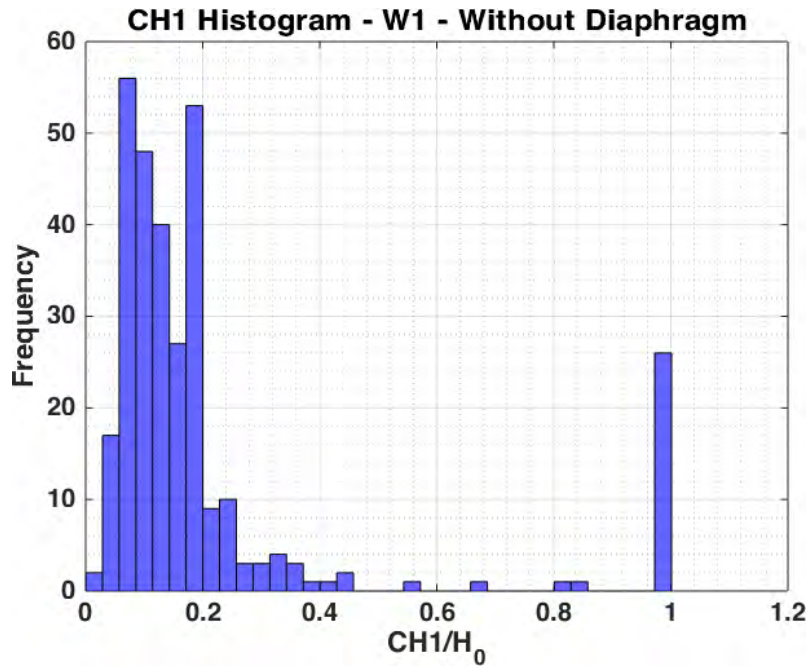
The distribution of CH1 for this pattern is depicted in Figure 28. From Figure 28 two dominant trends can be seen: (i) full height corrosion, or (ii) corrosion up to 40% of the web, which can be written as:

$$0 < CH_1 \leq 0.4H \text{ and } 0.9H \leq CH_1 \leq 1H$$

Figure 28: CH1 distribution of W1 pattern for beams without a diaphragm - CTDOT

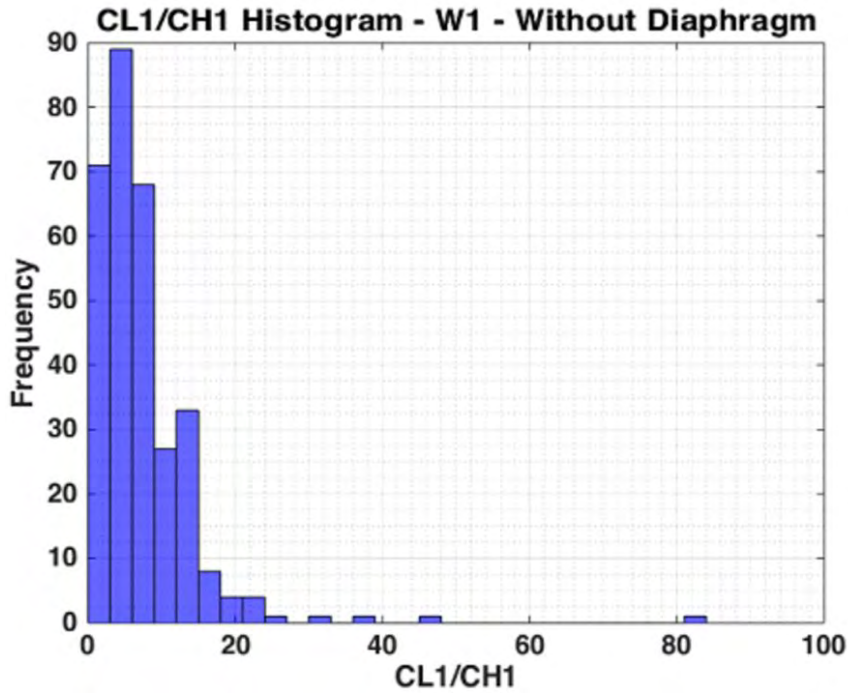
Aiming to compare the length and height of corrosion, Figure 30 depicts the ratio between the length and height of corrosion. It is possible to observe that the length is usually several times greater than the height.

Figure 30: Ratio of corrosion length (CL1) to corrosion height (CH1) of W1 pattern for beams without a diaphragm - CTDOT

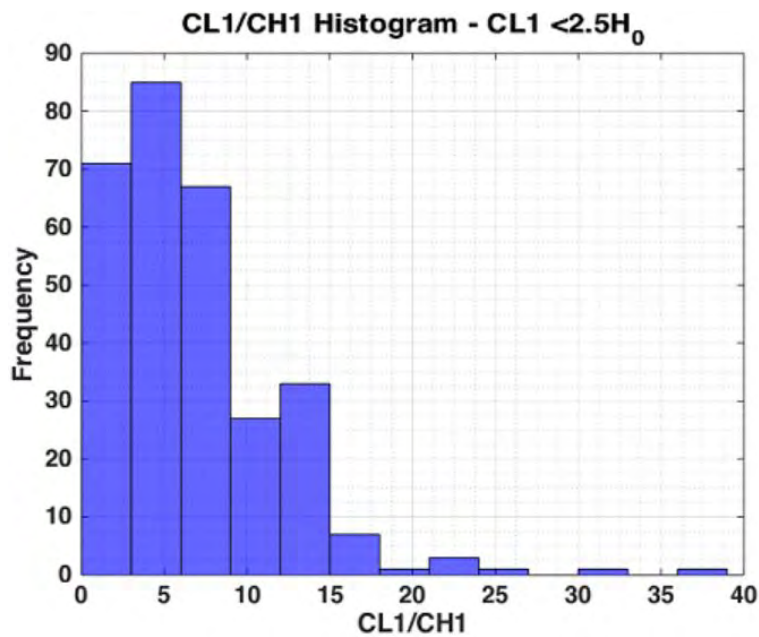
As many lengths are less than $2.5H$, our team was able to check the ratio for beams ends where $CL1 < 2.5H$. The resulting histogram is depicted in Figure 31.

Figure 31: Ratio of corrosion length (CL1) to corrosion height (CH1) for $CL1 < 2.5H_0$ - CTDOT

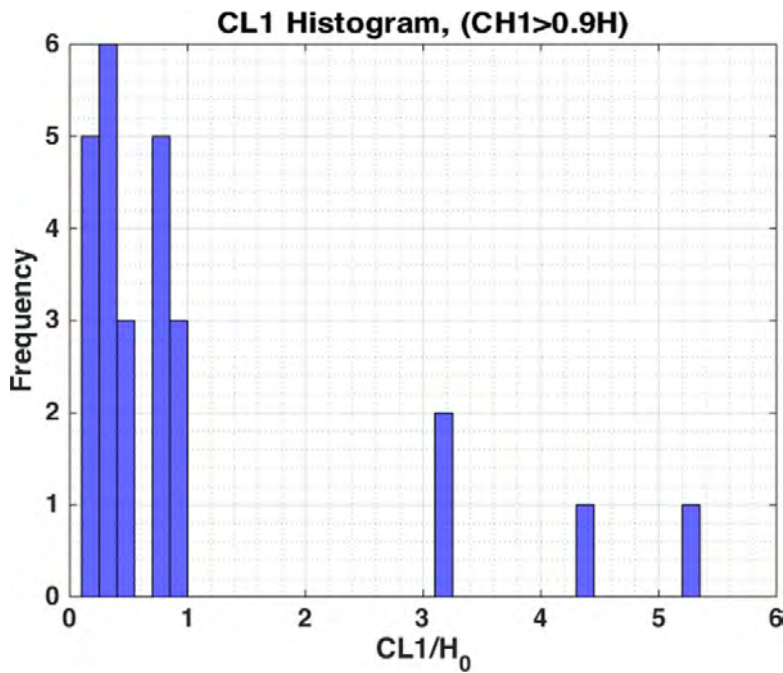
A similar study to the CH1 < 0.3H₀ case, our team conducted a study on the case where CH1 > 0.9H. Figure 33 below depicts the final distribution for this case.

Figure 33: CL1 distribution for CH1 > 0.9H - CTDOT

When comparing Figure 32 to Figure 33, it is apparent that when the corrosion height is large, the corrosion length is often smaller. On the other hand, for small heights of corrosion, the corrosion length tends to be greater than the corrosion height.

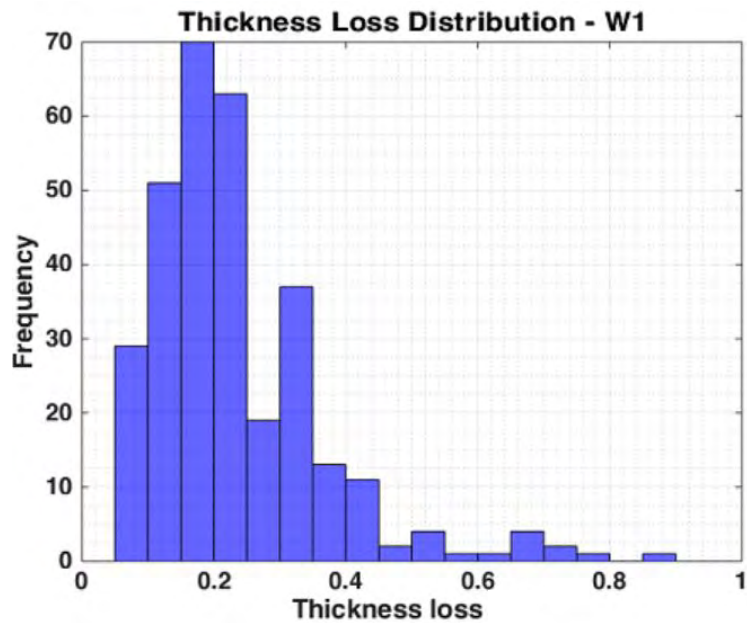
Figure 34 depicts the distribution of web thickness loss for pattern W1. It is noticeable that much of the thickness loss for the W1 case is no greater than 50%.

Figure 34: Web thickness loss distribution for pattern W1 - CTDOT

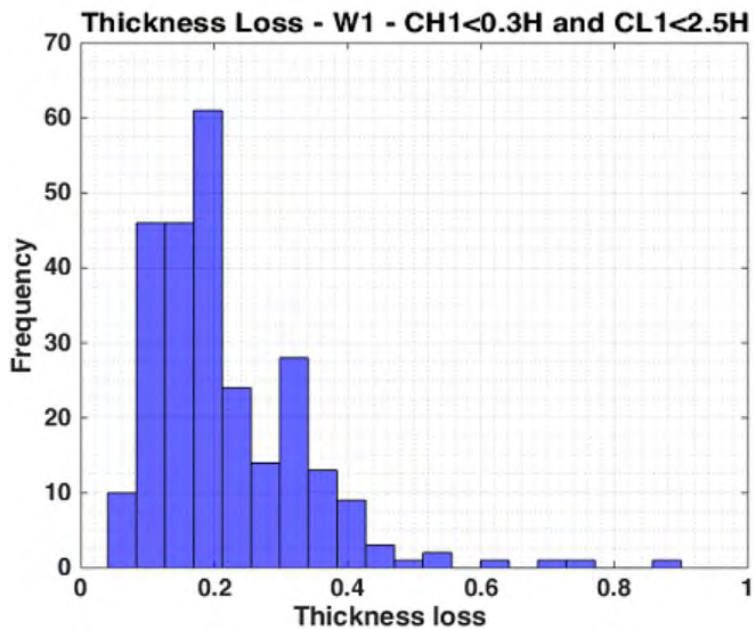
Similar to the analysis conducted for corrosion length, our team was able to study the thickness loss for the two main trends detected previously. The resulting distributions are depicted in the Figure 35 and Figure 36.

Figure 35: Web thickness loss distribution for CH1<0.3H and CL1<2.5H - CTDOT

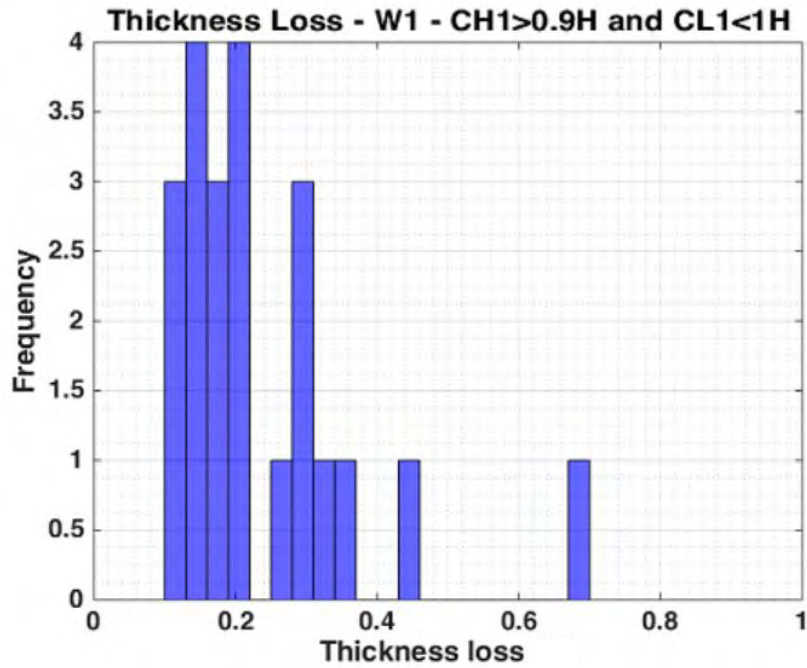
Figure 36: Web thickness loss distribution for Ch1<0.9H and CL1<1H - CTDOT

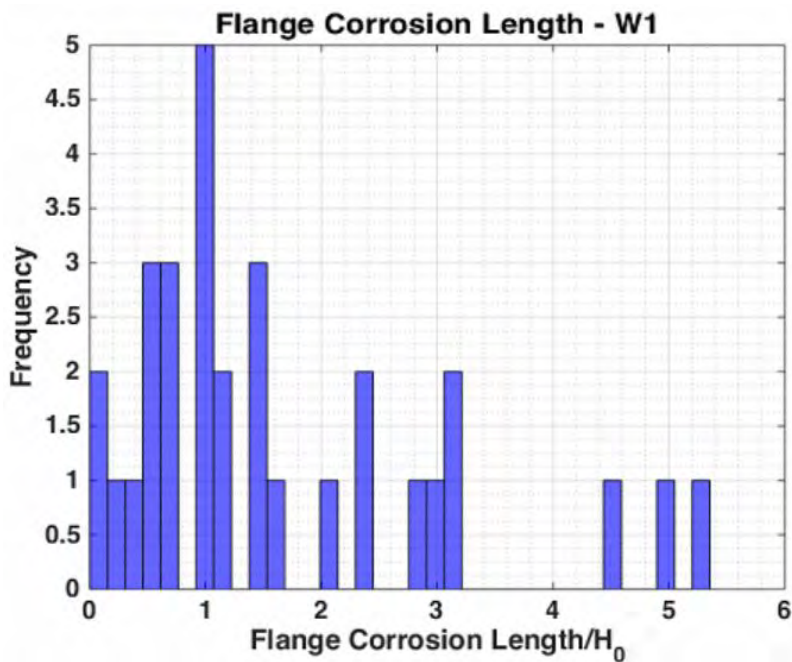
Figure 37 depicts the length of corrosion in the flanges. It is worthwhile in recognizing that there is significantly less information regarding flange corrosion.

Figure 37: Distribution of corrosion length for pattern W1 - CTDOT

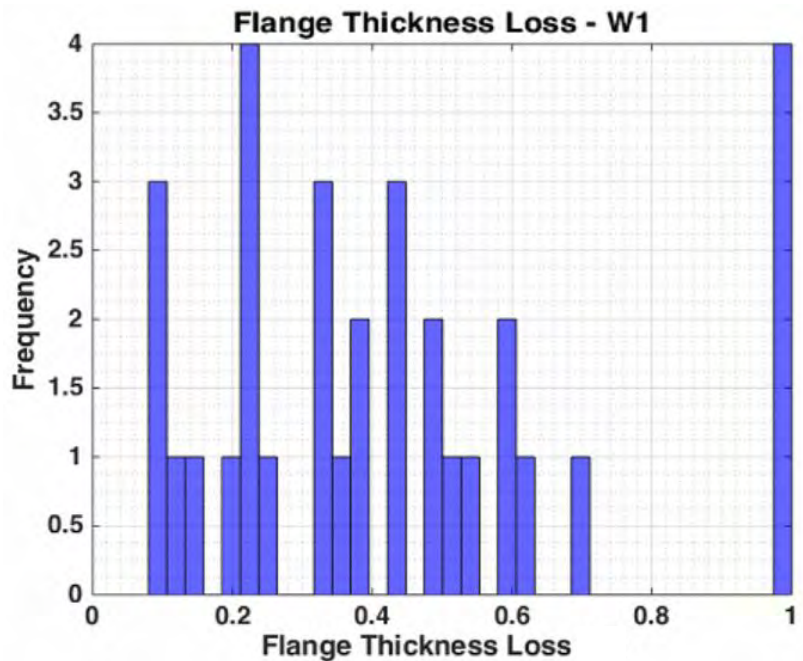
Regarding the thickness loss of the flanges, the research team was able to plot the distribution depicted in Figure 39.

Figure 39: Flange thickness Loss for pattern W1 - CTDOT

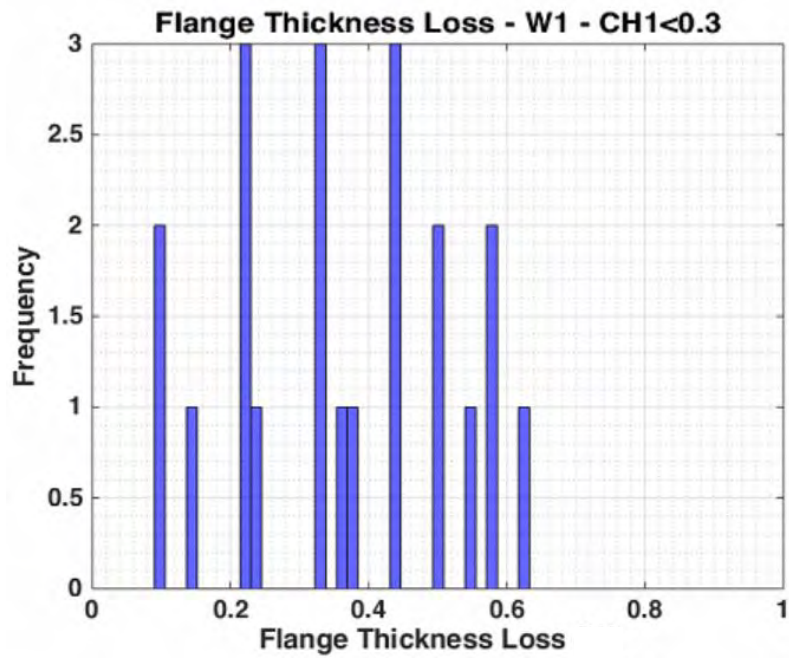
Similarly, our team was able to isolate the thickness loss for either trends found previously, as depicted in Figure 40 and Figure 41.

Figure 40: Flange thickness loss distribution for CH1<0.3 - CTDOT

For beam ends which CH1 is less than 0.3H, the thickness loss on the flanges tended to be small. This was different for cases which CH1 is greater than 0.9H, which resulted in a thickness loss of almost 100%. This allowed our team to assume the beams described by W1 patterns present the two patterns described in Table 47.

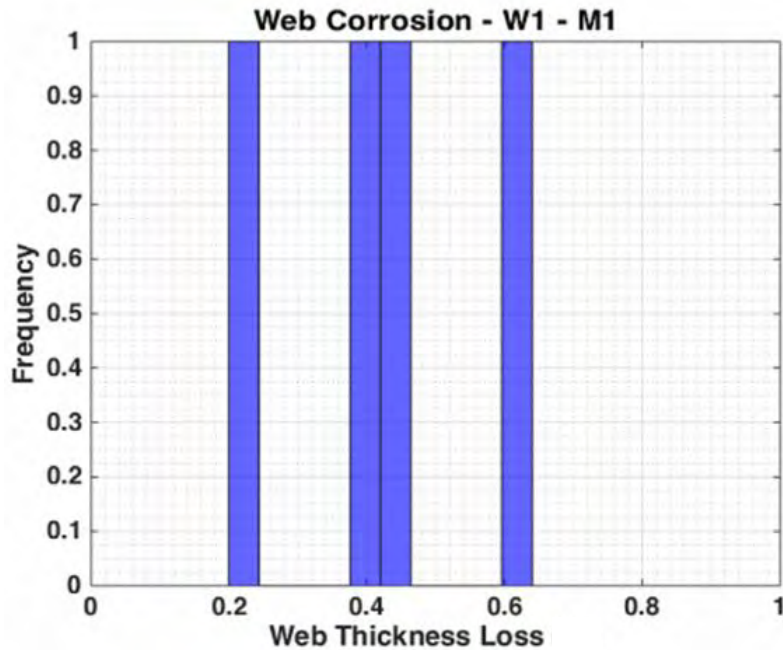
The web thickness loss distribution for beam ends with M1 holes is:

Figure 44: Web thickness loss for beam ends with M1 holes - CTDOT

From Figure 44, Figure 45, Figure 46, and Figure 47 is not possible to determine the thickness in which the holes will appear. While this is a clear observation, the figures hint that corrosion holes can appear even for cases in which the thickness loss is not extreme. As a result of this, and due to the small amount of data regarding corrosion holes, it is not possible to define any trend or try to make any prediction of what causes the holes to appear.

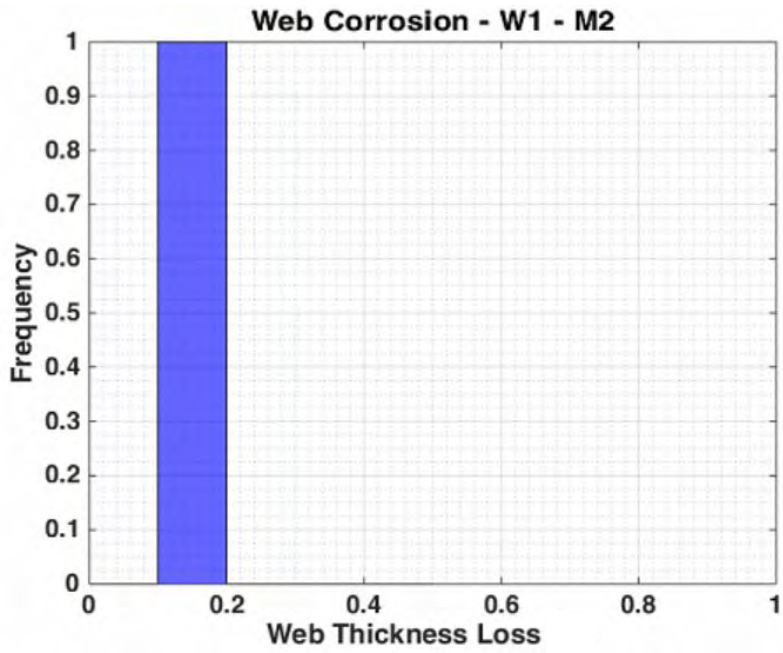
The web thickness loss distribution for beam ends with M2 holes is:

Figure 45: Web thickness loss for beam ends with M2 holes - CTDOT

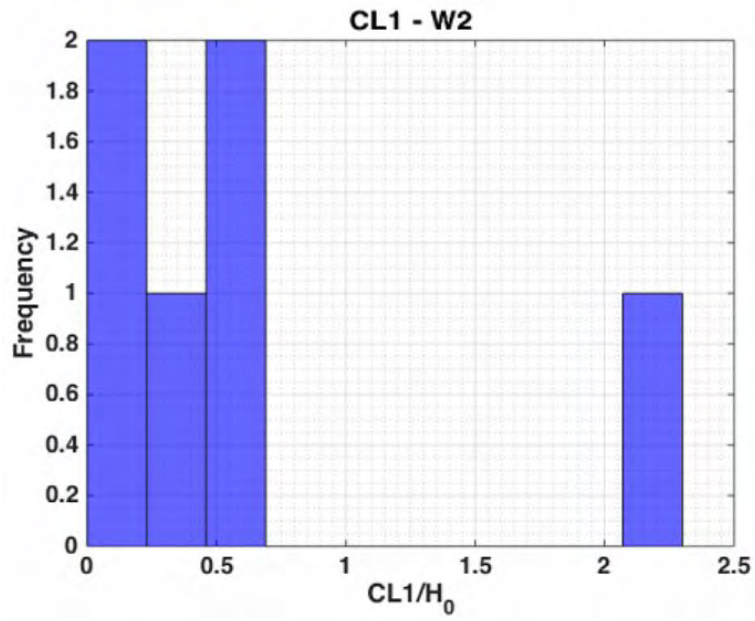
The W2 corrosion pattern was observed only six times throughout the reports from the state of Connecticut. In a similar way to how W1 was recorded, the measurements for the W2 pattern provided in the reports were normalized by H0. Figure 48, Figure 49 and Figure 50 depict the distribution of the parameters of pattern W2. The parameters for the corrosion patterns can be found with corresponding diagrams in Section 1.5 *Corrosion Patterns* of this report.

Figure 48: CL1 distribution for W2 pattern - CTDOT

From Figure 48, there is a trend present regarding CL1, as $CL1 < 0.6H_0$ for most of the beam ends reported. This allowed our team to analyze the behavior of the other parameters given that $CL1 < 0.6H_0$.

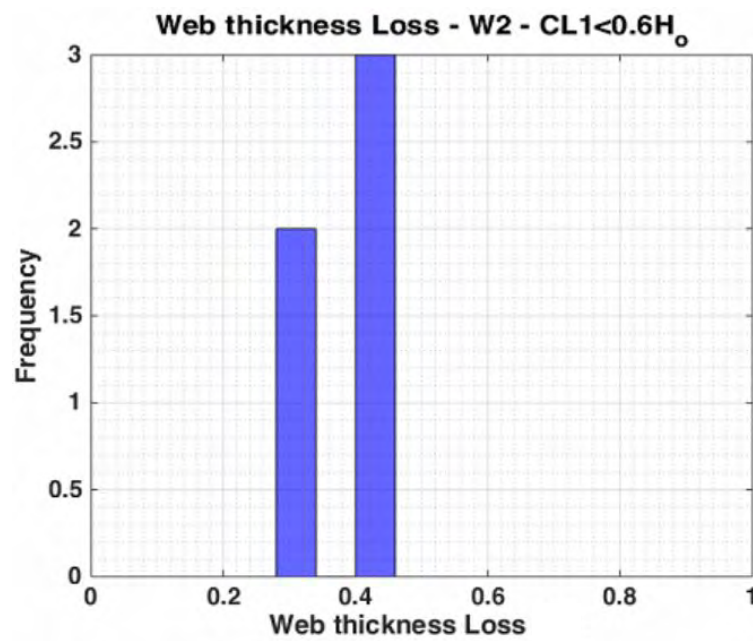
Figure 55: Web thickness loss for W2 pattern and CL1<0.6H - CTDOT

Therefore, it is valid to assume that $0 < CL_1 \leq 0.6H_0$, $0.1H_0 \leq CL_2 \leq 0.4H_0$, $0 < CH \leq 0.2H_0$ and $0.3 \leq \frac{t_{loss}}{t_{web}} \leq 0.45$. The extreme scenario for W2 is depicted in Figure 56.

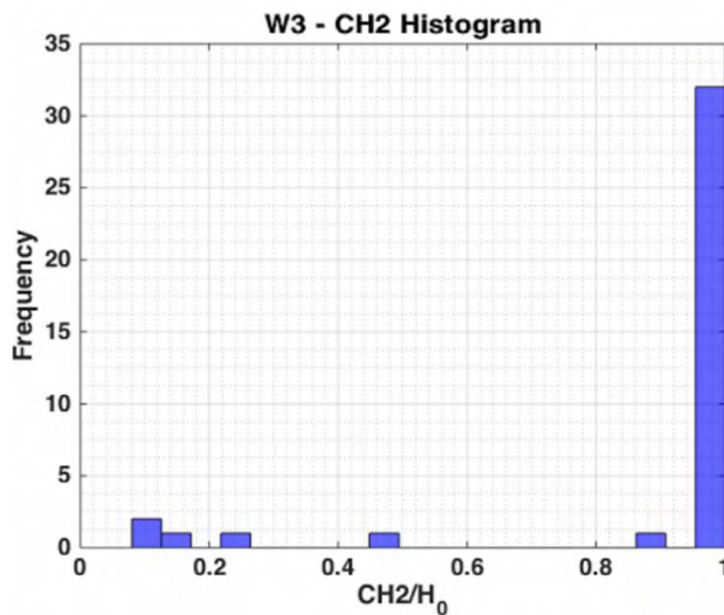
The analysis began by studying the distribution of CH2, depicted in Figure 57. The parameters for the corrosion patterns can be found with corresponding diagrams in Section 1.5 *Corrosion Patterns* of this report.

Figure 57: CH2 distribution for W3 pattern - CTDOT

A single trend for when $CH_2 > 0.9H_0$ is clearly observed in Figure 57. Given that $CH_2 > 0.9H_0$, our team could plot the distribution of the other parameters of the corrosion pattern given that $CH_2 > 0.9H_0$. This is shown in the following figures.

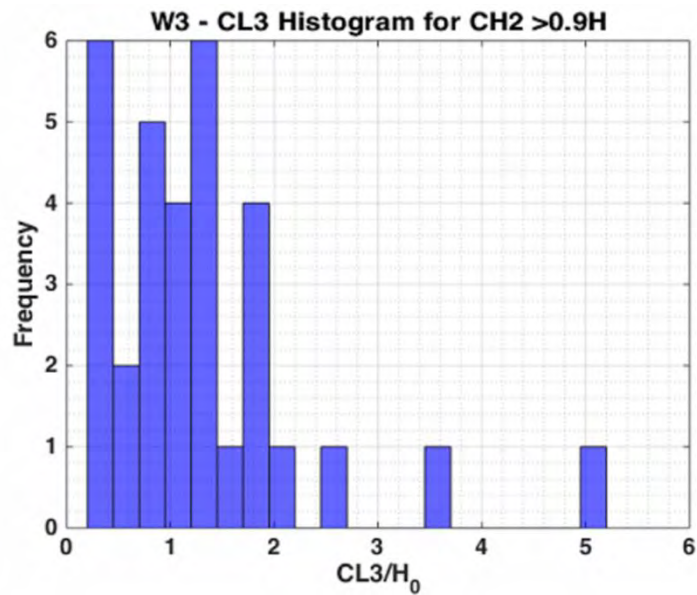
Figure 58: CL3 distribution for W3 pattern - CTDOT

$$\begin{aligned}
 0 < CH_1 &\leq 0.4H_0 \\
 0.9H_0 &\leq CH_2 \leq 1H_0 \\
 0 < CH_3 &\leq 0.4H_0 \\
 0 < CL_1 &\leq 1H_0 \\
 0 < CL_2 &\leq 1.5H_0 \\
 0 < CL_3 &\leq 2.5H_0 \\
 0 < \frac{t_{loss}}{t_{web}} &\leq 0.4
 \end{aligned}$$

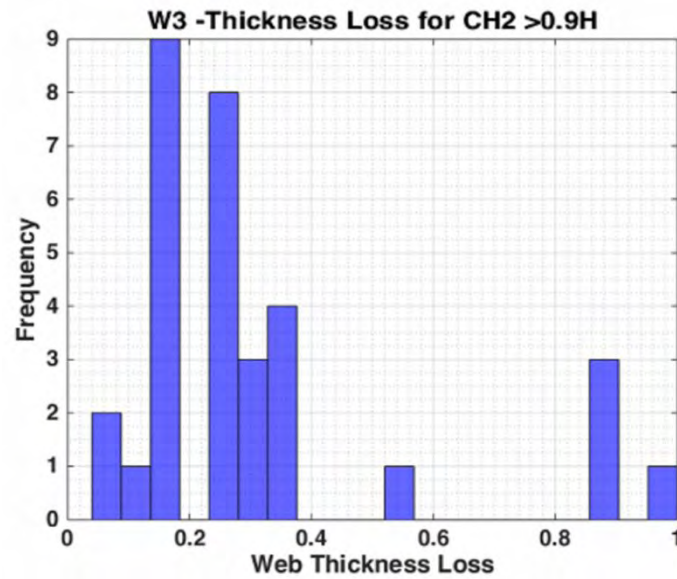
Figure 60: Web thickness loss distribution for W3 pattern and CH2>0.9H - CTDOT

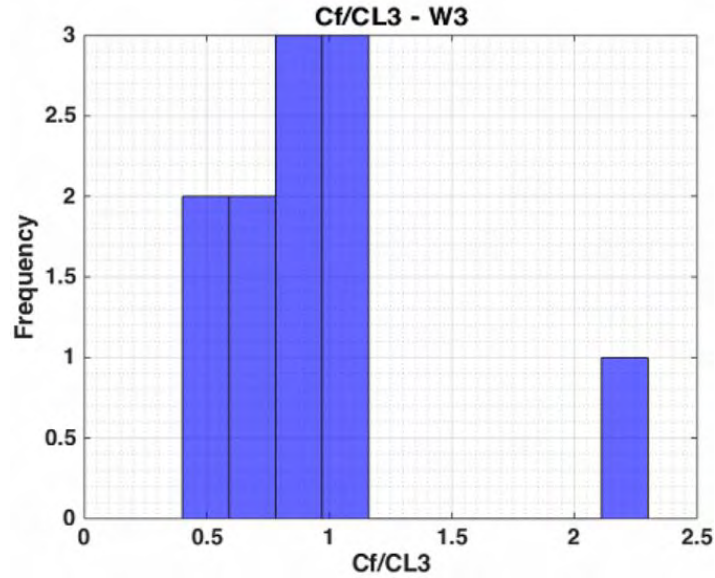
The ratio between the length of corrosion in the flanges and the total corroded length (CL3) is depicted in Figure 62. Figure 63 depicts the raw corrosion length in the flange.

Figure 62: Ratio between corrosion length in the flanges and CL3 for W3 pattern - CTDOT

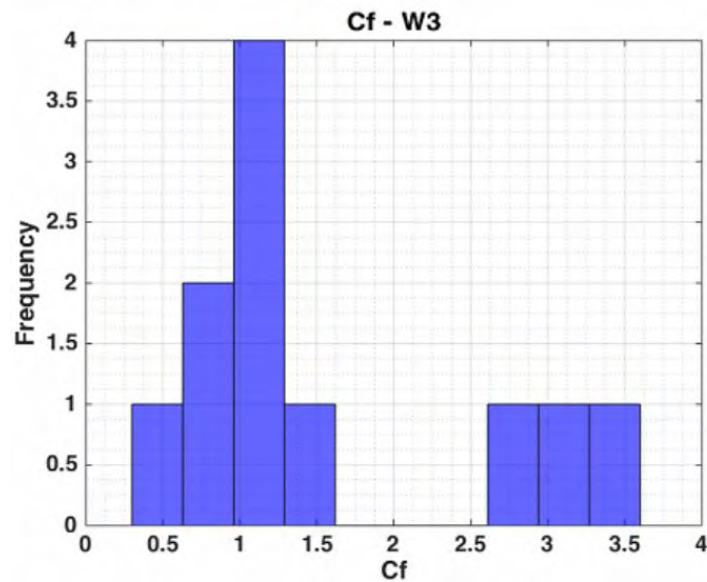
Figure 63: Raw corrosion length in the flanges for W3 pattern - CTDOT

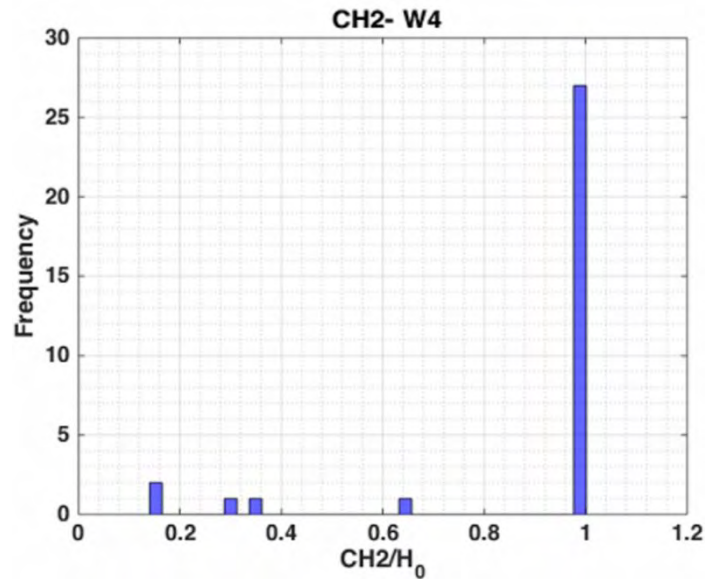
Figure 66: CH2 distribution for W4 pattern - CTDOT

Figure 66 clearly depicts that CH2 is equal to 1 for most beam ends reported. Using this information, our team was able to further analyze the other parameters for CH2>0.9H0. The following figures depict the behavior of the other parameters for CH2>0.9H0.

Like the other studies conducted, this study started by analyzing CH2, depicted in Figure 66. The parameters for the corrosion patterns can be found with corresponding diagrams in Section 1.5 *Corrosion Patterns* of this report.

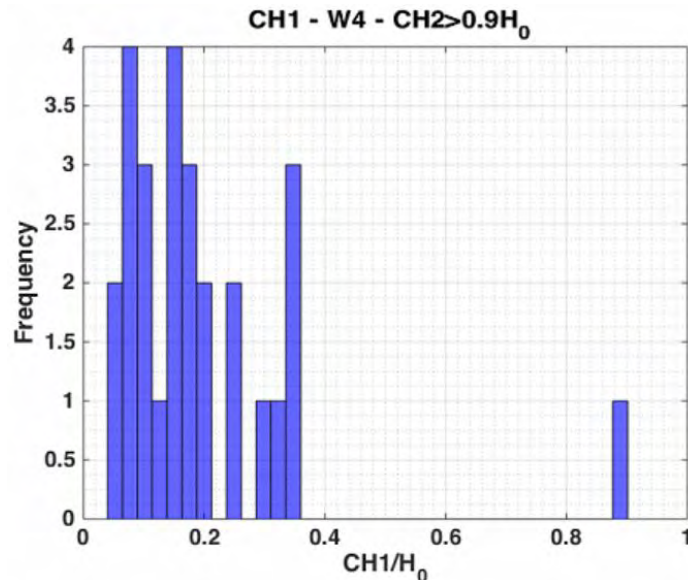
Figure 67: CH1 distribution for W4 pattern and CH2>0.9H - CTDOT

From these figures, our team was able to conclude that:

$$\begin{aligned}
 0 < CH_1 &\leq 0.4H_0 \\
 0.9H_0 &\leq CH_2 \leq 1H_0 \\
 0 < CL_1 &\leq 1H_0 \\
 0.5H_0 < CL_2 &\leq 1.5H_0 \\
 0.1H_0 < CL_3 &\leq 0.5H_0 \\
 0.1 \leq \frac{t_{loss}}{t_{web}} &\leq 0.6
 \end{aligned}$$

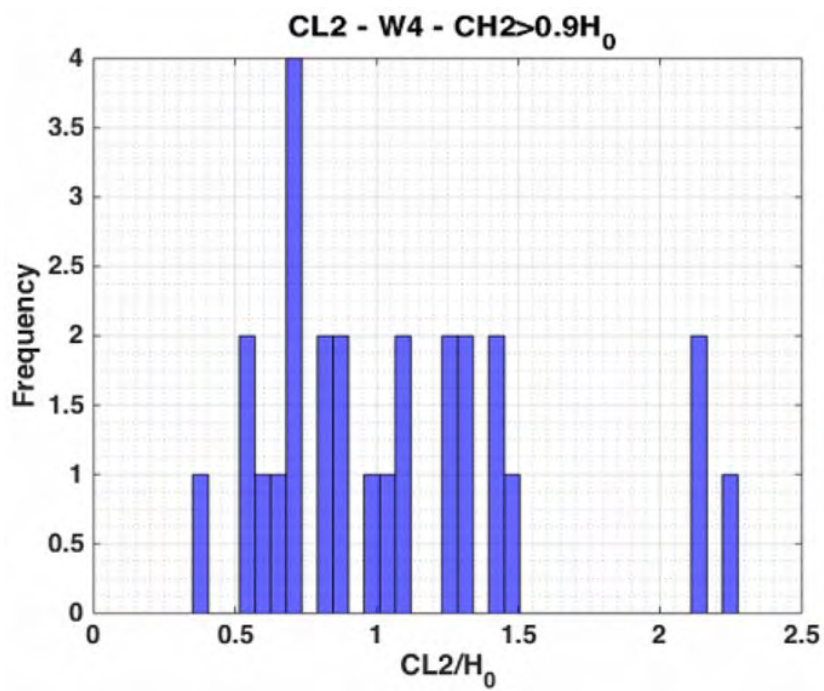
Figure 69: CL2 distribution for W4 pattern and CH2>0.9H - CTDOT

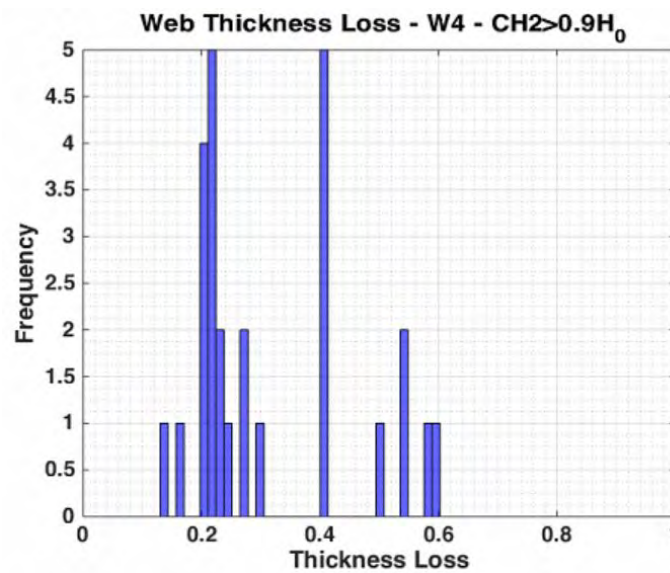
Figure 71: Web thickness loss distribution for W4 pattern and CH₂>0.9H - CTDOT

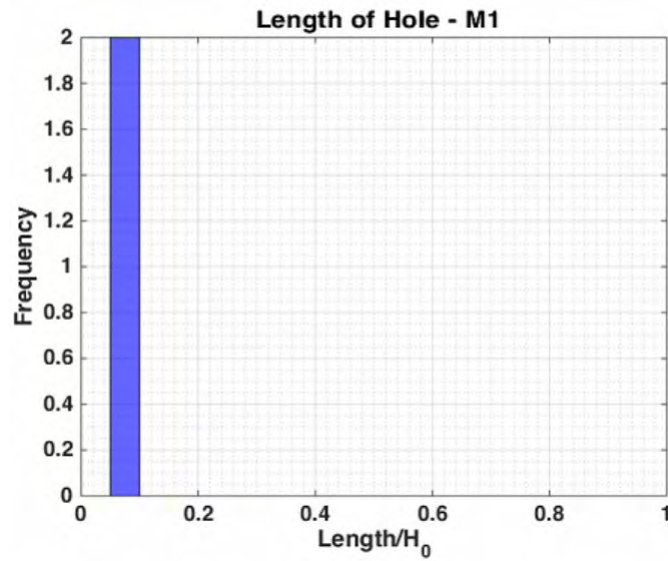
Figure 75: Length of hole M1 combined with W4 pattern - CTDOT

For the corrosion combination of W4 with holes, only three holes were observed with the W4 pattern. It is important to note that the data here is not enough in order to draw conclusions via the histograms in Figure 74, Figure 75, Figure 76, and Figure 77. These depict the dimensions of the holes observed.

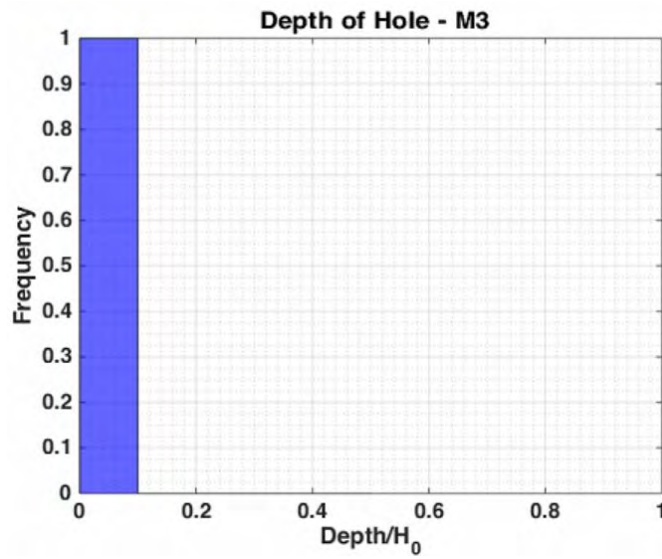
Figure 76: Depth of hole M3 combined with W4 pattern - CTDOT

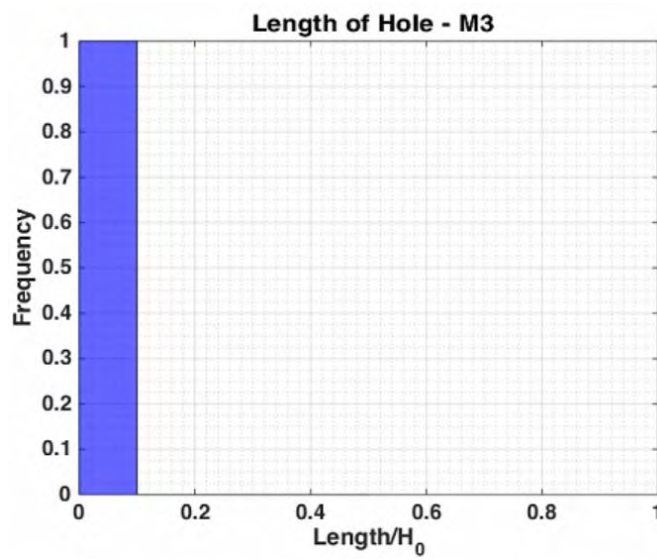
Figure 77: Length of hole M3 combined with W4 pattern - CTDOT

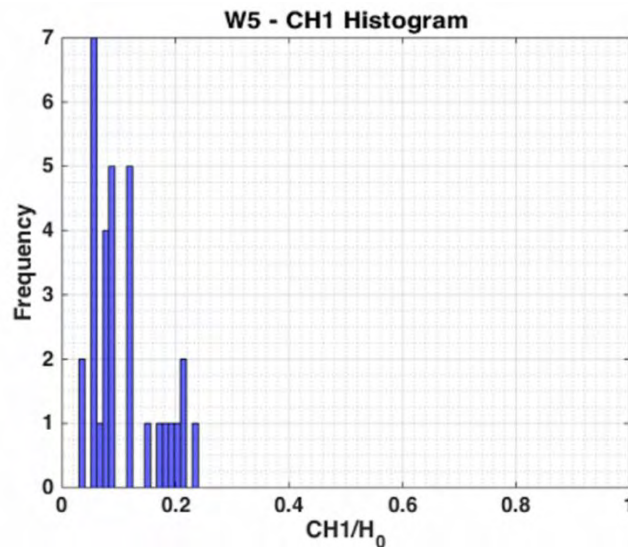
Figure 78: CH1 distribution of W5 pattern for beams without a diaphragm – CTDOT

Figure 78 clearly depicts that CH1 tends to be smaller than $0.2H_0$. This means that when analyzing the behavior of CL1 for when $CH1 < 0.2H_0$, we found:

The study began by analyzing the height of corrosion. Figure 78 depicts the distribution of CH1 for pattern W5. The parameters for the corrosion patterns can be found with corresponding diagrams in Section 1.5 *Corrosion Patterns* of this report.

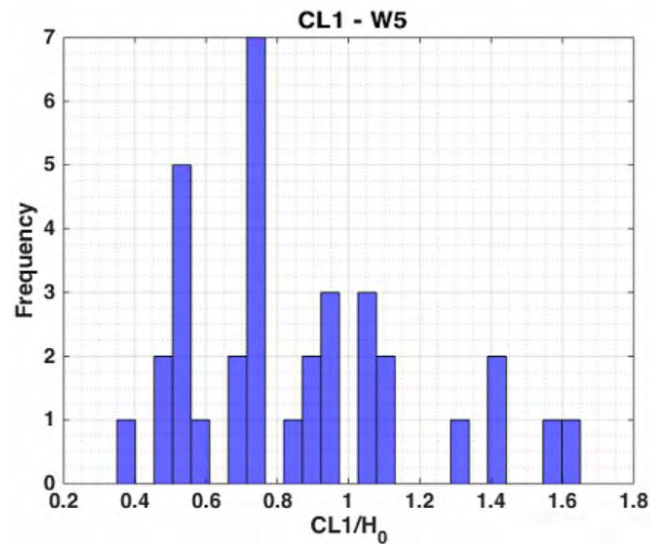
Figure 79: CL1 distribution of W5 pattern for beams without a diaphragm – CTDOT

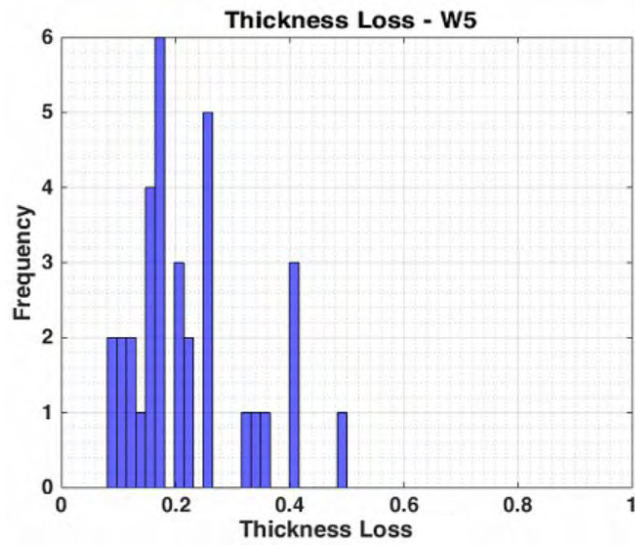
Figure 80 depicts the web thickness loss for $CH_2 > 0.9H_0$:

Figure 80: Web thickness loss distribution of W5 pattern for beams without a diaphragm – CTDOT

$$0.1 \leq \frac{t_{loss}}{t_{web}} \leq 0.5$$

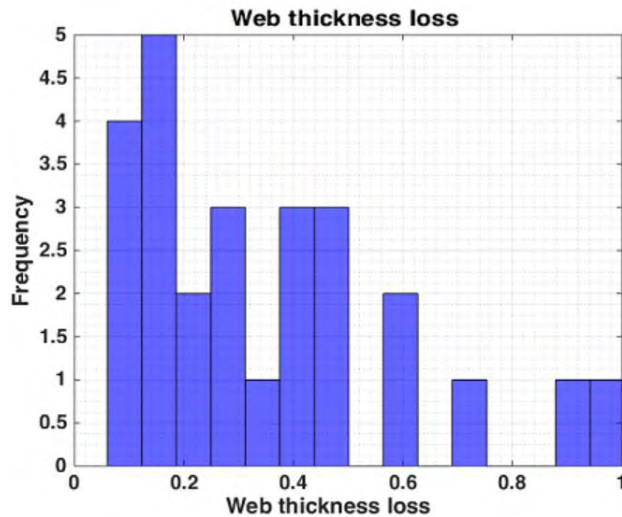
Figure 82: Web thickness loss histogram from the beam ends compiled - MaineDOT

Most of the reports presented information regarding web thickness loss. The information is provided without specifically referring to a beam. Figure 82 depicts the histogram of web thickness loss for the beams ends provided by MaineDOT.
