1. Report No.	2. Government Accession No.	3. Recipient's Catalog No.	
4. Title and Subtitle Improved Load Rating Procedures for Deteriorated Unstiffened Steel Beam Ends Deliverable 1: Identification of common unstiffened steel beam-end corrosion topologies		5. Report Date August, 2021

15. Supplementary Notes			
16. Abstract This report contains the information regarding the first task of an ongoing project aiming to enhance load rating methods for assessing corroded unstiffened beam ends for the six New England States. The first task of the project aims to collect and compile the information provided by DOTs within New England. Within this task, based on reports provided by the DOTs, the most common corrosion patterns were identified. From the information collected, the research team was able to carefully identify trends and patterns in the data, which allowed the research team to determine the most common scenarios of corrosion encountered in bridges within New England States.

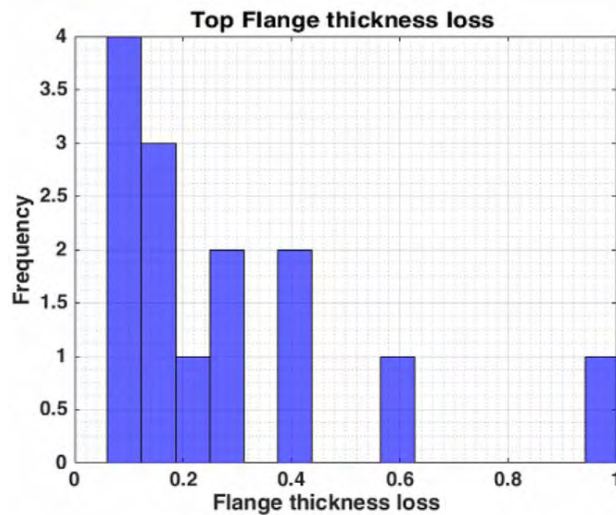
Figure 84: Top flange thickness loss histogram from the beam ends compiled - MaineDOT

Most of the reports that contained information regarding the web thickness loss also included information regarding flange thickness loss. More precisely, 29 out of the 39 beams ends compiled presented information regarding corrosion in the flanges. Figure 83 and Figure 84 depict the flange thickness loss for the bottom and top flanges, respectively.

The comparison between Figure 83 and Figure 84 clearly shows that the thickness loss of top flanges is smaller than the thickness loss of the bottom flanges. This is likely a result of how ice and water flow to the bottom flanges.

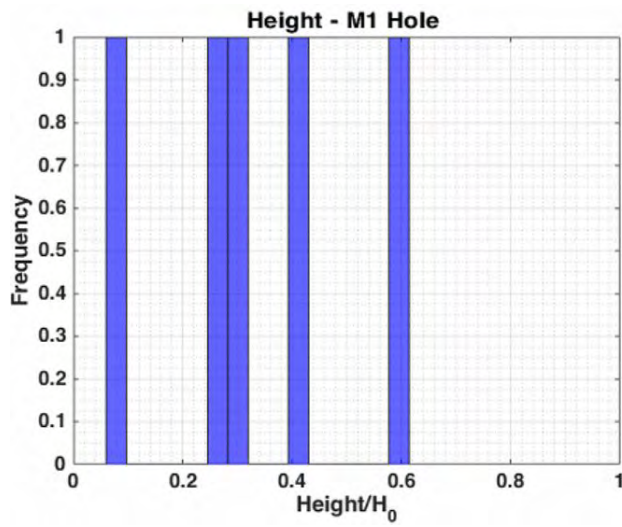
Figure 85: M1 web hole's height distribution of W1 web corrosion pattern for beams without a diaphragm - MaineDOT

All five holes observed in the reports are M1. Additionally, Figure 85 and Figure 86 depict the dimensions of the holes observed in the bridge inspection reports from MaineDOT.

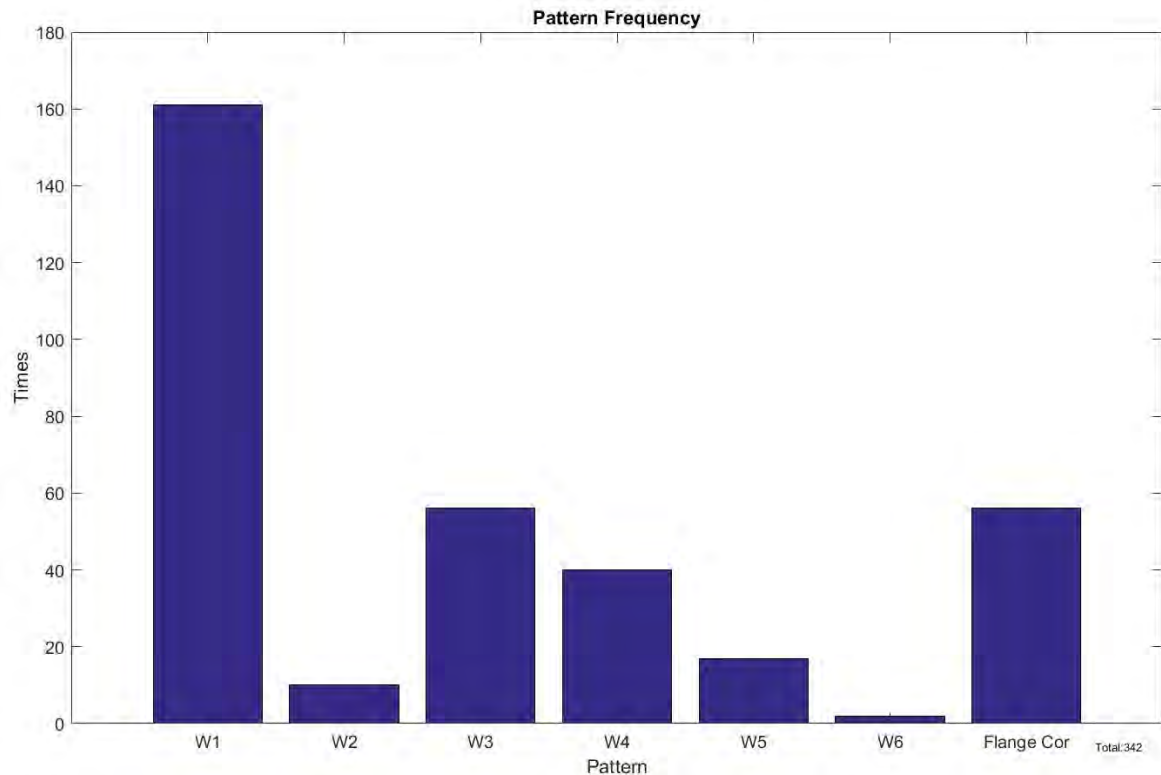
Figure 87: Web corrosion patterns distribution for beams without a diaphragm - MassDOT

The data for Massachusetts was divided in two main categories, beams ends with a diaphragm and without a diaphragm. All the graphs in this part of the document represent the second case. Figure 87 contains the frequency of each of the defined corrosion patterns (the total amount of times each pattern appears in the reports).

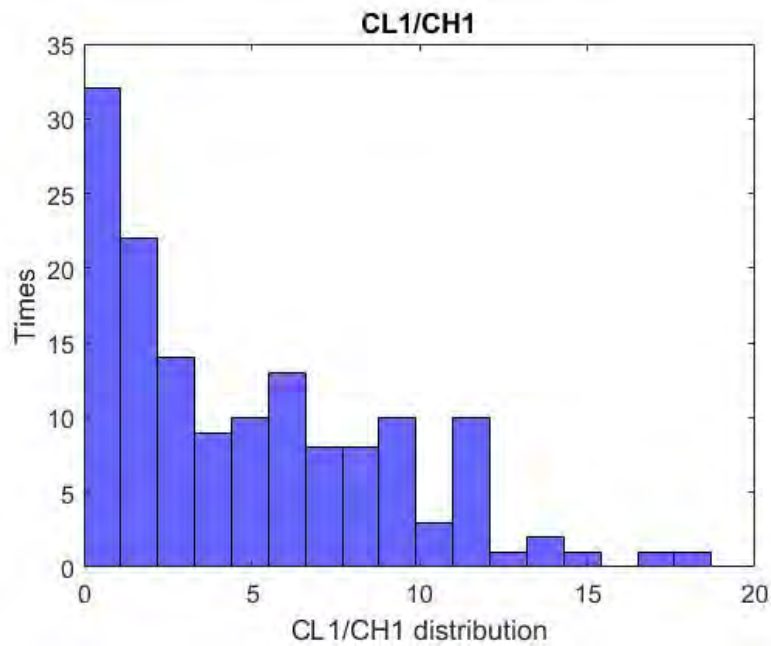
Figure 91: Ratio of corrosion length (CL_1) to corrosion height (CH_1) of W1 pattern for beams without a diaphragm (range 0-15) - MassDOT

Figure 90 shows the ratio of CL₁/CH₁ which indicates that in general, the length of the corroded area is bigger than its height. Figure 91 focuses on the range 0-15 for the same distribution.

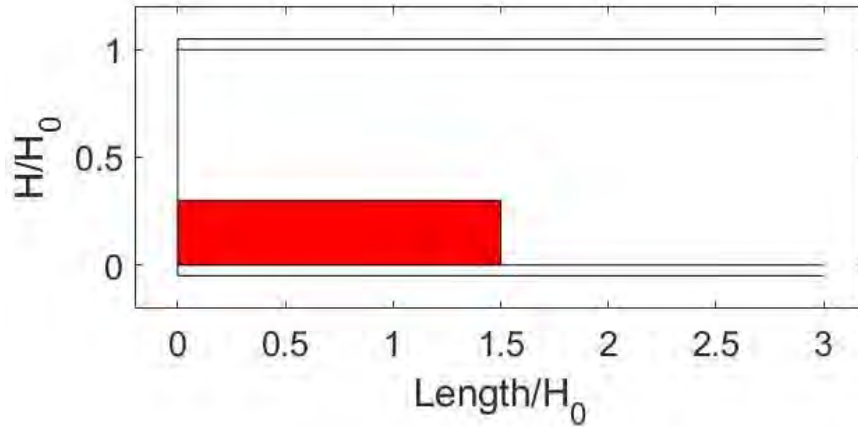
Figure 94: First extreme W1 web corrosion pattern, with corrosion height up to 30% of H0 for beams without a diaphragm - MassDOT

Based on Figure 94, the values for the web thickness loss are: $\frac{t_{loss}}{t_{web}}$ take values of {0.2,0.4,0.6,0.8}

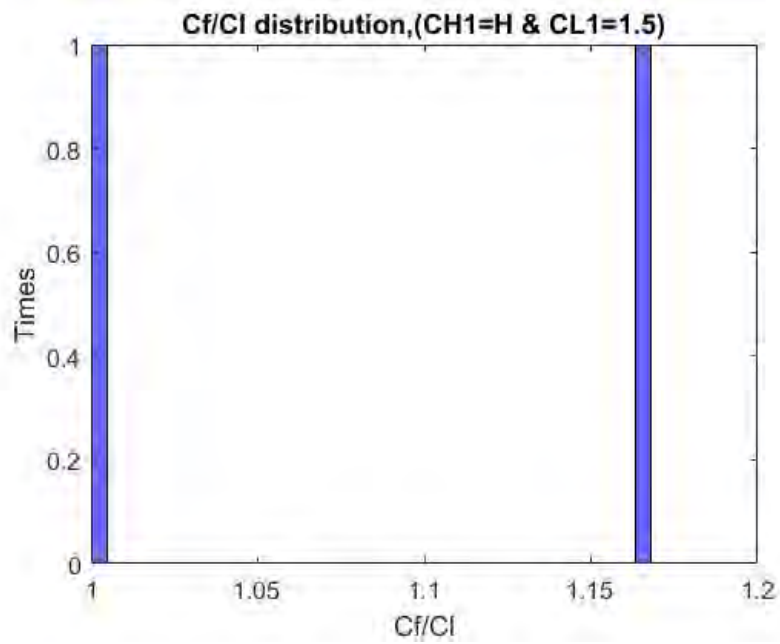
Figure 100: Ratio of flange to web corrosion length distribution of W1 web corrosion pattern for extreme scenario CASE B for beams without a diaphragm - MassDOT

For each of the three cases (Figure 94, Figure 97, Figure 98) the ratio of the length of the corroded flange over the length of the corroded web was plotted (figure Figure 99, Figure 100, Figure 101).

For all cases $1 \leq \frac{c_f}{c_l} \leq 2$ (Figure 99, Figure 100, Figure 101).

According to the table above, the W2 corrosion pattern is combined once with the M1 hole corrosion pattern and 4 times with the M2 hole corrosion pattern. As it was already mentioned W2 and W1 will be combined and used as one pattern. Thus, for the M1 hole corrosion pattern our team checked if the dimensions of the unique hole belong in the range of the W1 pattern and M1 pattern combination. The unique hole with $a=0.089H_0$ and $b=0.31H_0$ satisfies the limits of Figure 100.

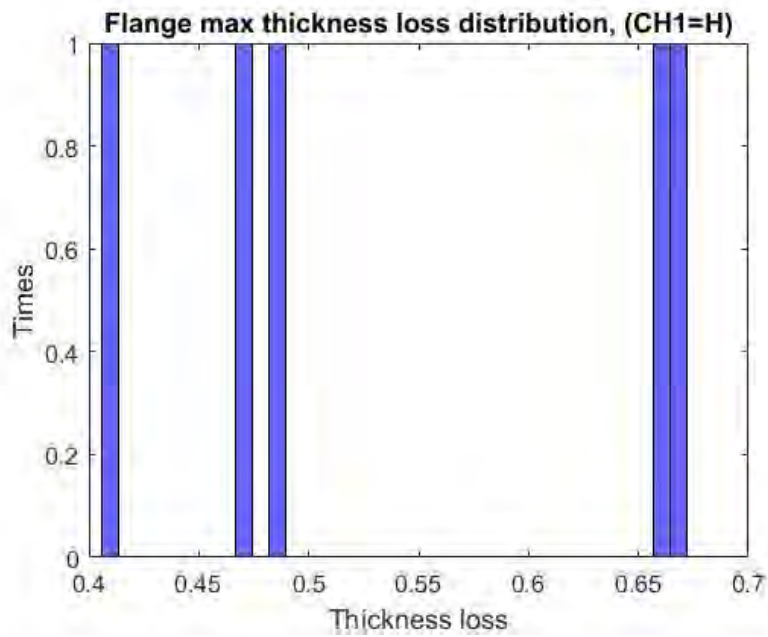
Figure 103: Max flange thickness loss distribution of W1 web corrosion pattern with full height corrosion for beams without a diaphragm - MassDOT

C: $\frac{t_{loss}}{t_{flange}}$ takes values of {0.45,0.65} (Figure 103).

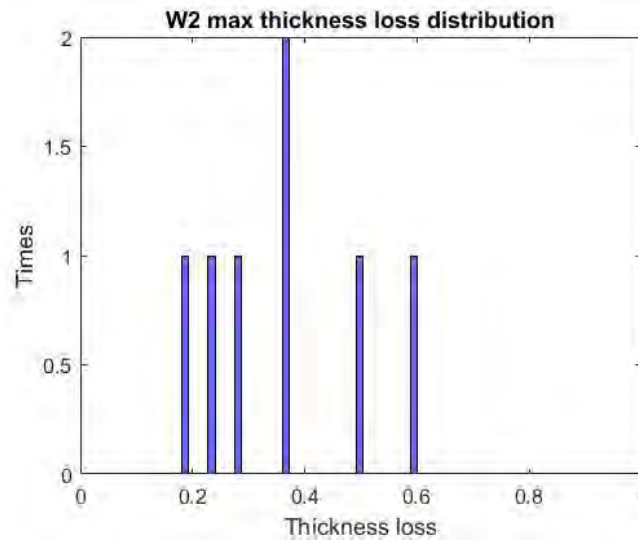
Figure 108: Web thickness loss distribution of W2 pattern for beams without a diaphragm - MassDOT

The blue area indicates the Case A of W1 pattern, and with red the extreme W2 pattern scenario. Since the rest of W2 cases fit in the blue shaded area, W1 case A can be merged with W2. According to Figure 108 the thickness loss for W2 is in the Case A-W1 range.

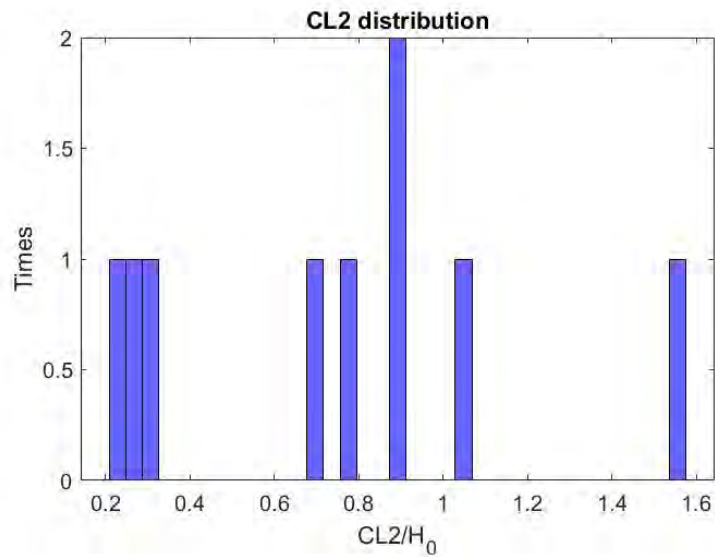
Figure 111: CL₂ distribution of W2 pattern for beams without a diaphragm - MassDOT

From Figure 110 and Figure 111: $0.5 < CL_1 \leq 1.1H$, $0.25 < CL_2 \leq 1.2H$, where the extreme scenario is illustrated as:

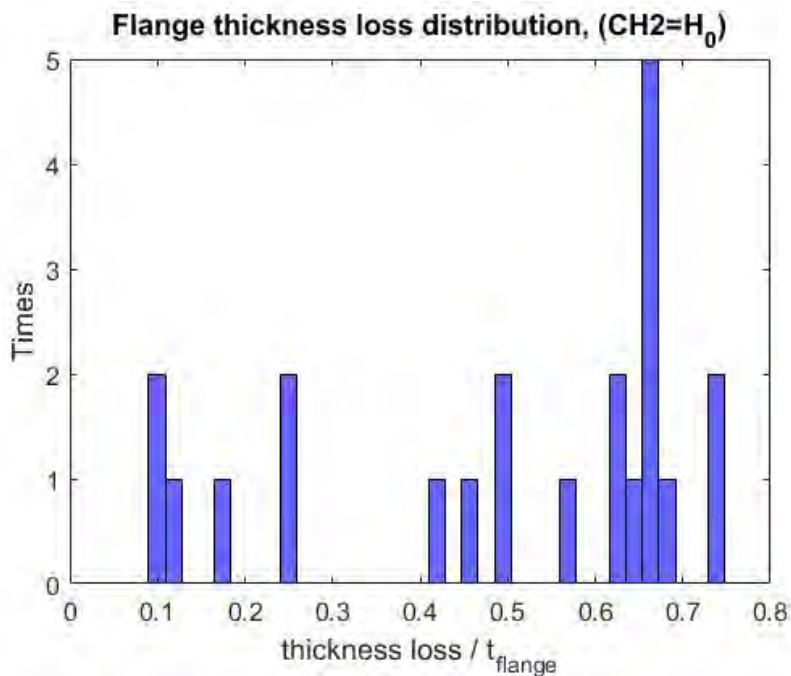
Figure 125: Max flange loss thickness distribution of W3 web corrosion pattern with full height corrosion for beams without a diaphragm - MassDOT

$$\frac{t_{loss}}{t_{flange}} \text{ takes values of } \{0.4, 0.6, 0.8\}$$

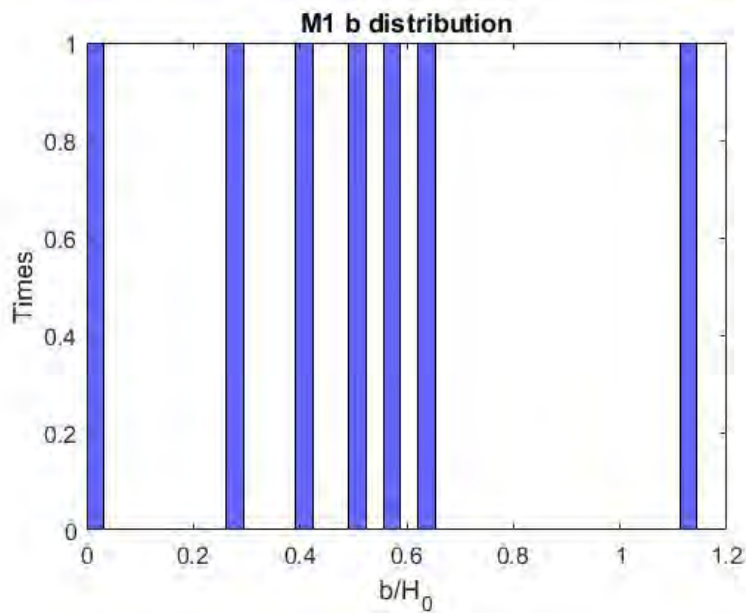
Figure 127: M1 web hole's pattern length distribution of W1 web corrosion pattern for beams without a diaphragm - MassDOT

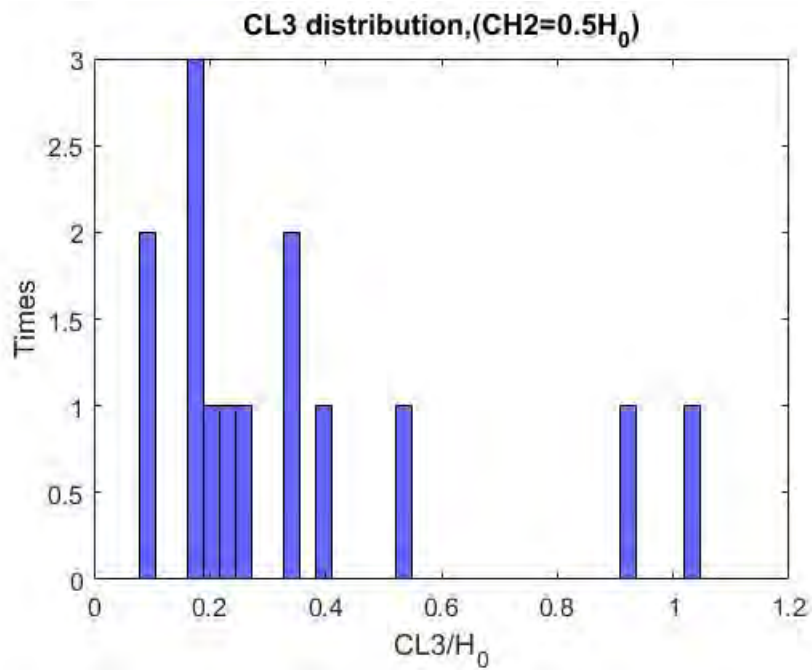
Figure 137: CL3 distribution of W4 web corrosion pattern, with corrosion height up to 50% of H₀ for beams without a diaphragm - MassDOT

Based on Figure 134, Figure 135, Figure 136, Figure 137, Figure 138:

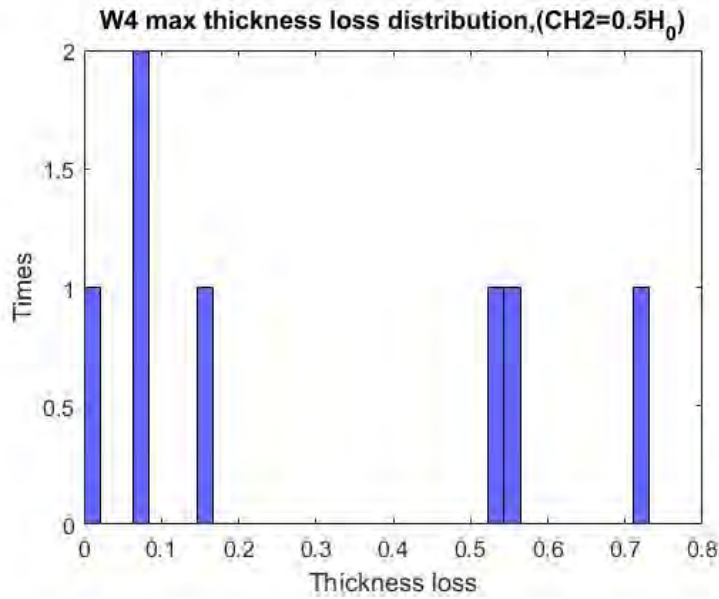
Figure 138: Max web thickness loss distribution of W4 web corrosion pattern, with corrosion height up to 50% of H_0 for beams without a diaphragm - MassDOT

$$\frac{t_{loss}}{t_{web}} \text{ takes values of } \{0.05, 0.15, 0.55, 0.75\}$$

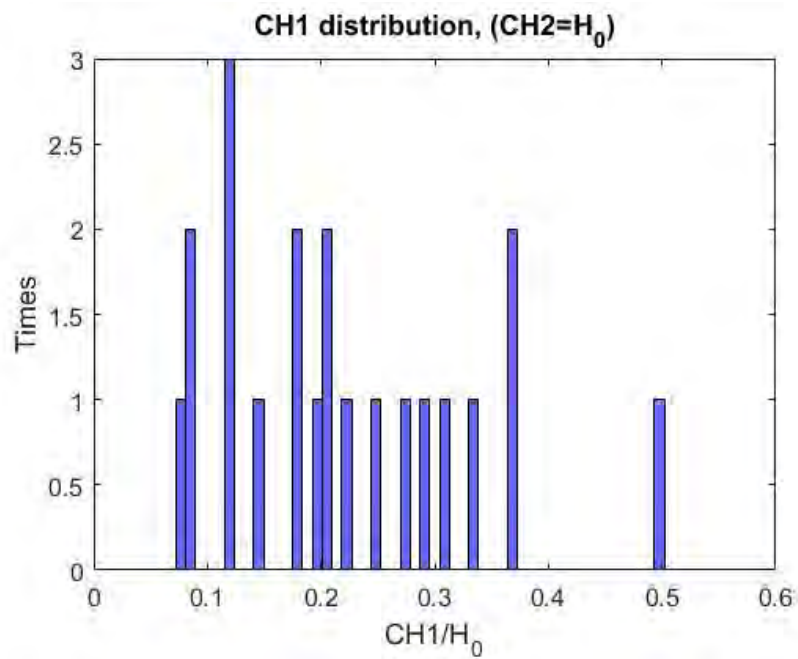
Figure 140: CH1 distribution of W4 web corrosion pattern, with full height corrosion for beams without a diaphragm - MassDOT

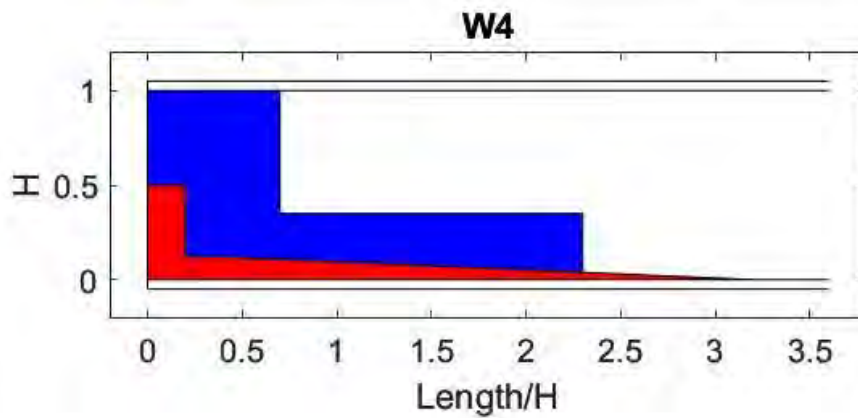
Figure 147: Second extreme W4 scenario (red) projected over extreme W3 web corrosion scenario (blue) - MassDOT

Considering the way W3 and W4 have been defined, W3 can be expressed by W4 if we set $W4CL1=W4CL3$ and $W4CH3 \neq 0$. Figure 146 and Figure 147 demonstrate that W3 includes the extreme W4 scenarios, thus W3 and W4 could be merged to one pattern.

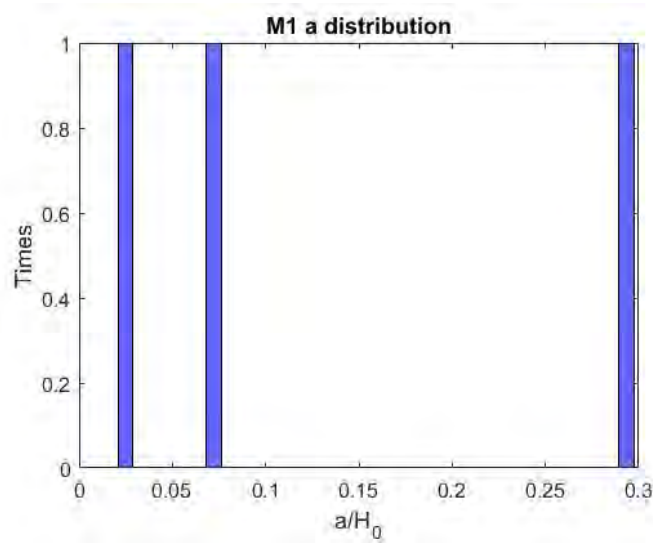
According to the table, the W4 pattern is combined four times with the M1 hole pattern. The available data are not enough to extract conclusions about the web thickness loss at these cases. The corrosion holes dimension distribution can be seen in the figures below:

Figure 148: M1 web hole's pattern height distribution of W4 web corrosion pattern for beams without a diaphragm - MassDOT

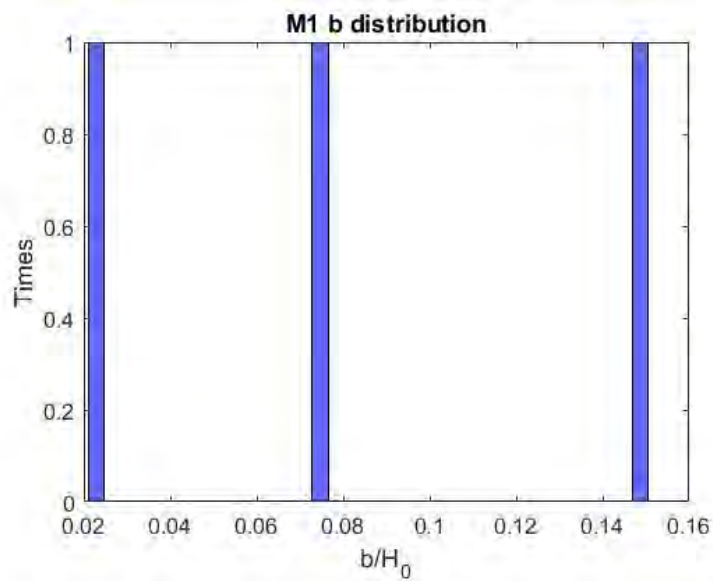
Figure 149: M1 web hole's pattern length distribution of W3 web corrosion pattern for beams without a diaphragm - MassDOT

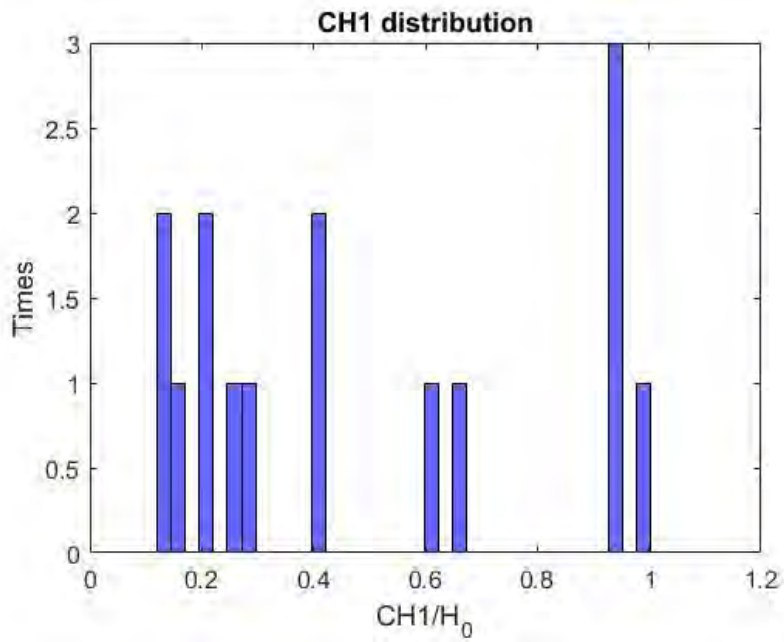
Figure 151: CH2 distribution of W5 web corrosion pattern for beams without a diaphragm - MassDOT

From Figure 151, our team described the following: $0.15H_0 \leq CH_1 \leq H_0$

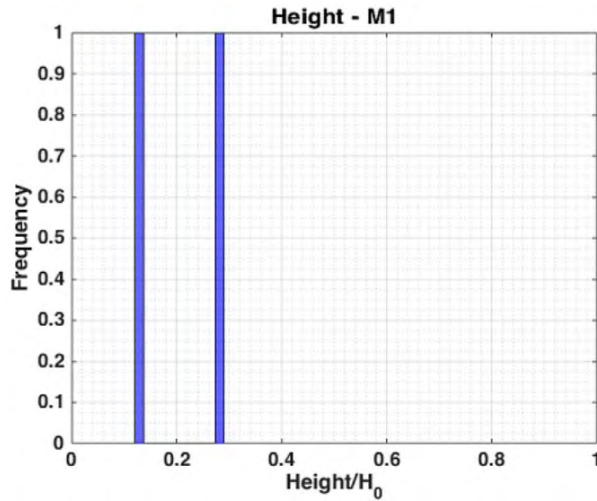
Figure 160: M1 web hole’s height distribution of W1 web corrosion pattern for beams without a diaphragm - NHDOT

Only two holes were observed in the inspection reports provided by NHDOT. Additionally, both holes were reported with photographs. The dimensions of the holes are described by the plots in Figure 160 and Figure 161.

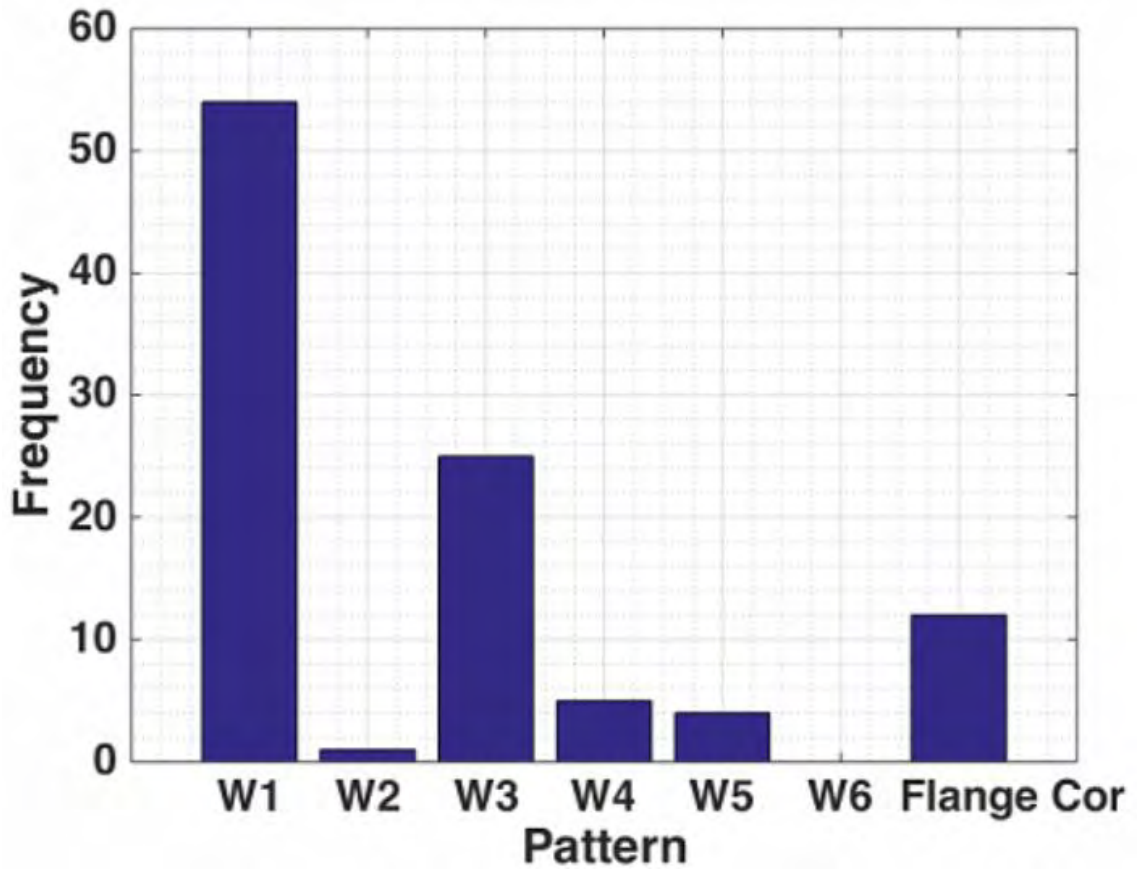
Figure 162 : Web corrosion patterns distribution for beams ends without diaphragm – RIDOT

From the reports provided by RIDOT, the research team was able to gather corrosion information of 89 beam ends without a diaphragm. Figure 162 depicts the frequency of corrosion patterns for beam ends without a diaphragm.

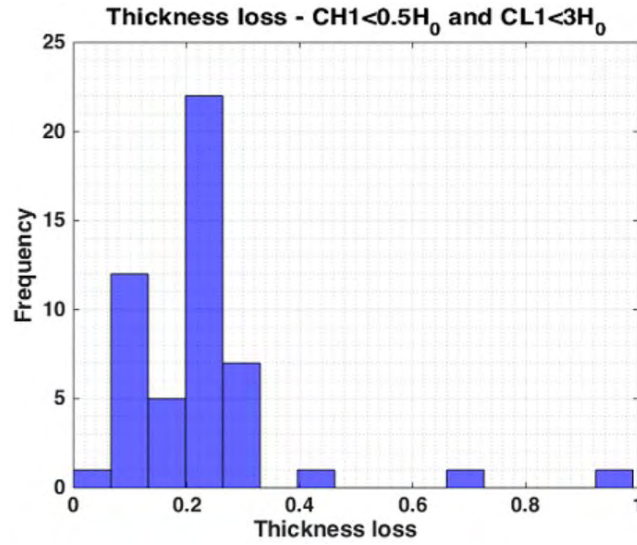
Figure 165: Web thickness loss of W1 pattern for beams without a diaphragm, $CH_1 < 0.5H_0$ and $CL_1 < 3H_0$ – RIDOT

Figure 165 depicts the web thickness loss for the case $CH_1 < 0.5H_0$ and $CL_1 < 3$.

Figure 165 depicts that the thickness loss clusters between 0% until 30%. That, is:

$$0 < \frac{t_{web}}{t_{loss}} \leq 0.3$$

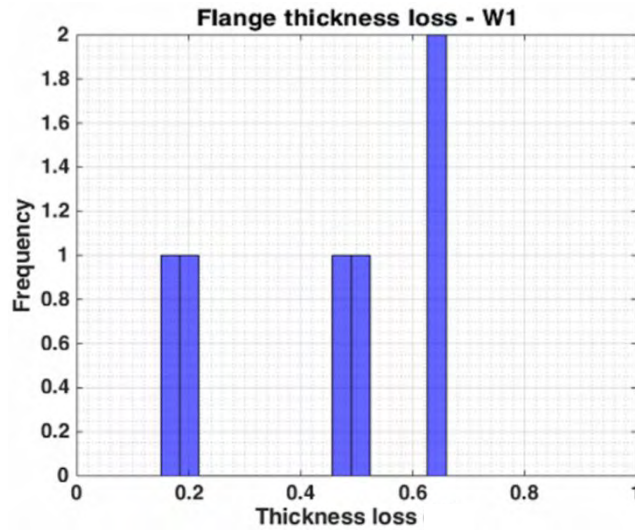
Figure 167: Flange thickness Loss for pattern W1 – RIDOT

Due to the limited quantities of beams with flange corrosion, the team was not able to detect any trend regarding flange corrosion from the recorded data. Figure 167, Figure 168 and Figure 169 depict the statistics the research team was able to extract from the available data.

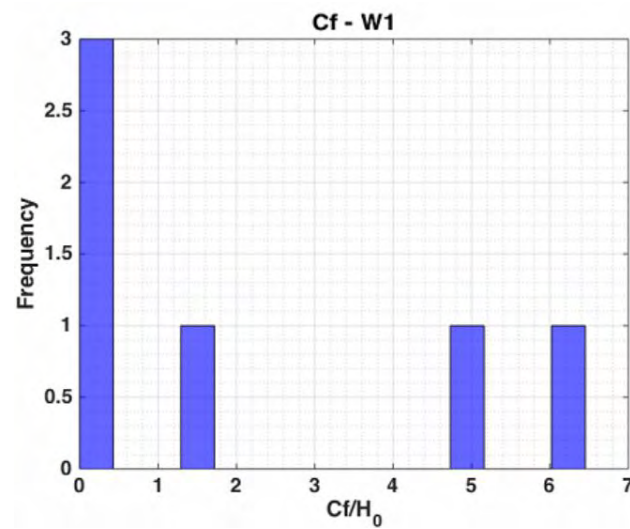
Figure 168: Flange corrosion length for pattern W1 – RIDOT

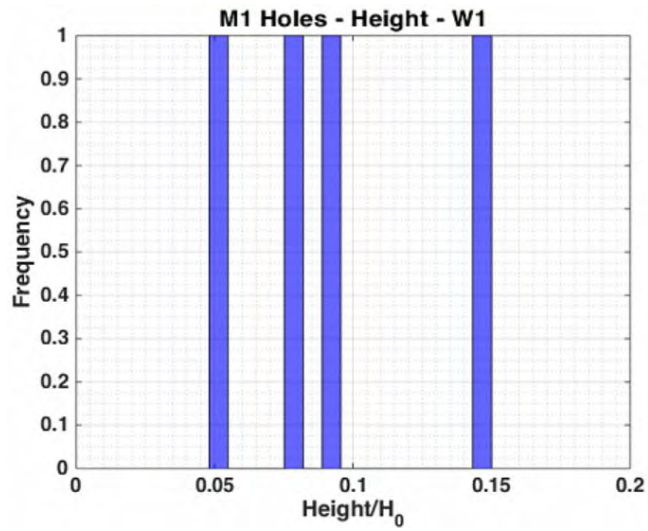
Figure 170: Height of M1 holes combined with W1 pattern – RIDOT

Therefore, only 5 holes were reported and were combined with the W1 corrosion pattern. Unfortunately, no trend was detected by the research team. Figure 170, Figure 171, Figure 172 and Figure 173 depicts the dimensions of the recorded corrosion holes.

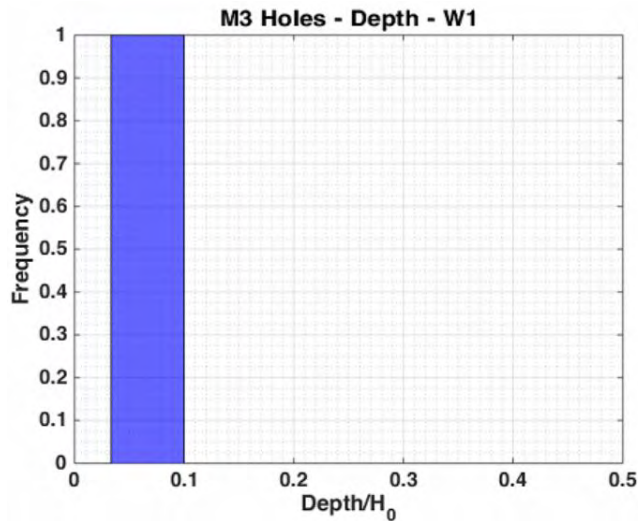
Figure 173: Depth of M3 holes combines with W1 pattern – RIDOT

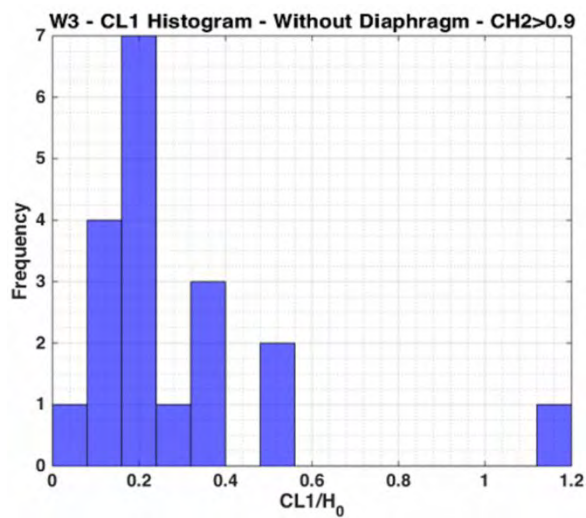
Figure 178: CL1 distribution for W3 pattern and $CH2 > 0.9H0$ - RIDOT

Figure 178, Figure 179 and Figure 180 depict the behavior of the other parameters given that $CH2 > 0.9H0$.

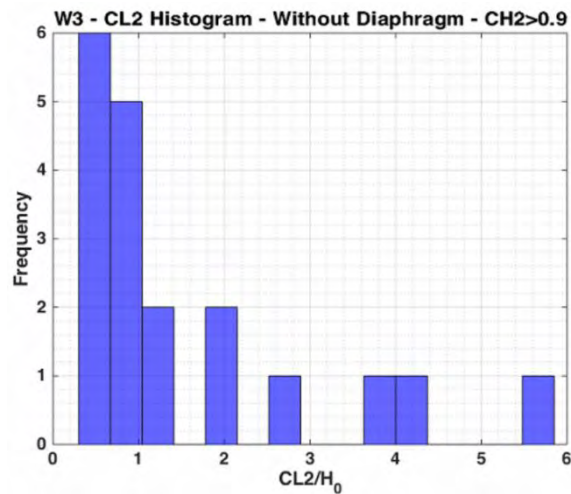
Figure 179: CL2 distribution for W3 pattern and CH2>0.9H0 - RIDOT

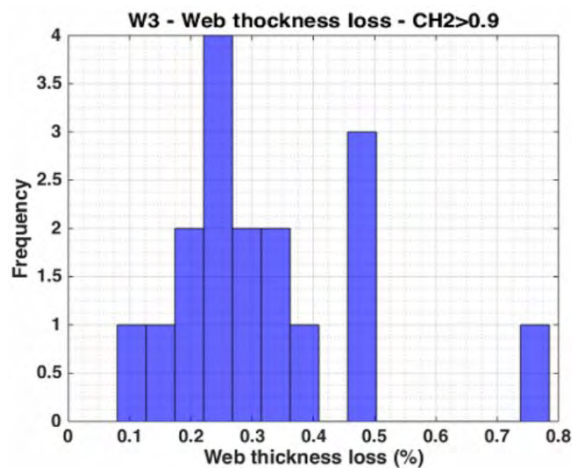
Figure 181: Web thickness loss distribution for W3 pattern and CH2>0.9H0 - RIDOT

Figure 181 depicts the web thickness loss for the W3 corrosion pattern.

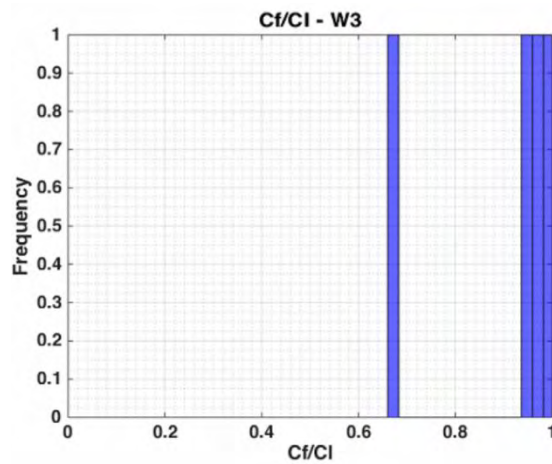
Figure 185: ratio between flange corrosion length and web corrosion length for W3 pattern – RIDOT

It is worth noting that, although no trend was depicted, it is possible to observe that the behavior of the corrosion of the flanges is similar to the corrosion of the web. That is, the length of corroded flange is close to the total length of web corrosion.

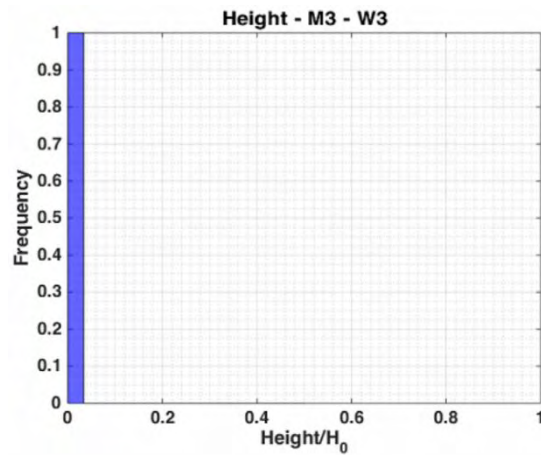
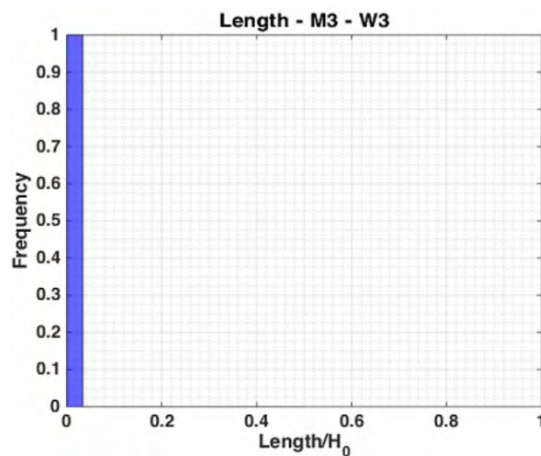
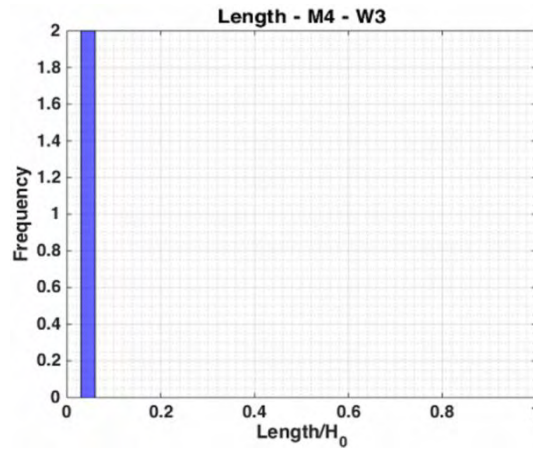
Figure 186: Height of M3 hole combined with W3 pattern – RIDOT

Figure 187: Length of M3 hole combined with W3 pattern – RIDOT

Figure 188: Height of M4 holes combined with W3 pattern – RIDOT

Figure 189: Length of M3 hole combined with W3 pattern – RIDOT

From the bridge inspection reports provided by RIDOT, the research team was able to record only 3 holes combined with the W3 corrosion pattern, as portrayed in Figures 186, 187, 188, and 189. As not all three holes belong to the same topology, the research team was not able to identify trends in the data.

Figure 186, Figure 187, Figure 188 and Figure 189 depict the dimensions of the recorded holes.

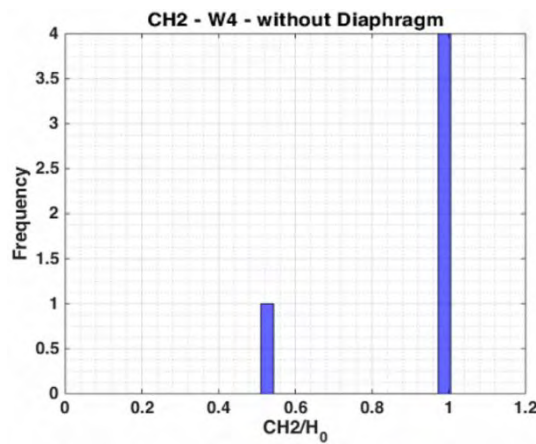
Figure 190: CH2 distribution for W4 pattern – RIDOT

Figure 190 depicts the distribution of CH2 of pattern W4. Figure 190 clearly depicts the trend of $CH2 > 0.9H_0$. The research team was not able to detect trends as the other parameters of W4 pattern are scattered, which limited our research team in detecting trends. The parameters for the corrosion patterns can be found with corresponding diagrams in Section 1.5 *Corrosion Patterns* of this report. Figure 191, Figure 192, Figure 193 and Figure 194 depict the distribution of the other parameters recorded from the bridge inspection reports.

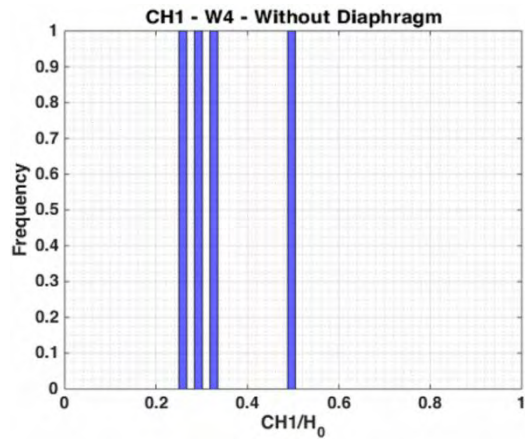
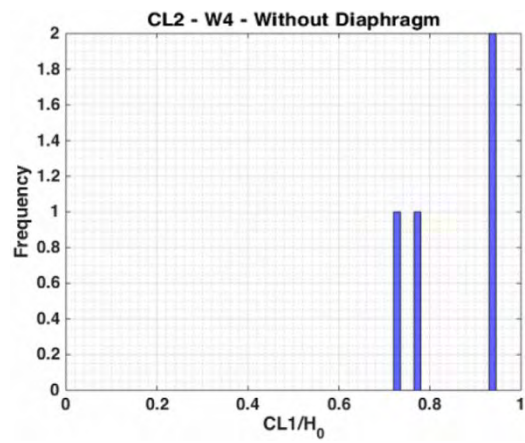
Figure 191: CH1 distribution for W4 pattern – RIDOT

Figure 192: CL1 distribution for W4 pattern – RIDOT

Figure 193: CL2 distribution for W4 pattern – RIDOT

Figure 194: CL3 distribution for W4 pattern – RIDOT

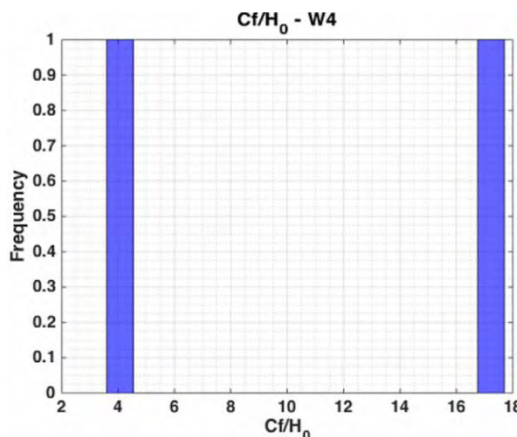
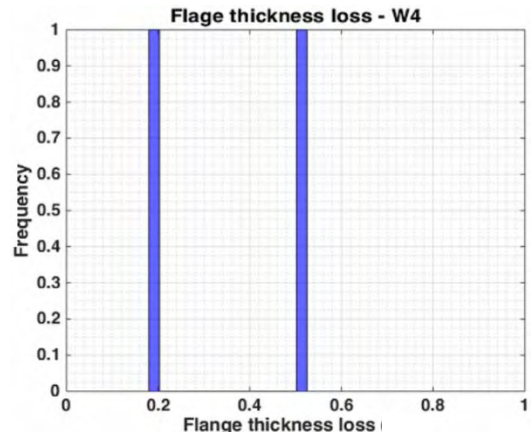
Figure 196: Flange corrosion length distribution for W4 pattern – RIDOT

Figure 197: Ratio between flange corrosion length and corrosion length for W4 pattern – RIDOT

Figure 198: Flange thickness loss distribution for W4 pattern – RIDOT

From the bridge inspection reports, the research team was able to record just two measurements of flange corrosion combined with the W4 corrosion pattern. As two recorded pattern instances are not enough to define trends, Figure 196, Figure 197, and Figure 198 depict the measurements provided by the inspection reports.

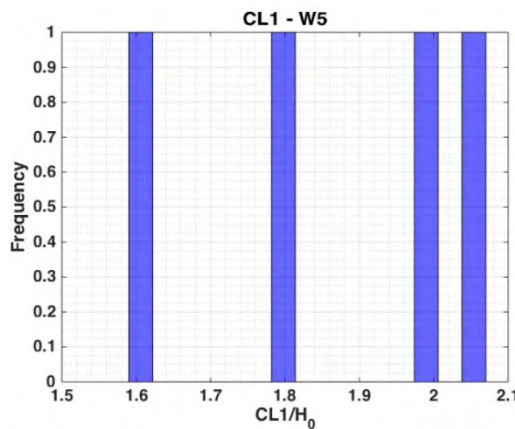
Figure 199: CH1 distribution for W5 pattern – RIDOT

Figure 200: CL1 distribution for W5 pattern – RIDOT

The research team was able to record data from 4 cases of the W5 corrosion pattern. The parameters for the corrosion patterns can be found with corresponding diagrams in Section 1.5 *Corrosion Patterns* of this report. As the amount of data recorded was not enough to detect any trends, Figure 199 and Figure 200 depict only the histogram of the parameters.

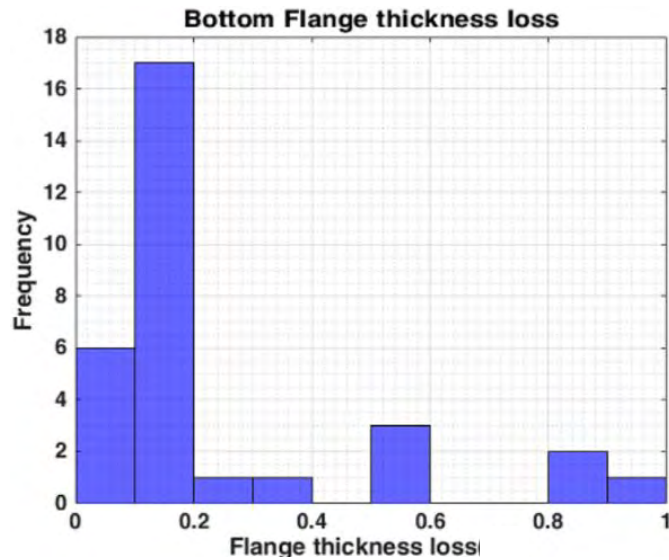
Figure 203: Bottom flange thickness loss histogram from the beam ends compiled - VTrans

Figure 204: Top flange thickness loss histogram from the beam ends compiled - VTrans

Similar to the reports from MaineDOT and NHDOT, the reports from VTrans often present information regarding the thickness loss in the flanges. Figures Figure 203 and Figure 204 depict the thickness loss for bottom and top flanges, respectively.

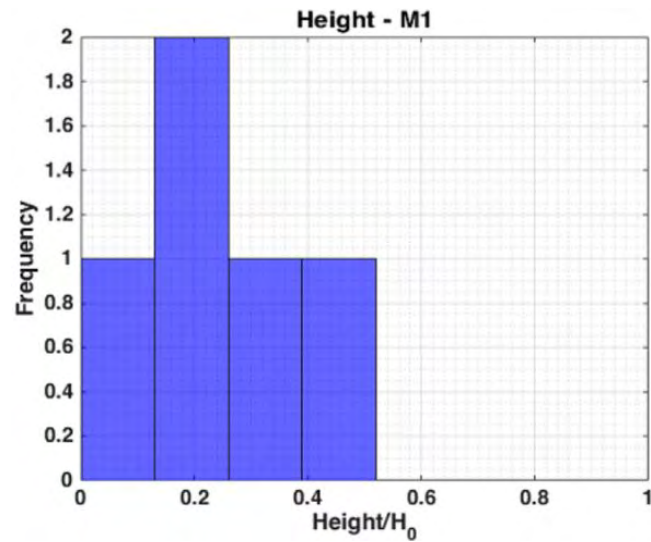
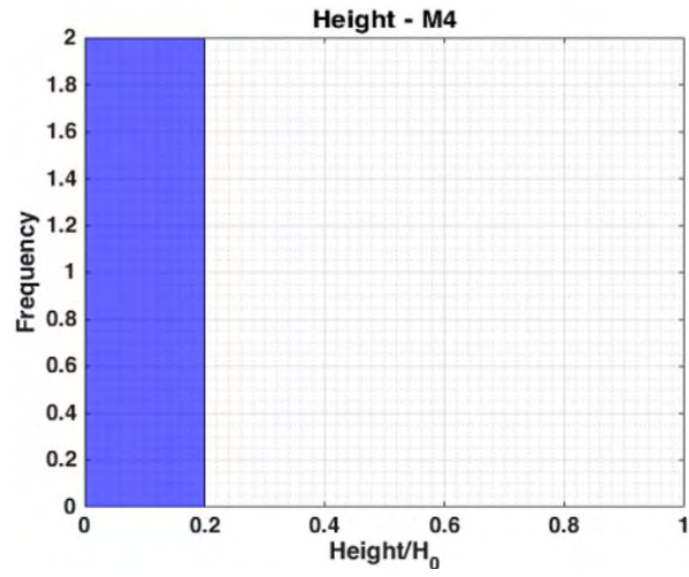
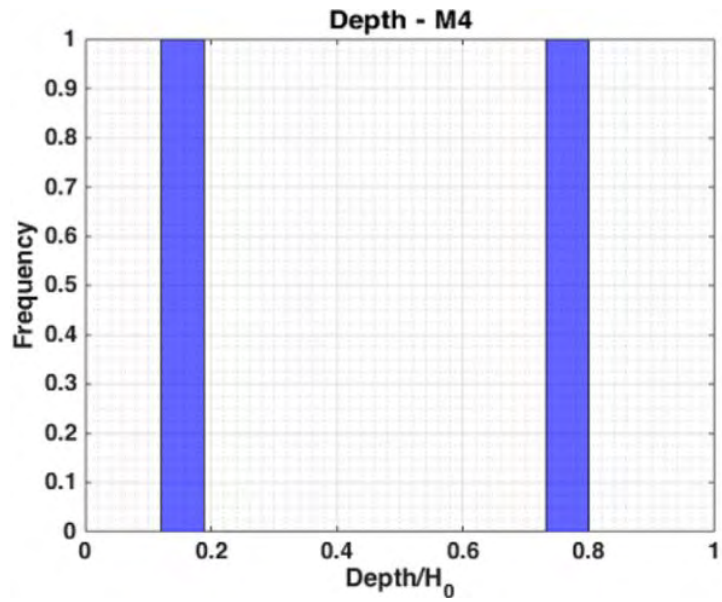
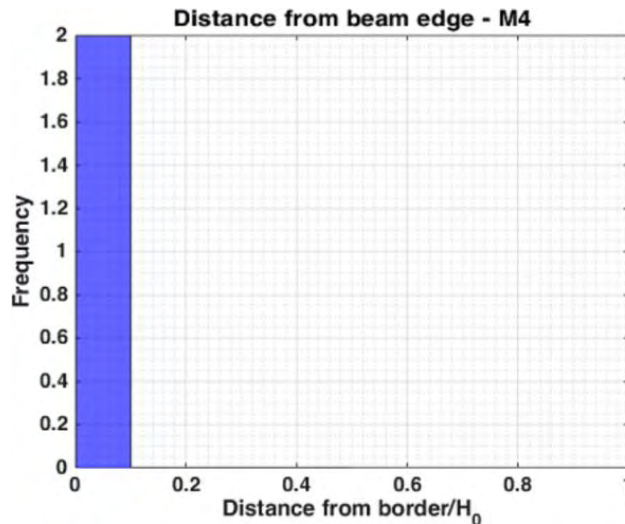
Figure 205: M1 web hole's height distribution beams without a diaphragm - VTrans

Figure 206: M1 web hole's depth distribution beams without a diaphragm - VTrans

Figure 207: M3 web hole's height distribution beams without a diaphragm - VTrans

Figure 208 : M3 web hole's depth distribution beams without a diaphragm - VTrans

Figure 209: M4 web hole's height distribution beams without a diaphragm - VTrans

Figure 210: M4 web hole's depth distribution beams without a diaphragm - VTrans

Figure 211 : M4 web hole’s distance from beam edge distribution beams without a diaphragm - VTrans

The dimensions of the holes are depicted in Figure 205, Figure 206, Figure 207, Figure 208, Figure 209, Figure 210, and Figure 211.

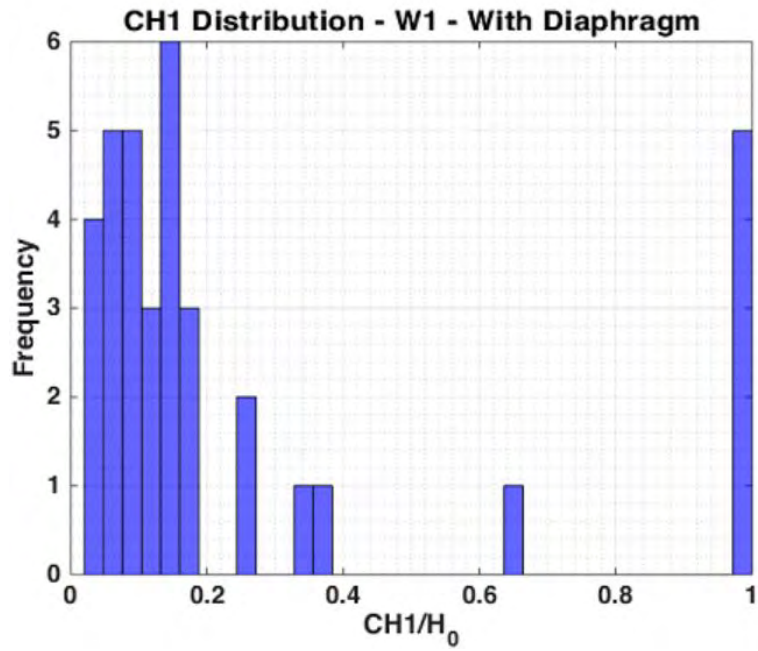
Figure 213: Distribution of corrosion height for W1 pattern – CTDOT

The study began with the analysis of the distribution of the corrosion height, depicted in Figure 213. The parameters for the corrosion patterns can be found with corresponding diagrams in Section 1.5 *Corrosion Patterns* of this report.

Our team discovered that, similar to the beams without a diaphragm, two trends are noticeable: (i) $CH1 < 0.2H_0$, (ii) $CH1 > 0.9H_0$.

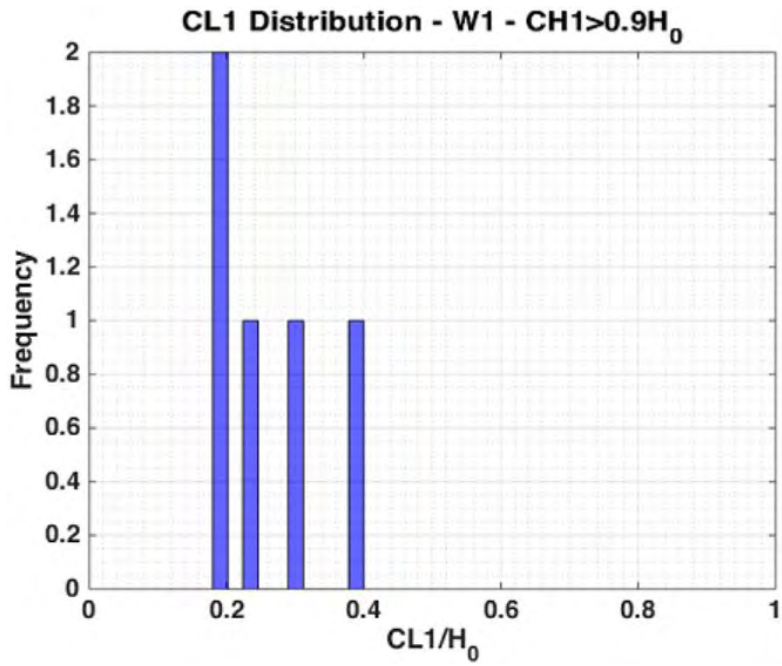
Figure 214: Corrosion length distribution for W1 pattern and $CH1 < 0.2H_0$ – CTDOT

Figure 215 : Corrosion length distribution for W1 pattern and CH1 > 0.9H0 – CTDOT

Figure 214 depicts the length of corrosion for $CH1 < 0.2H_0$, whereas Figure 215 depicts the length corrosion distribution for $CH1 > 0.9H_0$.

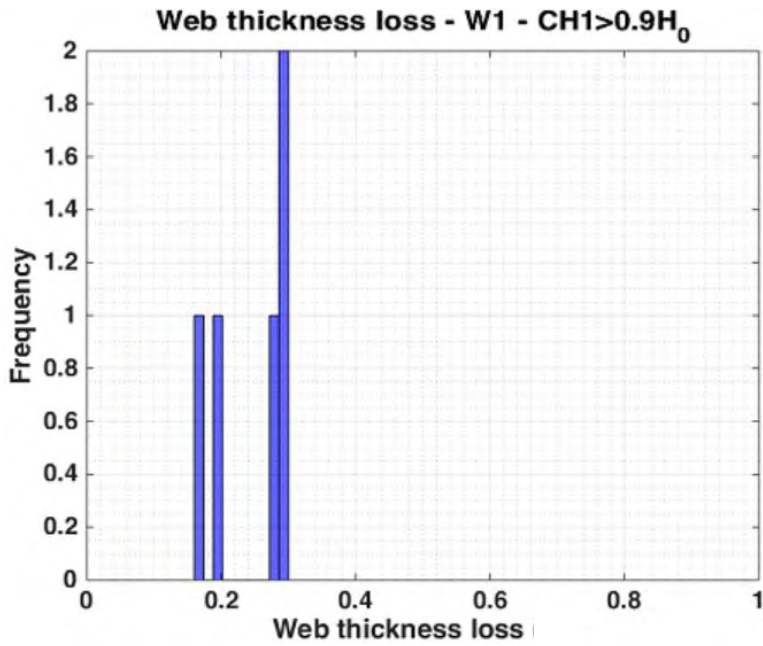
Figure 216 : Web thickness loss for W1 pattern and CH1 < 0.2H0 – CTDOT

Figure 217 : Web thickness loss for W1 pattern and CH1>0.9H0 – CTDOT

Figure 216 and Figure 217 depict the web thickness loss for CH1 < 0.2H0 and CH1 > 0.9H0, respectively.

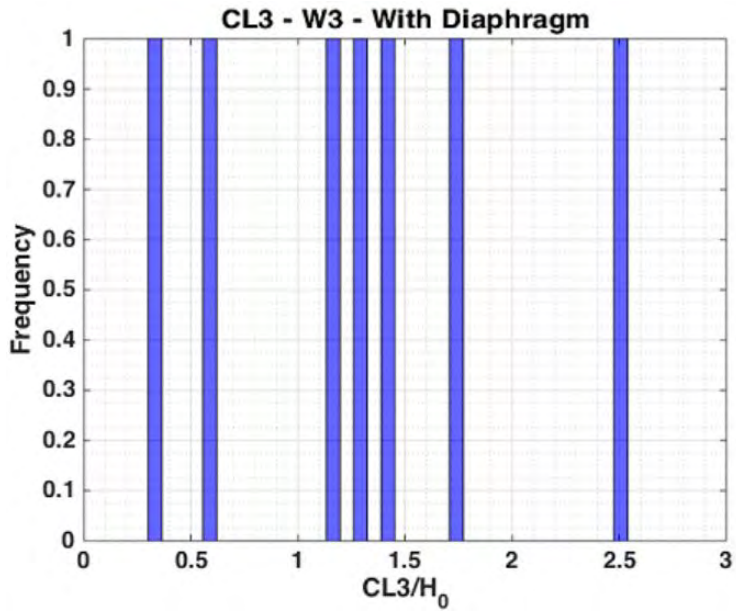
Figure 227: CL3 distribution for W3 pattern for beams with a diaphragm – CTDOT

The other parameters of the W3 corrosion pattern are plotted in Figure 223, Figure 224, Figure 225, Figure 226 and Figure 227.

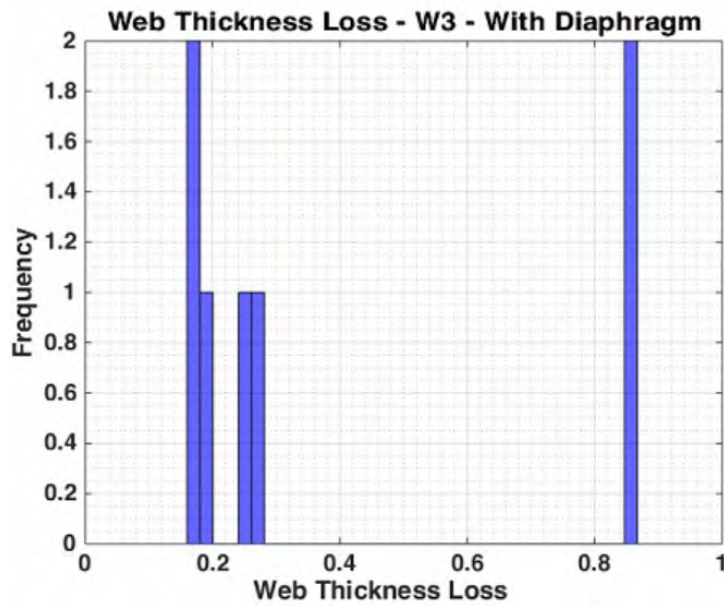
Figure 228 depicts the web thickness loss distribution for pattern W3.

Figure 228: Web thickness loss distribution for W3 pattern for beams with a diaphragm – CTDOT
