1. Report No.	2. Government Accession No.	3. Recipient's Catalog No.	
4. Title and Subtitle Improved Load Rating Procedures for Deteriorated Unstiffened Steel Beam Ends Deliverable 1: Identification of common unstiffened steel beam-end corrosion topologies		5. Report Date August, 2021

15. Supplementary Notes			
16. Abstract This report contains the information regarding the first task of an ongoing project aiming to enhance load rating methods for assessing corroded unstiffened beam ends for the six New England States. The first task of the project aims to collect and compile the information provided by DOTs within New England. Within this task, based on reports provided by the DOTs, the most common corrosion patterns were identified. From the information collected, the research team was able to carefully identify trends and patterns in the data, which allowed the research team to determine the most common scenarios of corrosion encountered in bridges within New England States.

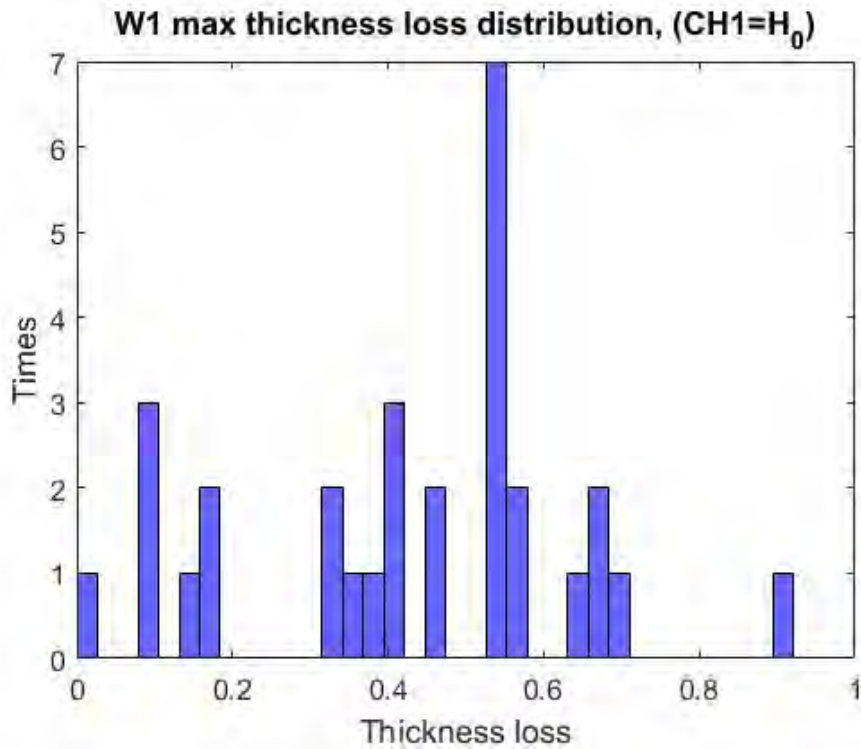
Figure 236: Max thickness loss distribution of full height W1 web corrosion pattern for beams with a diaphragm - MassDOT

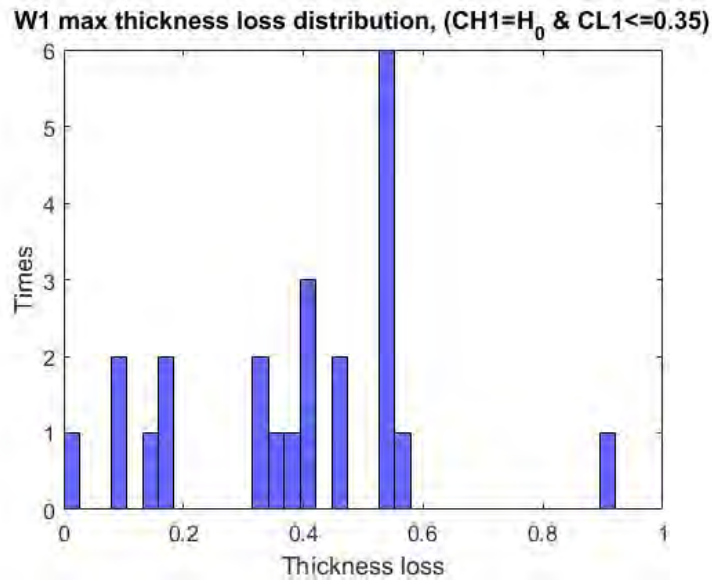
Figure 237: Max web thickness loss distribution of W1 web corrosion pattern, with corrosion height up to 35% of H₀, for beams with a diaphragm - MassDOT

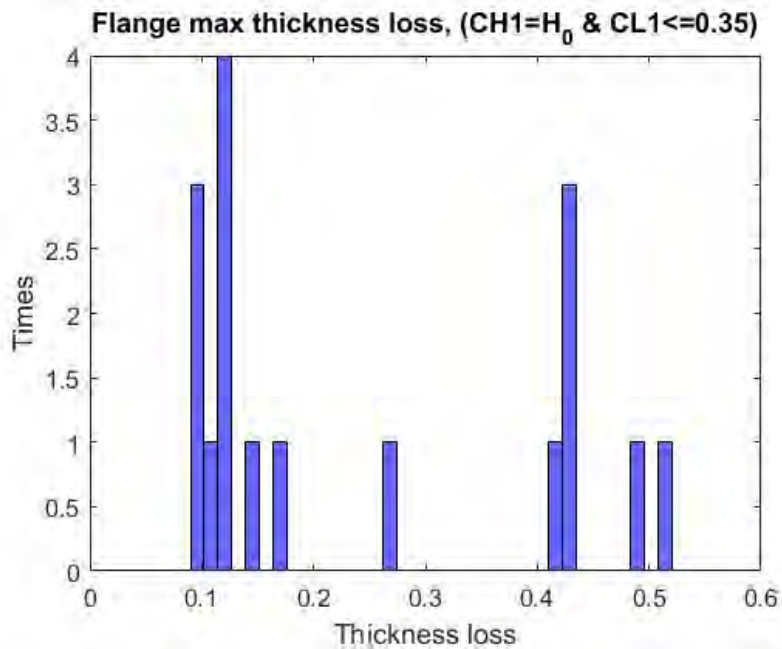
Figure 240: Max flange thickness loss distribution of W1 web corrosion pattern, with full height corrosion and up to 35% of H_0 length, for beams with a diaphragm - MassDOT

Thus, for case A: $\frac{t_{loss}}{t_{flange}}$ takes values of {0.15,0.45} (Figure 240). The ratio of the length of the corroded flange over the length of the corroded web $1 \leq \frac{C_f}{C_l} \leq 1.7$

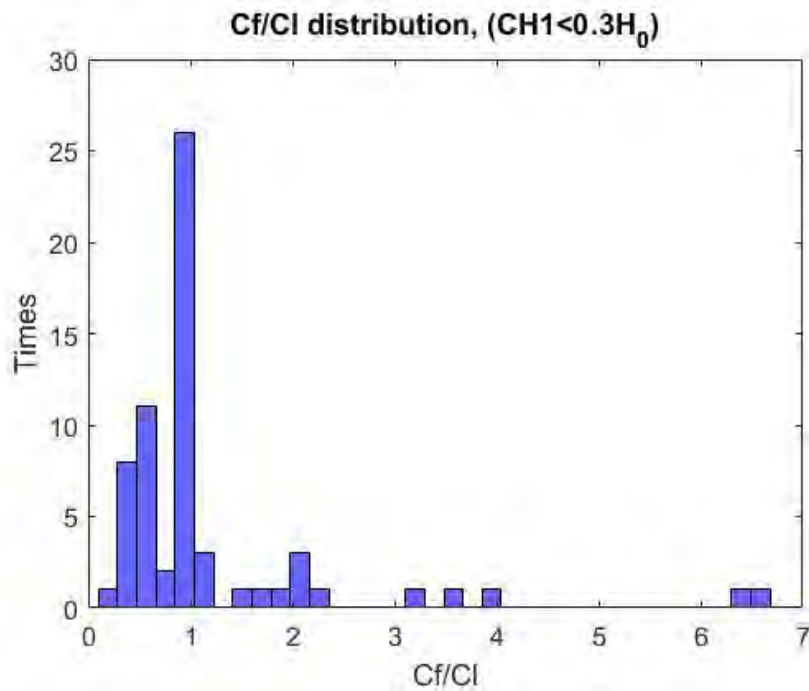
Figure 244: Ratio of flange to web corrosion length distribution of W1 web corrosion pattern with corrosion height up to 30% of H_0 for beams with a diaphragm - MassDOT

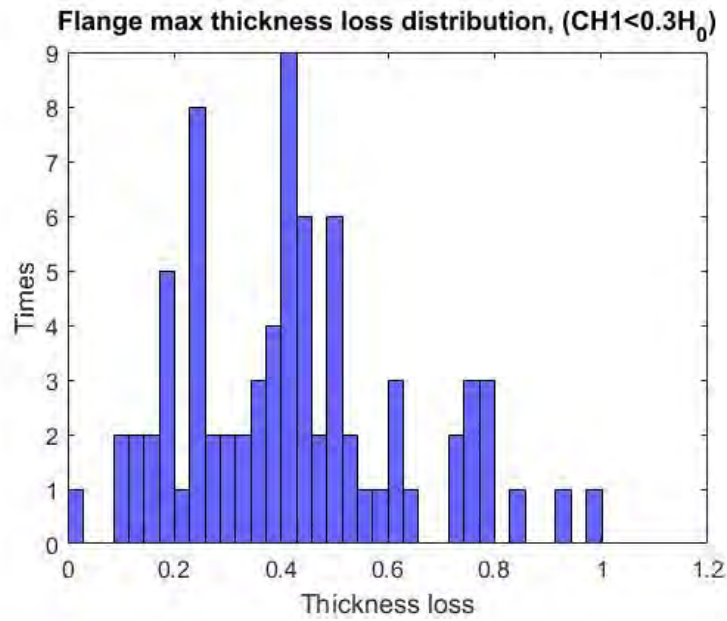
Figure 245: Max flange thickness loss distribution of W1 web corrosion pattern with corrosion height up to 30% of H_0 for beams with a diaphragm - MassDOT

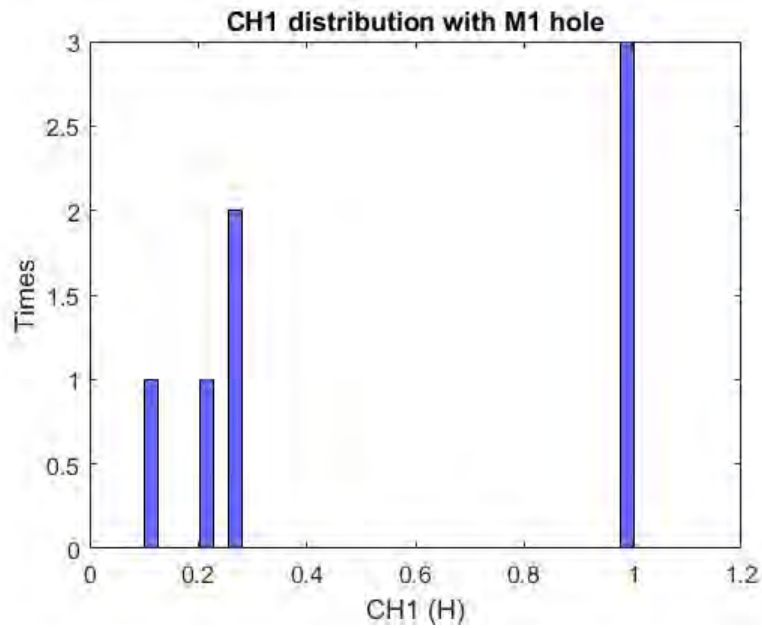
Figure 249: CH1 distribution for beams with M1 hole and W1 web corrosion pattern and a diaphragm - MassDOT

From Figure 249, we can conclude that holes are equally distributed between web corrosion scenarios CASE A and CASE B. It is worth mentioning that there are two cases of long holes that are parallel to flange holes (Figure 248). The two longest holes ($1.3H_0$ and $1.4H_0$) are also the corrosion holes with the highest height (0.18 and 0.21) respectively. As a result, an extreme hole case is considered the following (projected on Case B web corrosion scenario):

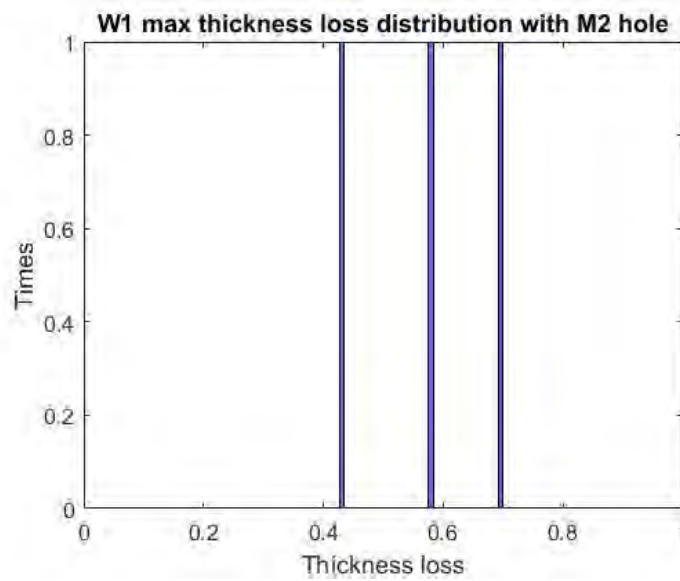
Figure 251. Max thickness loss distribution for W1 web corrosion patterns and M2 hole for beams with a diaphragm - MassDOT

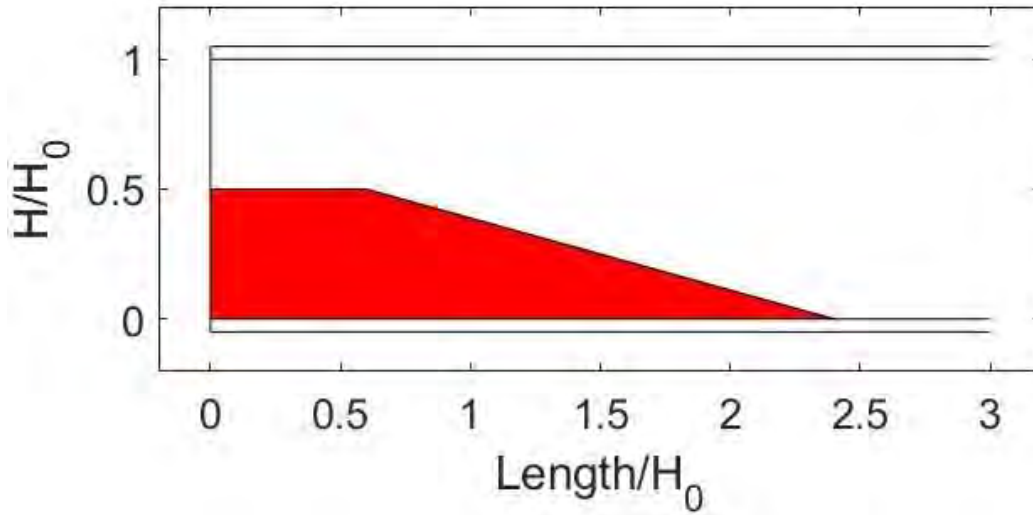
Figure 258: Extreme W2 web corrosion pattern for beams with a diaphragm - MassDOT

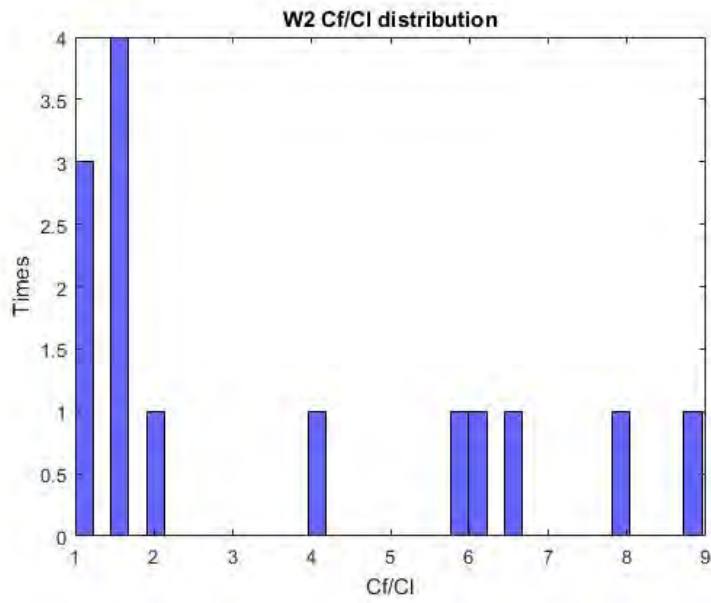
Figure 260: Ratio of flange to web corrosion length distribution of W2 web corrosion pattern corrosion for beams with a diaphragm - MassDOT

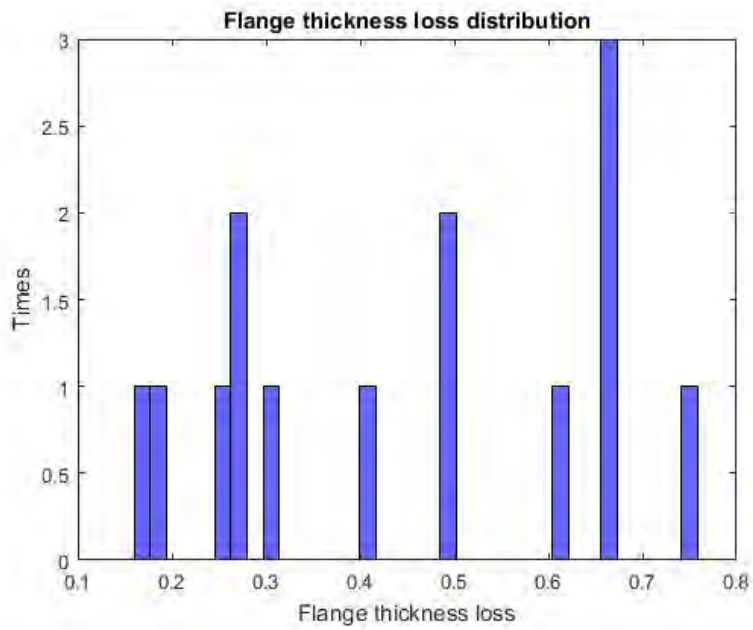
Figure 261: Max flange loss thickness distribution of W2 web corrosion pattern for beams without a diaphragm – MassDOT

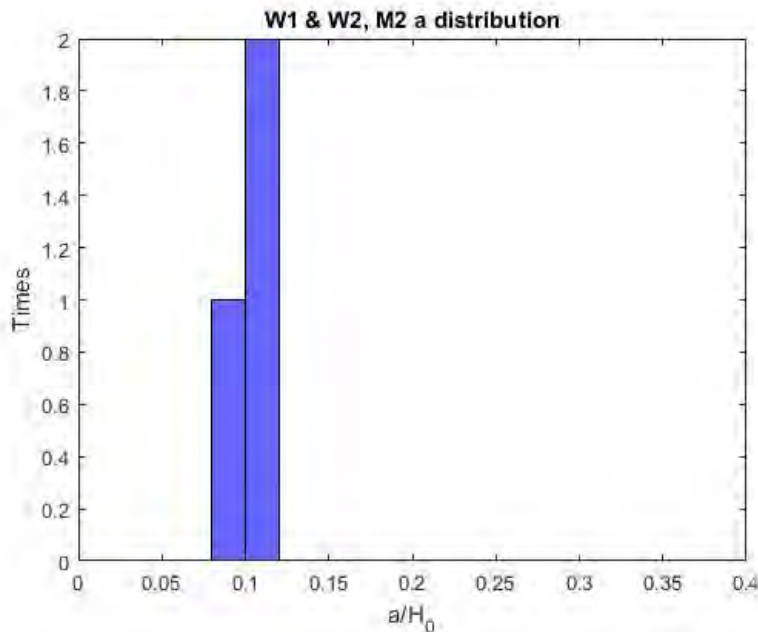
Figure 262: M2 web hole's pattern height distribution of W1 and W2 web corrosion patterns for beams with a diaphragm - MassDOT

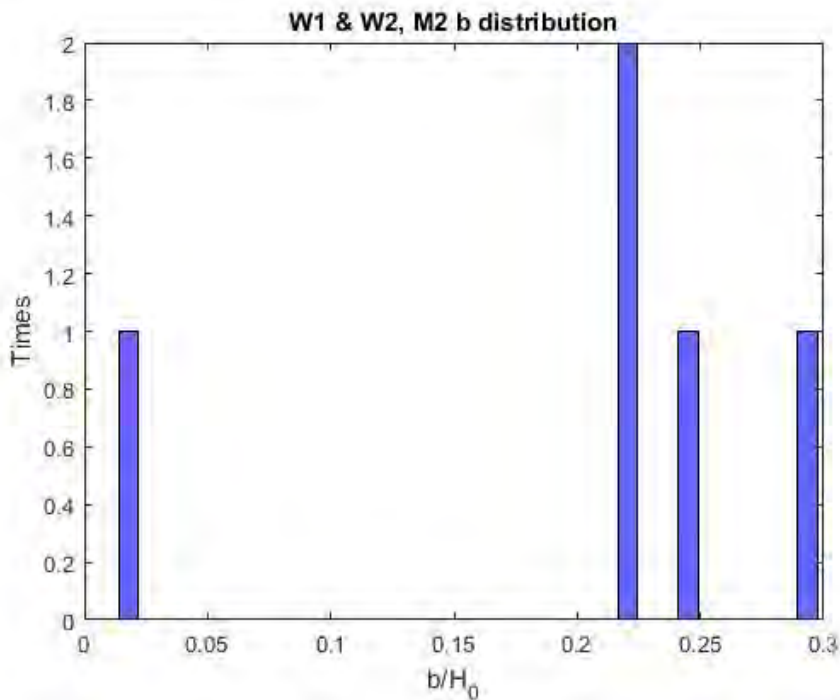
Figure 263: M2 web hole's pattern length distribution of W1 and W2 web corrosion patterns for beams with a diaphragm - MassDOT

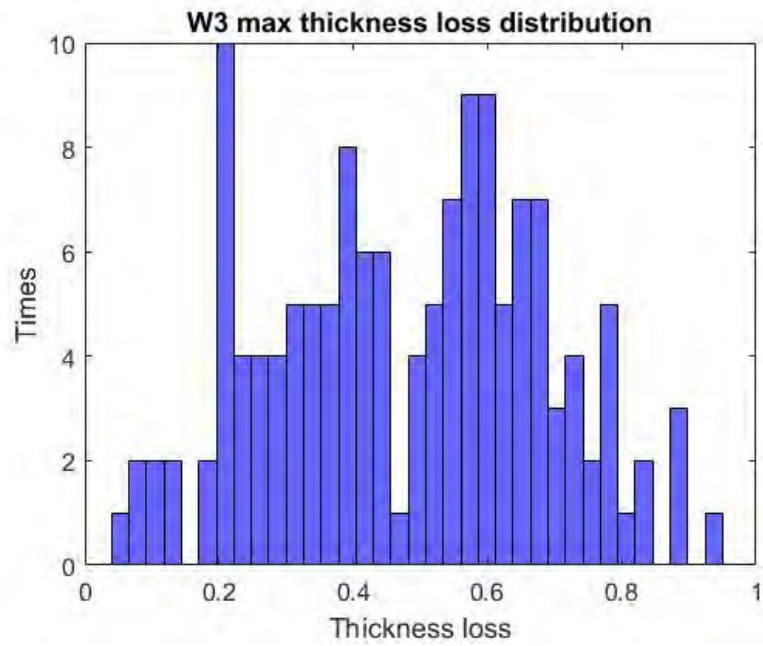
Figure 271: Ma web thickness loss distribution of W3 web corrosion pattern for beams with a diaphragm - MassDOT

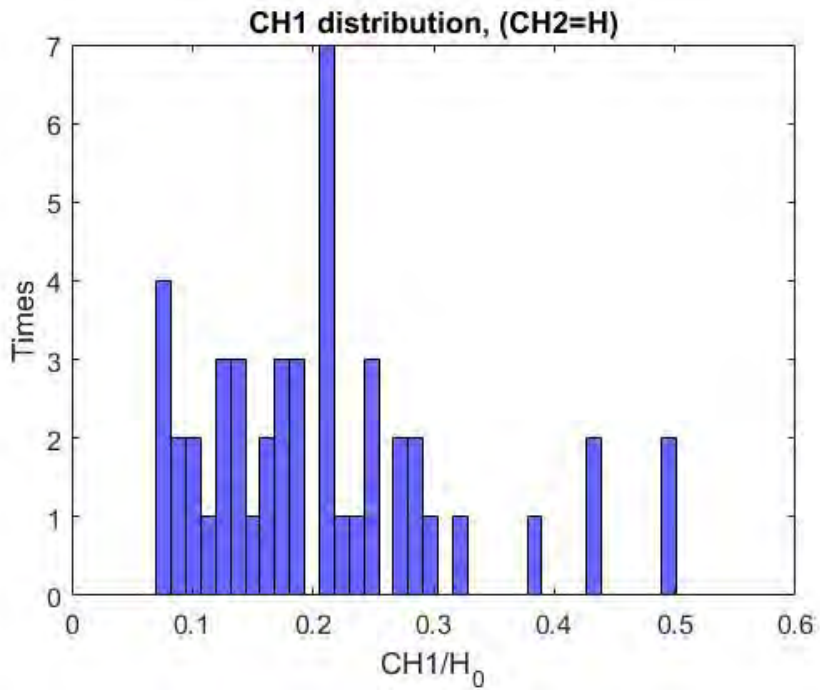
Figure 275: CH1 distribution of W3 web corrosion pattern with full height corrosion for beams with a diaphragm - MassDOT

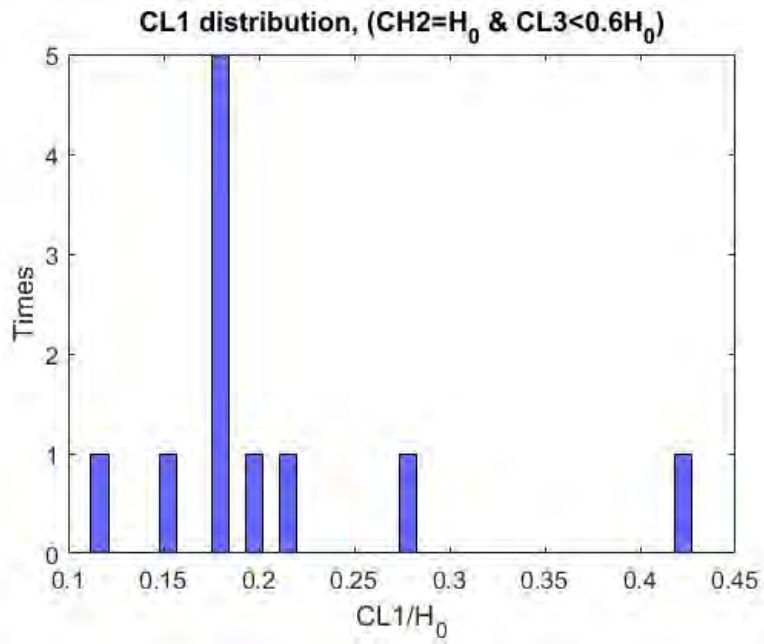
Figure 278: CL1 distribution of W3 web corrosion pattern with full height corrosion and deteriorated length up to 60% of H_0 for beams with a diaphragm - MassDOT

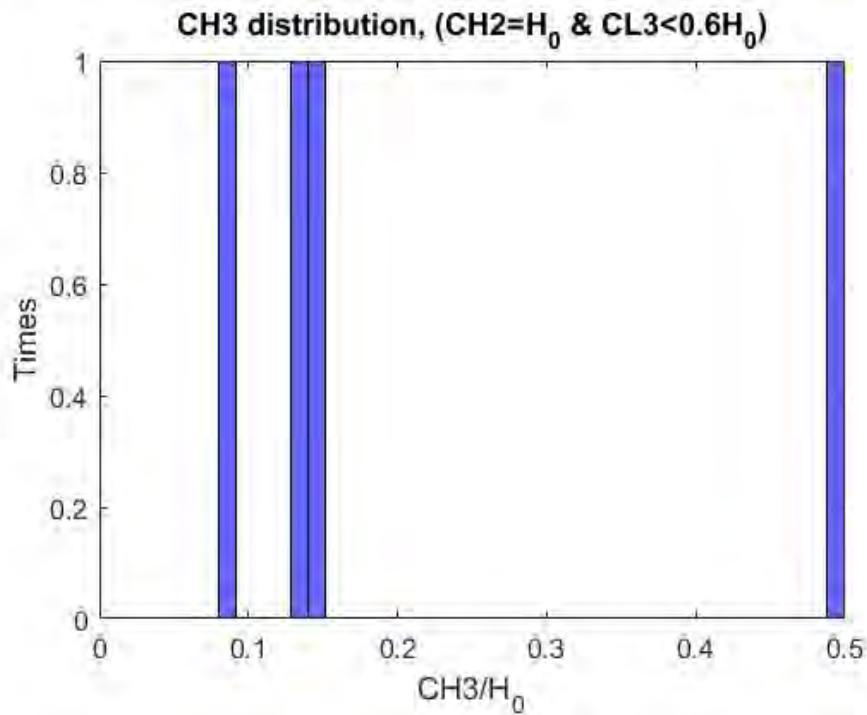
Figure 280: CH3 distribution of W3 web corrosion pattern with full height corrosion and deteriorated length up to 60% of H₀ for beams with diaphragm a - MassDOT

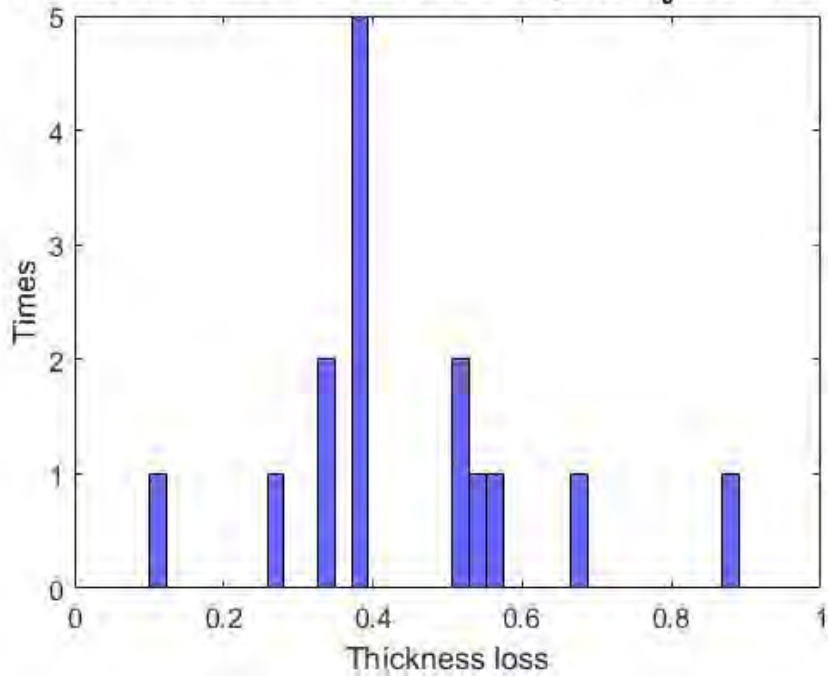
W3 max thickness loss distribution, ($CH2=H_0$ & $CL3<0.6H_0$)

Figure 282: Max web thickness loss distribution, of W3 web corrosion pattern, with full height corrosion and deteriorated length up to 60% of H_0 for beams with a diaphragm - MassDOT

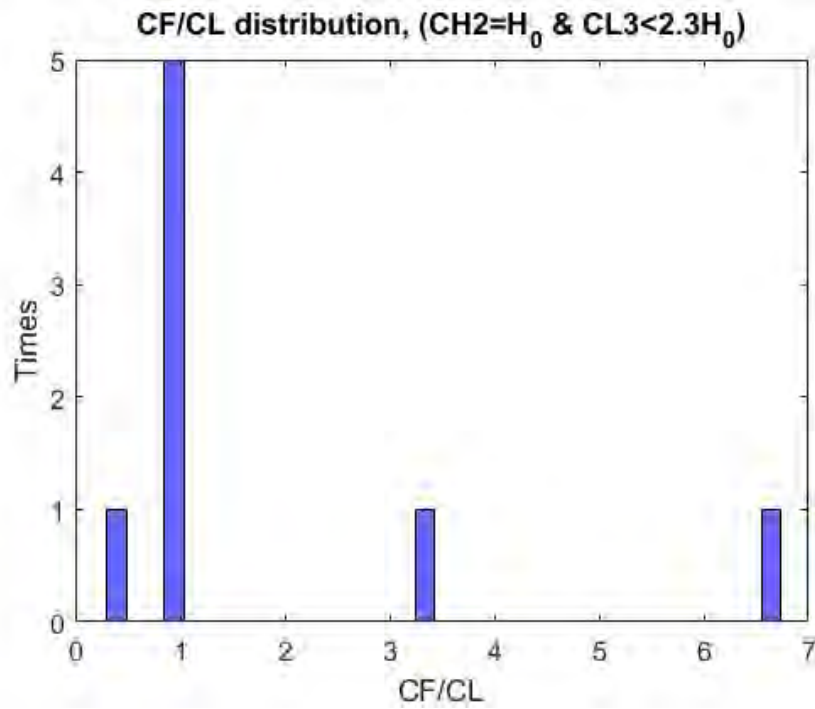
Figure 290: Ratio of flange to web corrosion length distribution, of W3 web corrosion pattern, with full height corrosion and deteriorated length up to 230% of H_0 for beams with a diaphragm - MassDOT

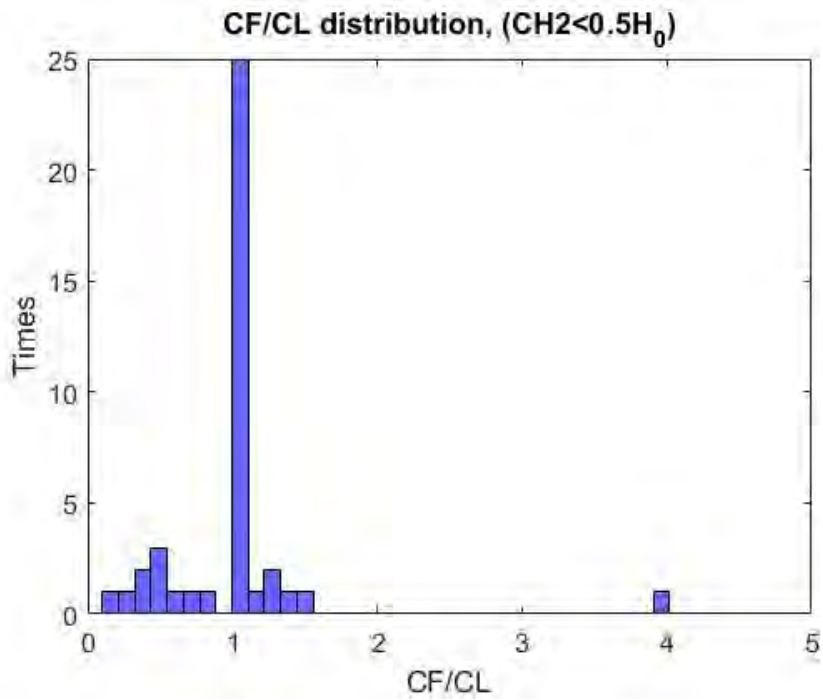
Figure 300: Ratio of flange to web corrosion length distribution, of W3 web corrosion pattern, with corrosion height up to 50% of H_0 , for beams with a diaphragm - MassDOT

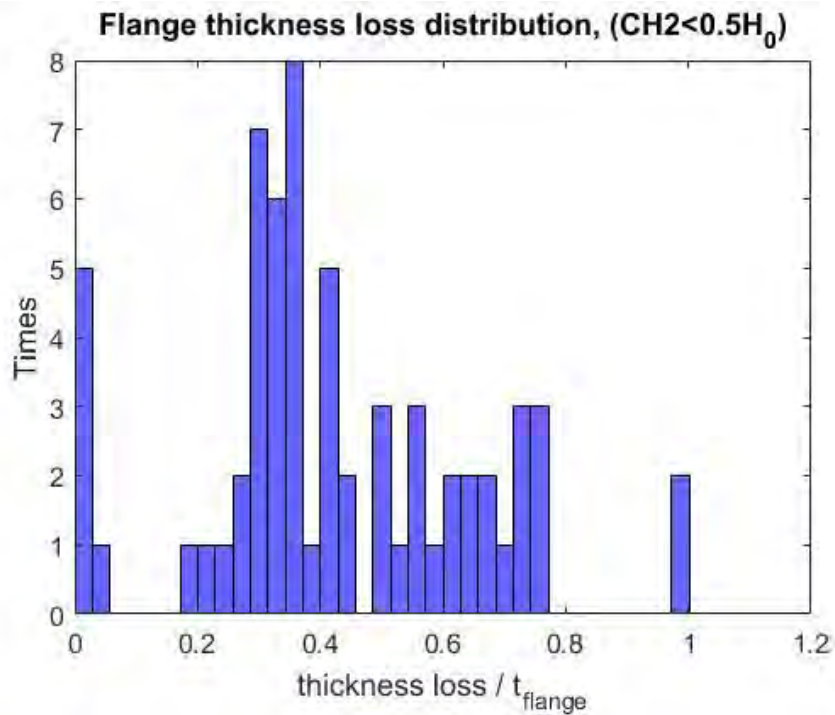
Figure 301: Max flange loss thickness distribution, for beams with W3 web corrosion pattern, with corrosion height up to 50% of H_0 , for beams with a diaphragm - MassDOT

$\frac{t_{loss}}{t_{flange}}$ takes the values of {0.3,0.6,0.8}

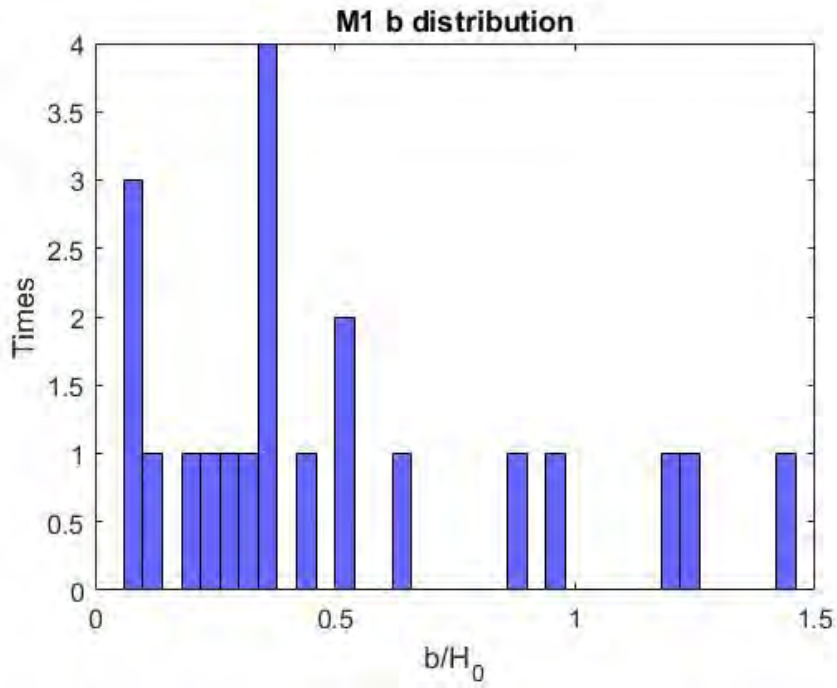
Figure 304: M1 web hole's pattern length distribution of W3 web corrosion pattern for beams with a diaphragm - MassDOT

From the figure above, it was noticed that holes appear mainly at the full height of the corroded web. The holes observed seem to be mainly thin and long across the web. From Figure 305, most of the cases have ratio of hole's length to height up to 6. From Figure 304, the hole length is up to 50% of H_0 . Thus, for the extreme corrosion hole scenario, the hole's height is considered as 0.083.

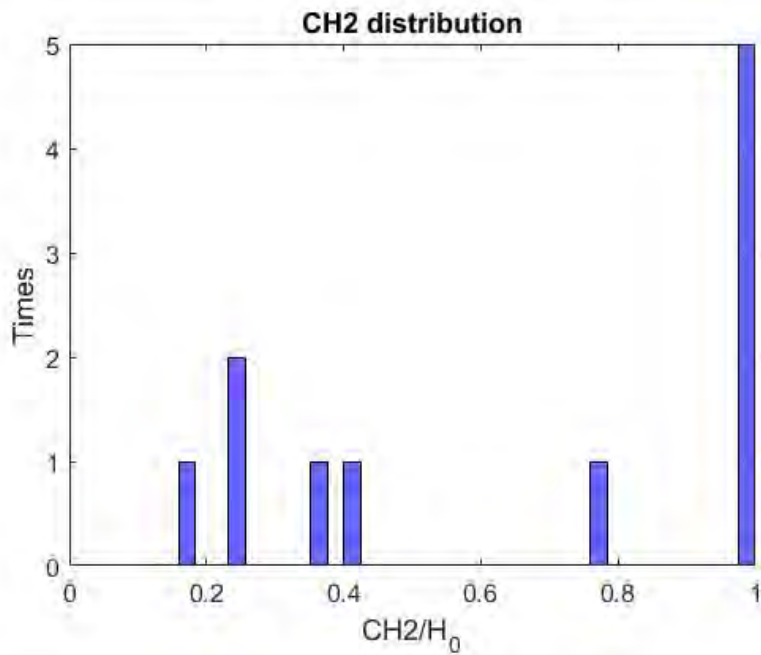
Figure 309: CH2 distribution of W4 web corrosion pattern for beams with a diaphragm - MassDOT

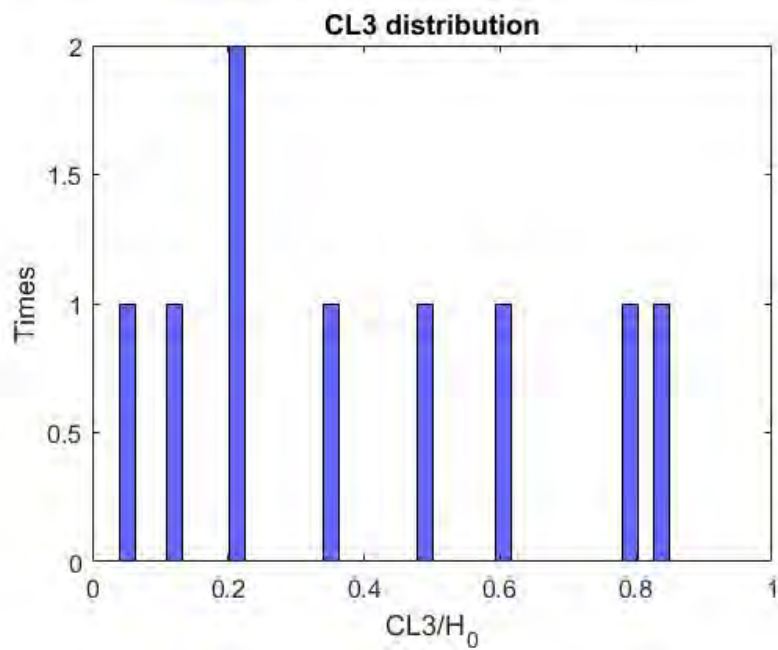
Figure 313: CL3 distribution of W4 web corrosion pattern for beams with a diaphragm - MassDOT

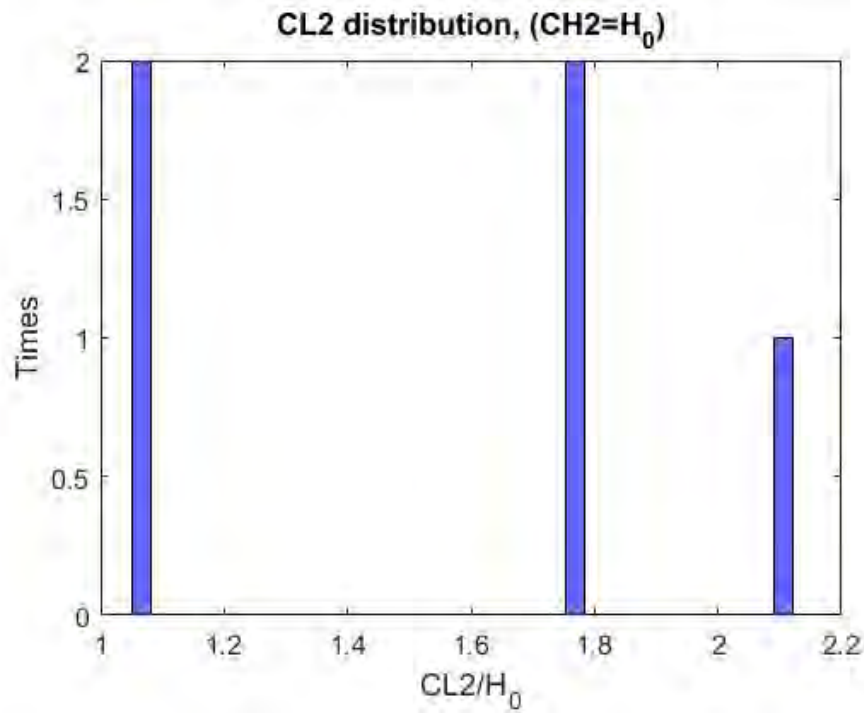
Figure 316: CL2 distribution of W4 web corrosion pattern with full height corrosion for beams with a diaphragm - MassDOT

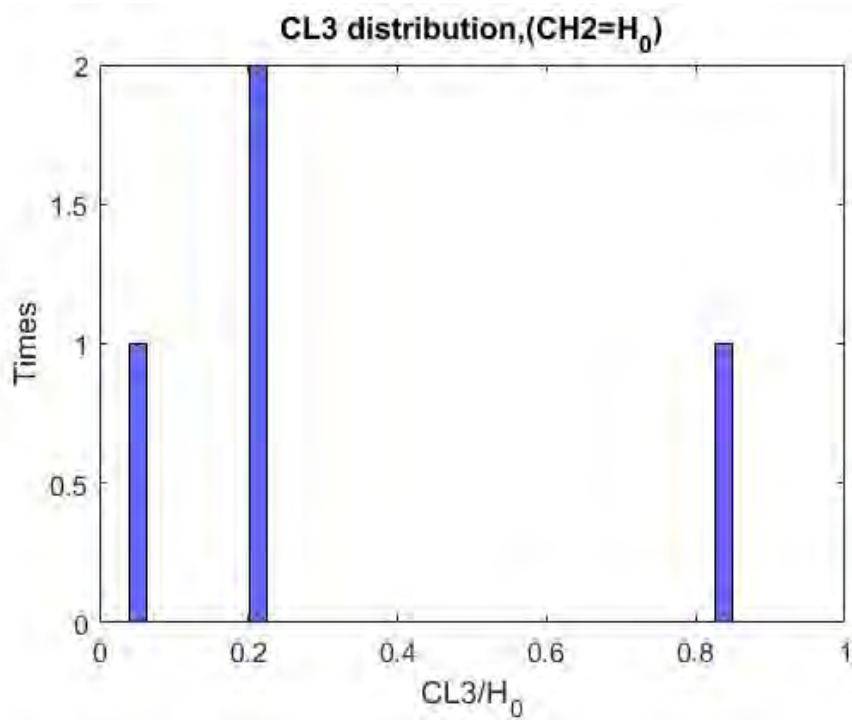
Figure 317: CL3 distribution of W4 web corrosion pattern with full height corrosion for beams with a diaphragm - MassDOT

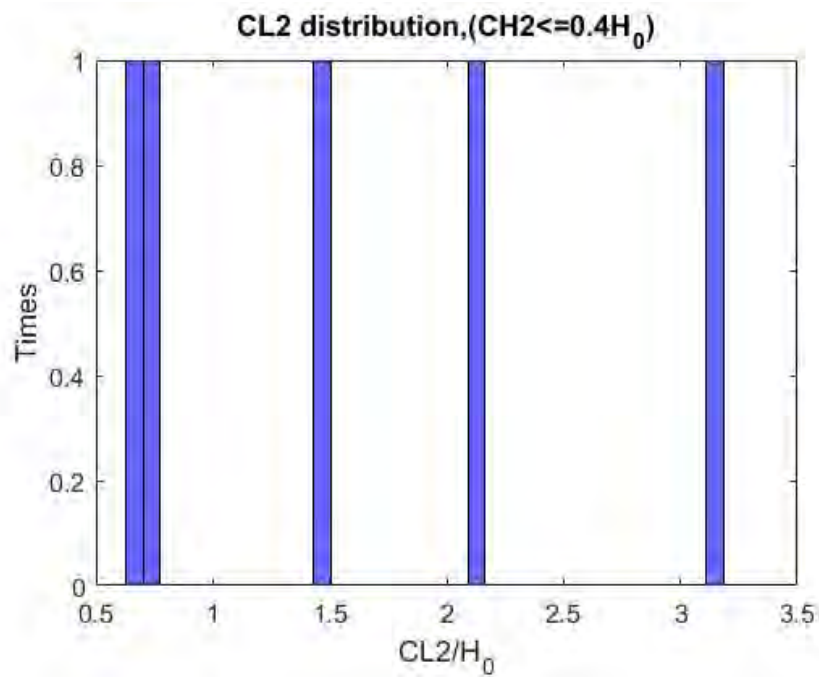
Figure 323: CL2 distribution of W4 web corrosion pattern, with corrosion height up to 40% of H₀, for beams with a diaphragm - MassDOT

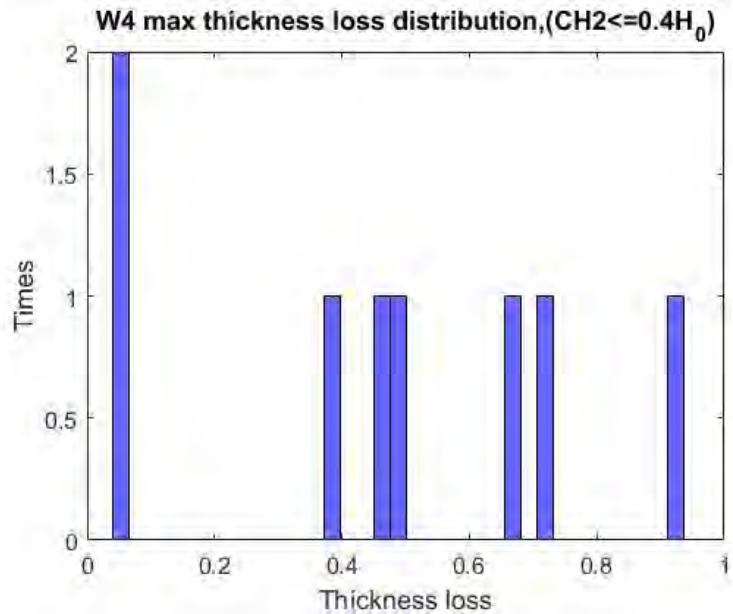
Figure 324: Max web thickness loss distribution of W4 web corrosion pattern, with corrosion height up to 40% of H_0 , for beams with a diaphragm - MassDOT

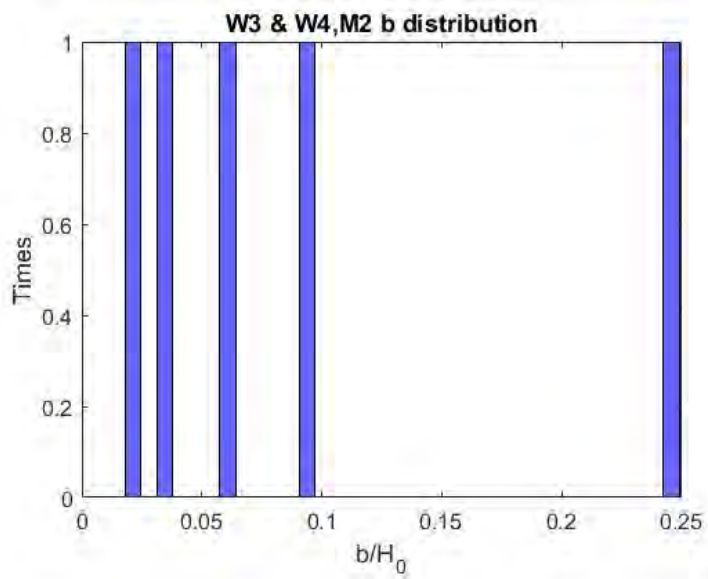
Figure 327: M2 web hole's pattern length distribution of W3 and W4 web corrosion pattern for beams with a diaphragm - MassDOT

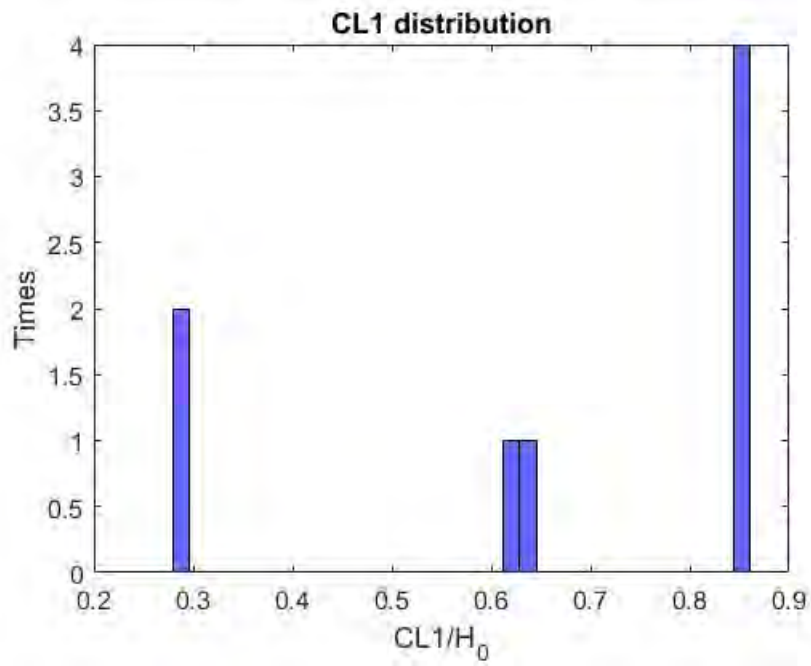
Figure 330: CL1 distribution of W4 web corrosion pattern for beams with a diaphragm - MassDOT

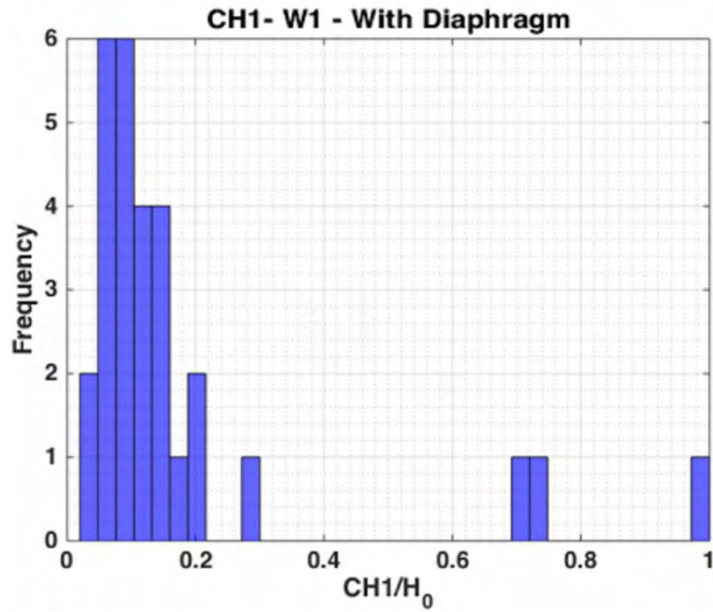
Figure 336: CH1 distribution for beams with diaphragm and W1 corrosion pattern – RIDOT

Figure 336 clearly depicts that $0 < CH_1 \leq 0.2H_0$. With the goal of understanding the relationship between the other parameters of corrosion and the corrosion height, our team had to analyze the behavior of the other parameters given that $CH_1 < 0.2H_0$. Figure 337 and Figure 338 depict the length of corrosion and the web thickness loss for this case.

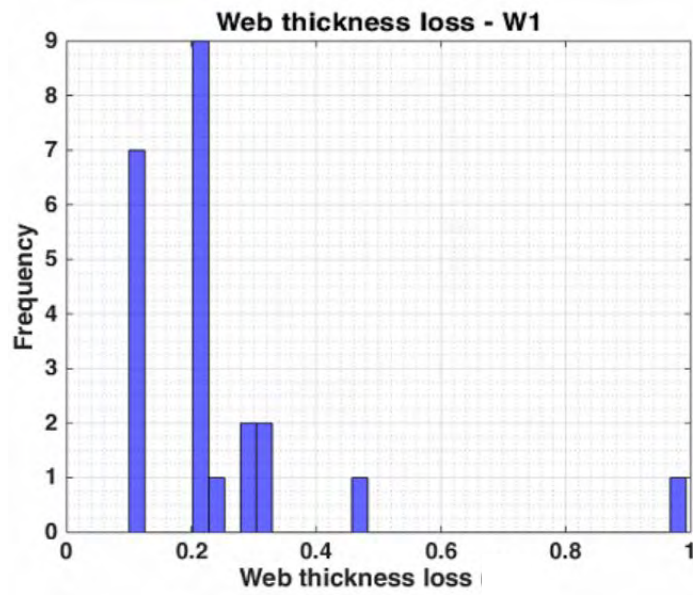
Figure 338: Web thickness loss distribution for beams with diaphragm and W1 corrosion pattern – RIDOT

Figure 338 depicts the distribution of web thickness loss given that $CH1 < 0.2H_0$.

From Figure 338, our team assumed that most of the beams have web thickness loss found in the following interval:

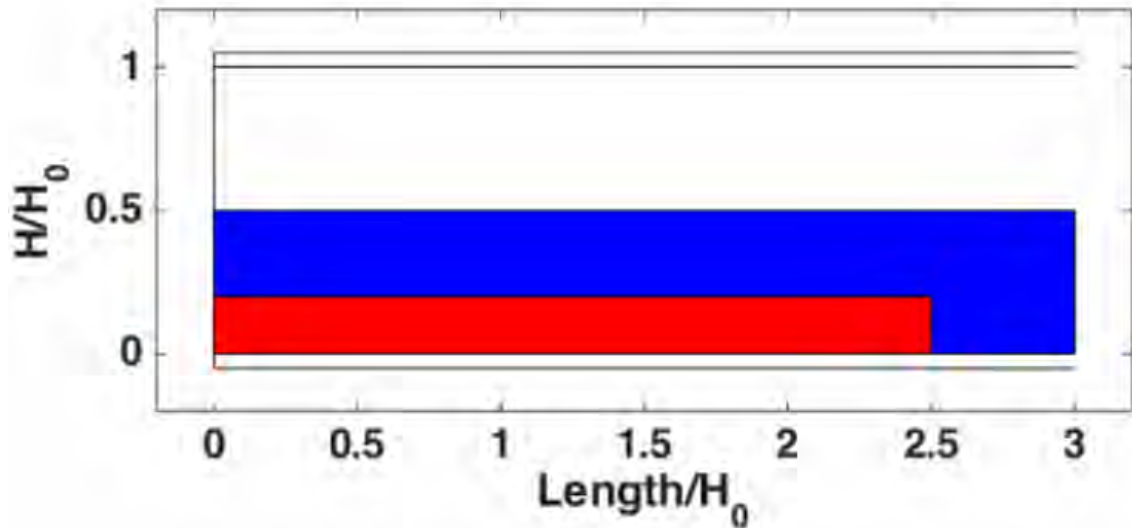
Figure 340: Comparison between extreme corrosion scenarios. Blue represents the extreme scenario for beams without diaphragm, whereas the region in red depicts extreme corrosion scenario for beams with a diaphragm – RIDOT

Figure 340 describes the comparison between the extreme corrosion case pattern for the W1 corrosion pattern of beam ends with and without a diaphragm system.

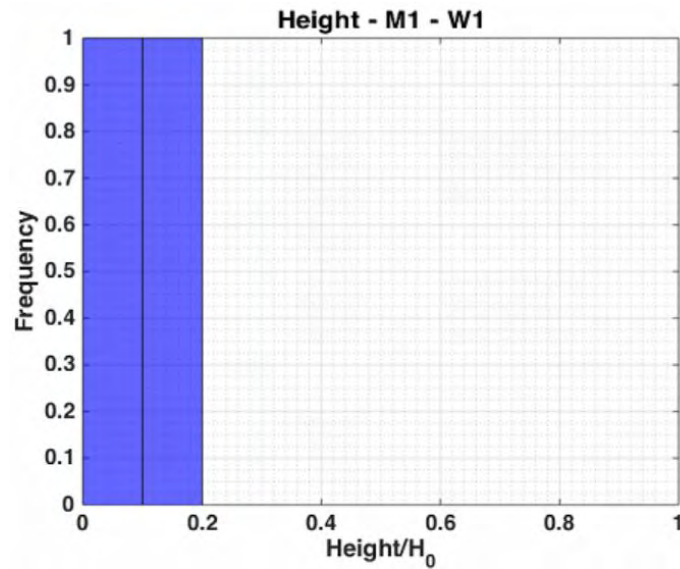
Figure 344: Height of M1 holes combined with W1 pattern – RIDOT

As showed in Table 56, just three holes were recorded combined with the W1 corrosion pattern. Due to the small amount of available data, it was not possible to detect any trends. For this reason, Figure 344 and Figure 345 depict the dimensions of the M1 corrosion holes. Figure 346 and Figure 347 depict the dimensions of the M3 corrosion hole.

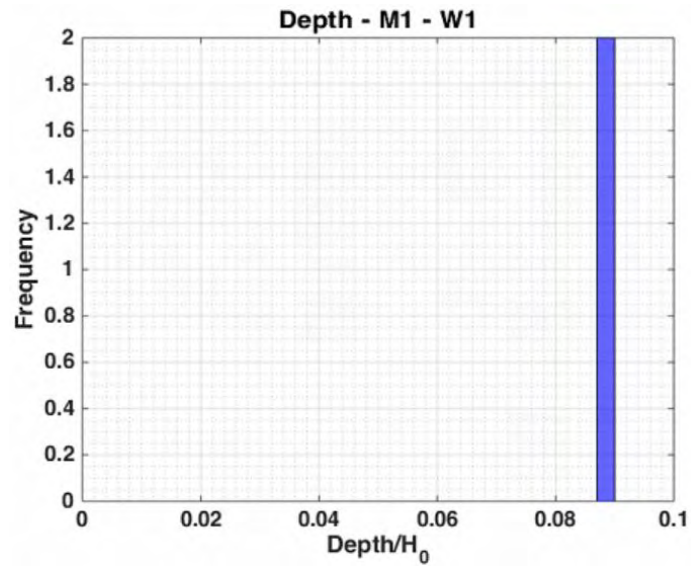
Figure 345: Depth of M1 holes combined with W1 pattern – RIDOT
