Improved Load Rating Procedures for Deteriorated Unstiffened Steel Beam Ends

- **Current State of Inspection and Corrosion Topologies**
- **Corrosion Mapping via 3D Scanning**
- **Laboratory Experiments and Capacity Evaluation of Rolled Girders with Corroded Ends**

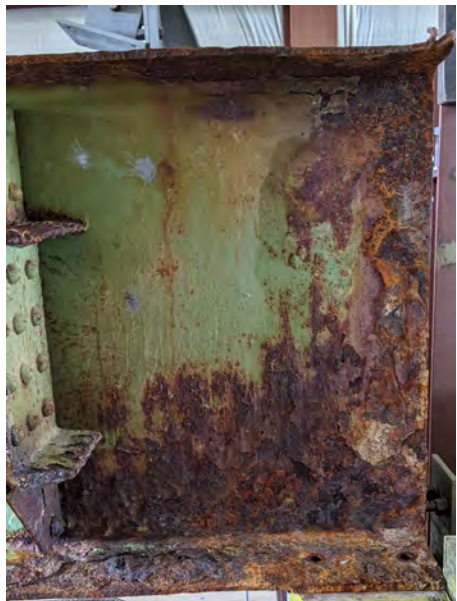
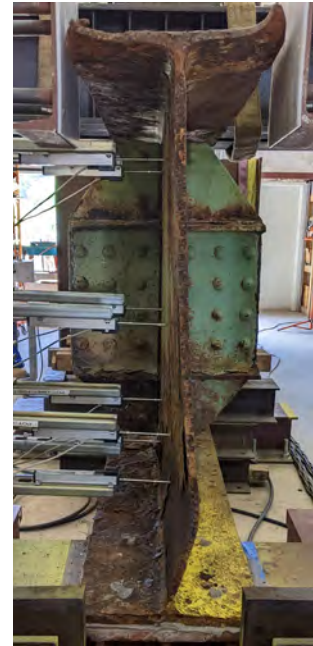
Beam Type: CB 24x8.5 (Best match)
Intact Thickness: 0.42 inches
Height: 24 inches

Peak Load:
113.27 kips

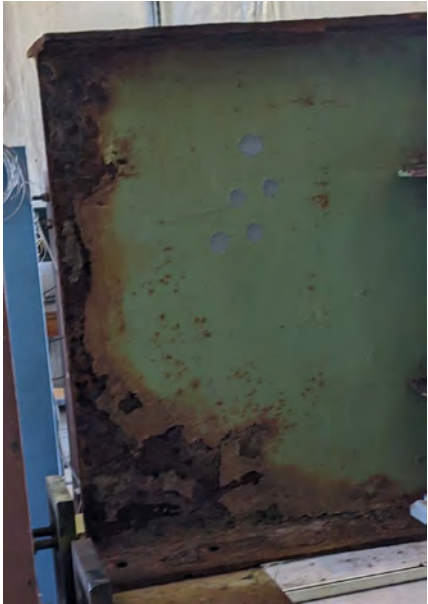
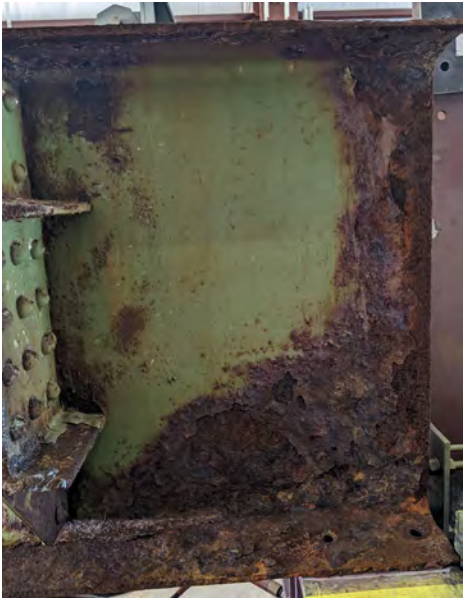
Beam Type: B33x132 Assumed
Intact Thickness: 0.58 inches
Height: 33.150 inches

Peak Load:
 224.14 kips

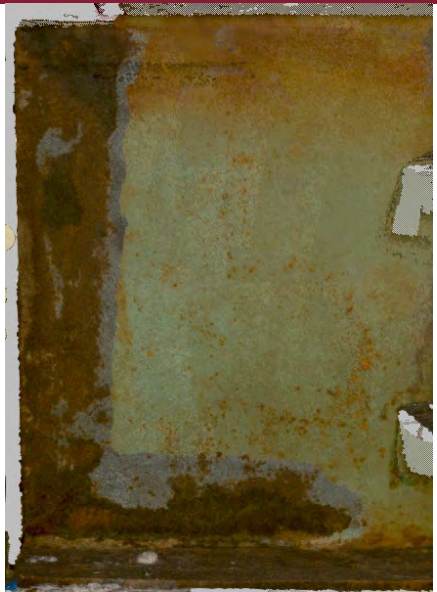
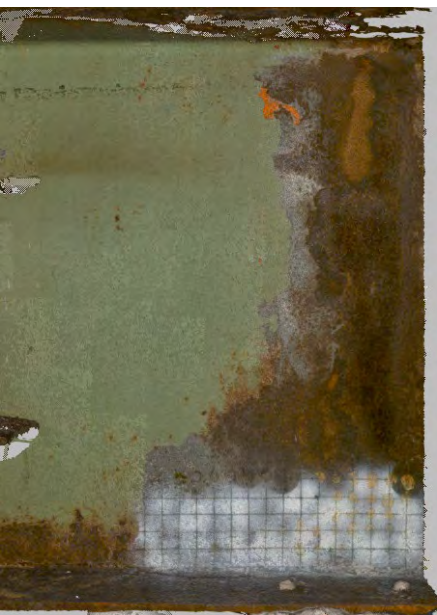
Beam Type: B33x132 Assumed
Intact Thickness: 0.58 inches
Height: 33.150 inches

Peak Load:
211.06 kips

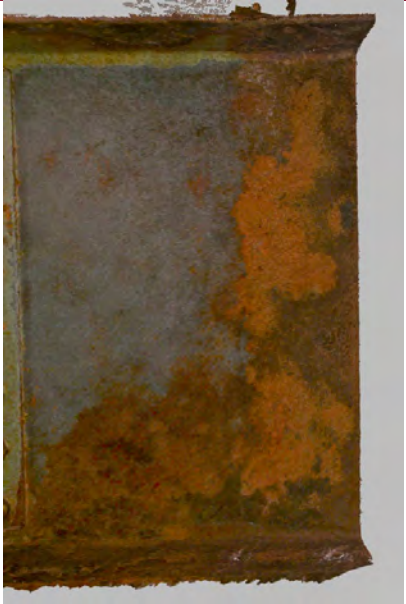
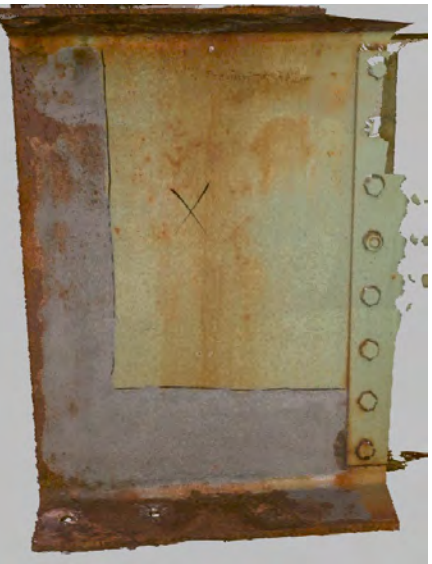
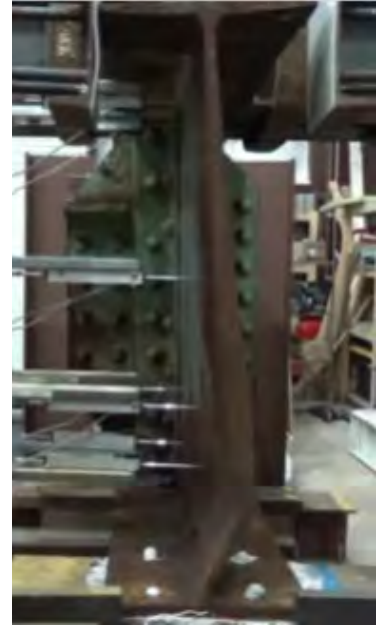
Beam Type: B33x132 Assumed
Intact Thickness: 0.58 inches
Height: 33.150 inches

Peak Load:
 247.36 kips

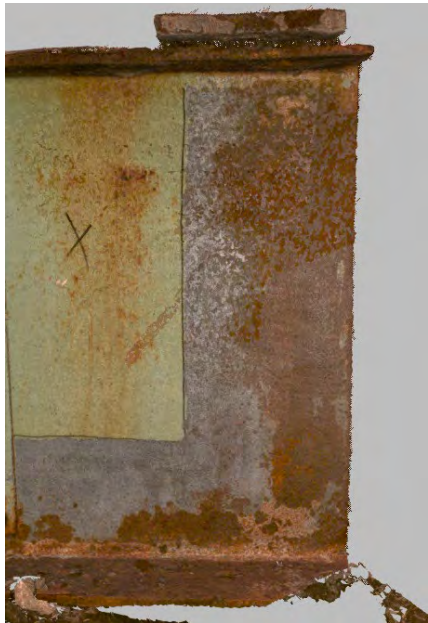
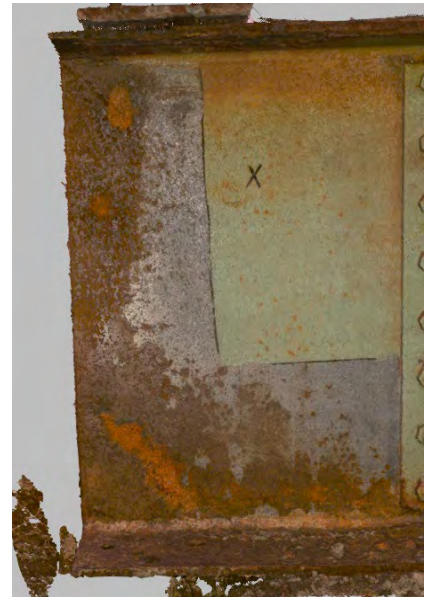
Beam Type: B33x132 Assumed
Intact Thickness: 0.58 inches
Height: 33.150 inches

Peak Load:
257.31 kips

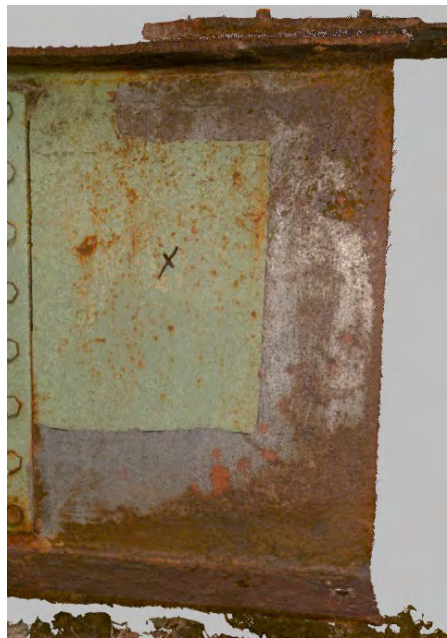
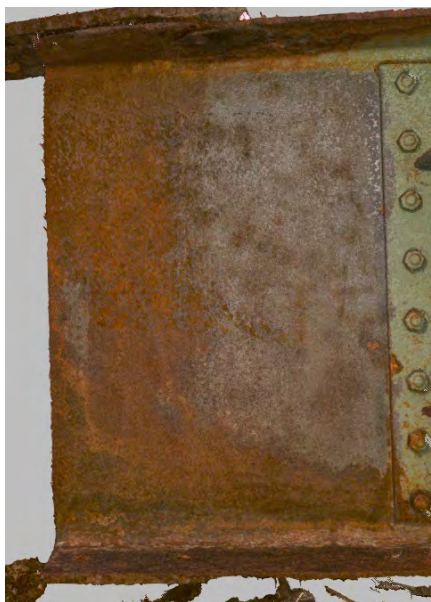
Beam Type: B33x132 Assumed
Intact Thickness: 0.58 inches
Height: 33.150 inches

Peak Load:
267.14 kips
